# Greenham and Crookham Commons Access Audit

*Initial baseline findings of the site's physical and intellectual access provisions.*

**Author: James Stevenson, BBOWT West Berkshire Access Audit Officer**

**Date: 27<sup>th</sup> April 2015**

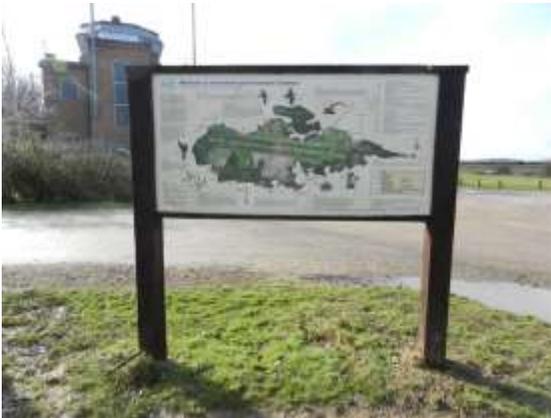
10/02 2014	G4	SU 49908 65072	<p>Commons interpretation sign within the control tower car park, one of 3 located in the three car parks. The sign is made of GRP and gives the visitor a lot of information with regards the history and wildlife present on the Commons. Some of the information is out of date and the branding no longer reflects</p> <p>On the back side of the sign is a hastily fixed 'Don't leave your valuables in the car' warning sign.</p> <p>Size: Display board; 147.5cmx73cm. Frame; 172cmx80cm and 163cm tall.</p> <p>Condition: The wooden frame is tired looking and some of the wooden trim around the board is coming away and broken. Overall appearance is dirty and in poor condition. The contact details are now incorrect.</p>	<p>Suggestions: The sign is due for replacement as the text is out of date, the waymarked routes will likely be changed and the contact details are now obsolete. The sign needs to be redesigned the same time as any waymarking occurs. The wooden frame has also badly deteriorated and needs renovation. The location is not appropriate as vehicles can park in front of the sign and make it unapproachable to those wanting to view, especially those in wheelchairs or who have walking aids. The sign itself may become redundant in this location due to the plans to renovate the control tower, depends if there will be information on the outside of the building viewable outside opening hours. The sign is included within Phase 2 of the signage replacement project. The waymarking has become defunct and needs replacing as part of a new board.</p>	4	2	No.

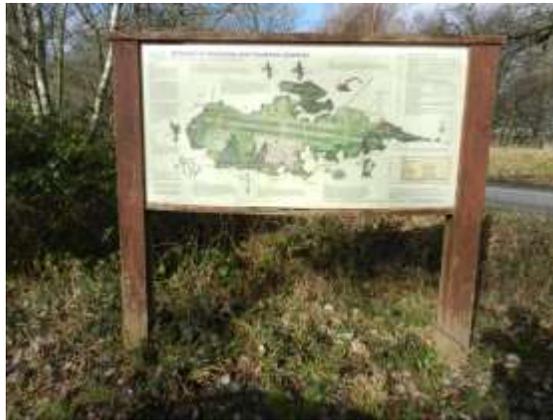
Date Visited	Report Ref.	Location	Findings	Recommendations	Priority Level	Cost Band	Any Work Completed?
10/02 2014	G5	SU 52333 64570	This sign is the same as that in G4. The condition is a little worse as the GRP has hazed and is bowing out of the frame. The location is also not suitable as cars can park in front of the sign and block access for those wishing to view it.	The same as for G4	4	2	No.

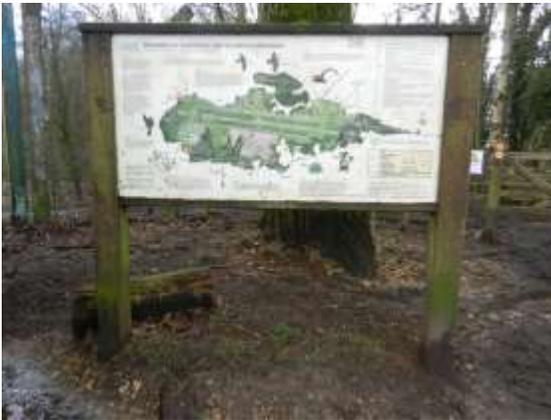
10/02 2014	G7	SU 48379 65275	This is the same sign as in target note G4 and G5 and is placed here at Pyle Hill car park. The same suggestions apply here including the accessibility. In addition the location of this sign is inappropriate to those wishing to read the information due to vehicles parking and manoeuvring in front of the sign. It is also very dirty and requires regular cleaning.	The recommendations are the same as in G4 and G5. The sign should be moved to the other side of the hard standing so it can be viewed by visitors entering the eastern gate. Any new sign is likely to be part of a larger re-modelling of the location and should be given ample safe access.	3 4	1 2	The sign was cleaned in June 2014.

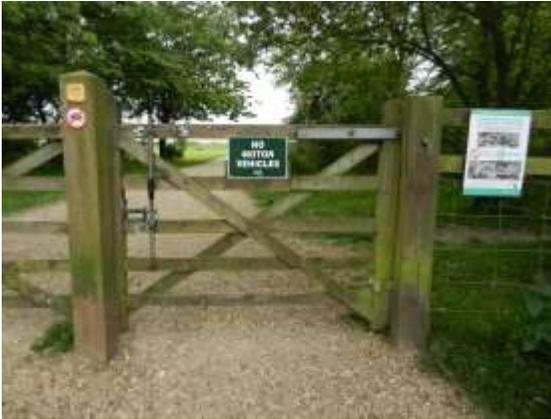
20/05 2014	G21	SU 4987 6500	Wooden bridle gate fitted with an 'easy latch' extended handle. The ground through the gate is compacted naturally present gravels, wear has meant that the ground has hollowed and water pools. The gate is fitted with off-set hinges and no post preventing opening too far. 145cm accessible gap. This gate is the most used access point from the car park and thus the fixtures are worn but are in working condition.	A wooden gate is more aesthetically pleasing than a metal gate that would sustain heavy use. Therefore regular maintenance checks and oiling as part of the general condition checking of the car park is required. The ground through the gate needs to be raised to prevent water pooling.	2	1	No.

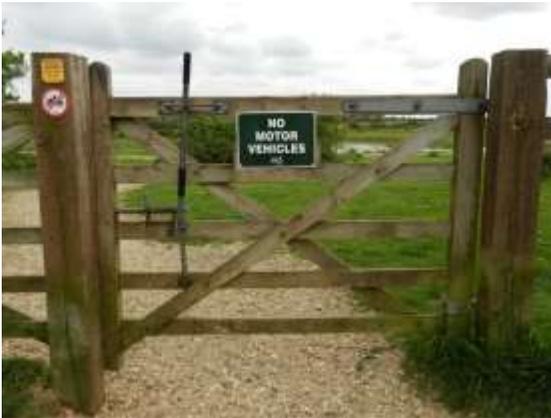
20/05 2014	G23	SU 4995 6506	Wooden bridle gate. 'Easy latch' extended sprung handle fitted incorrectly and is very worn making operation difficult. Displays: no motor vehicle, no motor cycle and stock grazing discs/signs. Ground through the gate is naturally occurring gravels. 146cm accessible.	Re-fit the latch system so it functions correctly.	2	1	No.

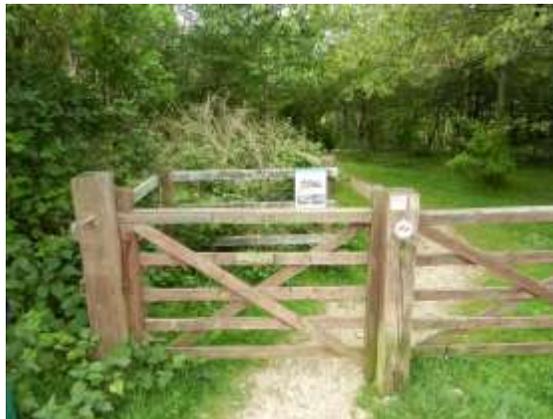
20/05 2014	G25	SU 4998 6513	Wooden bridle gate fitted with a return spring. Simple triangular latch. Latch post is loose in the ground (possibly rotten). Gate does not automatically return. No vehicle sign missing. Natural ground through the gate which is becoming vegetated.	Repairs/modifications required so the gate returns to closed position. An 'easy latch' extended handle would be beneficial to those in wheelchairs or on horseback for example. Clear vegetation so the gates full accessible width can be used without interference.	2	1	No.
------------	-----	--------------	---	---	---	---	-----

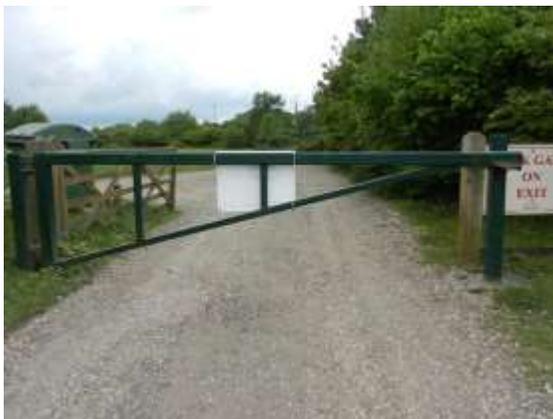
Date Visited	Report Ref.	Location	Findings	Recommendations	Priority Level	Cost Band	Any Work Completed?
20/05 2014	G27	SU 5004 6519	1x 5 bar wooden field gate and 1 x green painted metal vehicle access gate, swing type, locked with an estate padlock. Wooden gate needs adjusting. Both in good condition. Access to the maintenance building (Estovers) and the livestock pens.	Adjust wooden gate.	3	1	No.
20/05 2014	G28	SU 5004 6528	Wooden bridle gate fitted with gravity catch. This type of latch requires the user to lean over to open the gate and so is not useable by those seated, on horse back or who are of short stature or physically disabled. Displays: stock grazing, old and incorrect nesting bird season discs. Ground nesting bird zoning sign to the right of the gate. Gate has split.	Remove the old nesting bird disc. Recommend removal of gravity catch and fit an extended handle easy latch system.  Clear vegetation through the full accessible width of the gate.  Repair wooden structure.	3 4	1 1	Old disc has been removed.

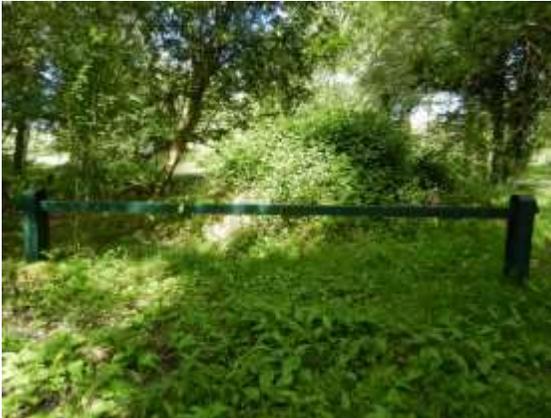
20/05 2014	G38	SU 5032 6523	Green painted sliding metal vehicle barrier. 4m accessible gap. There was once an accessible road past the barrier. A large mound of earth has been deposited behind the barrier so essentially the barrier has become redundant.	If no longer required and for purely aesthetics, remove the barrier.	4	1	No.

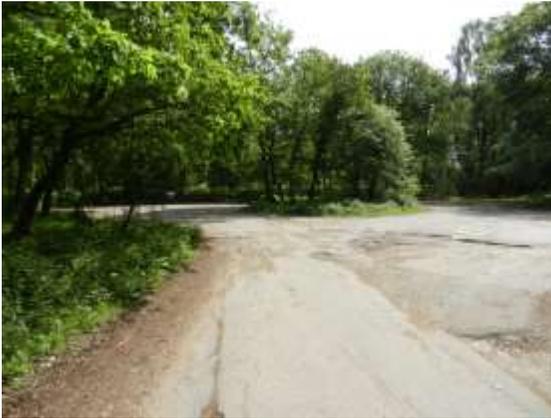
20/05 2014	G40	SU 5054 6527	Informal car park for the Bomb Site area of BBOWT's Bowdown Woods. Also is useful for those wanting to access the area south of the car park. The surface is made up of different ages of sealed surface and also compacted gravels. Condition is poor with large potholes. Joint ownership BBOWT/WBC and now BBOWT manages the entire area. Low branches protruding into informal parking area around the edge.	A new surface throughout the car is required. There is no priority disabled parking space and so this should be considered when installing a new surface. The Bomb Site are has sealed tracks and is therefore suitable to those using wheelchairs or pushchairs. A smooth car park surface would facilitate access to these user groups.	2 4	1 3	No.

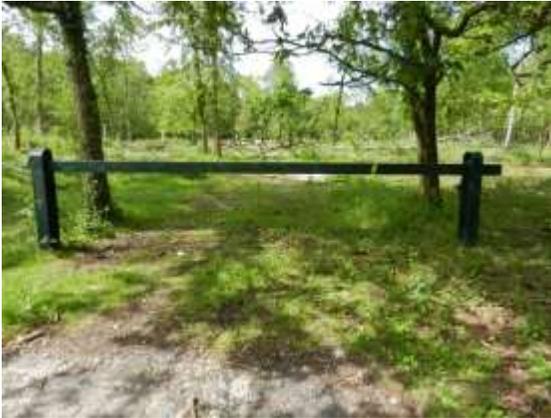
20/05 2014	G41	SU 5053 6527	Green painted sliding metal vehicle barrier. Welded bar. 4m accessible gap. There was once an accessible road past the barrier. Prevents vehicle access into the cleared area south of the barrier.	None	n/a	n/a

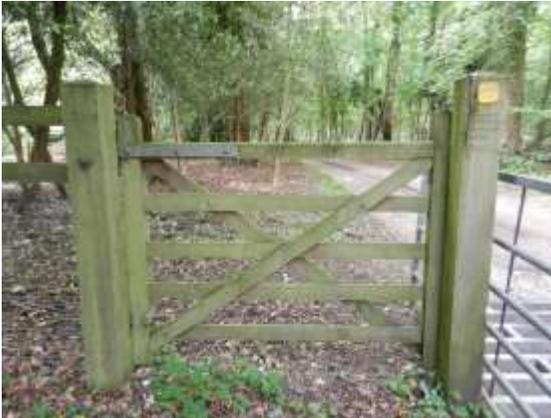
20/05 2014	G44	SU 5054 6504	Wooden bridle gate to the east of the cattle grid (G43). Useful to those living in the neighbouring private properties if they should want to ride onto the Commons. Displays two dirty stock grazing discs. The gate is fitted with a simple striker and triangular gravity latch.	To assist t horse riders or those with short stature or disability, it would be beneficial to fit an extended easy latch sprung system.	4	1	No.

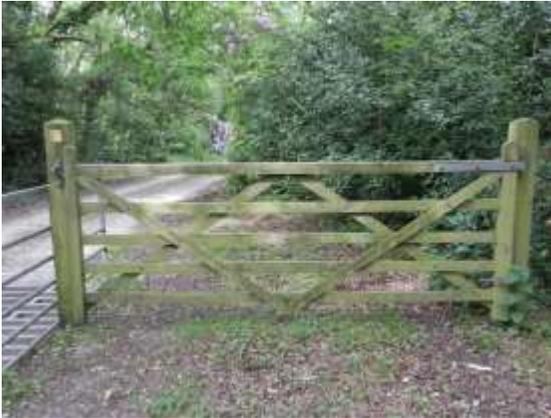
20/05 2014	G50	SU 5114 6499	5 bar wooden field gate. Fitted with a simple striker and triangular gravity catch.	As previously mentioned, to facilitate easier access the gate could be fitted with an extended easy latch sprung system, but this may not be need in this location if there is no demand from private residents in the non-grazed area.	4	1	No.

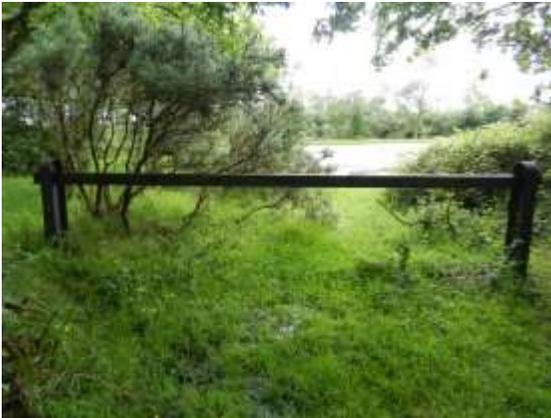
20/05 2014	G53	SU 5099 6487	Green painted metal vehicle barrier. Sliding type fitted with an estate padlock. Has become redundant in its current position.	Consider removal and replace with wooden dragons teeth.	4	1	No.

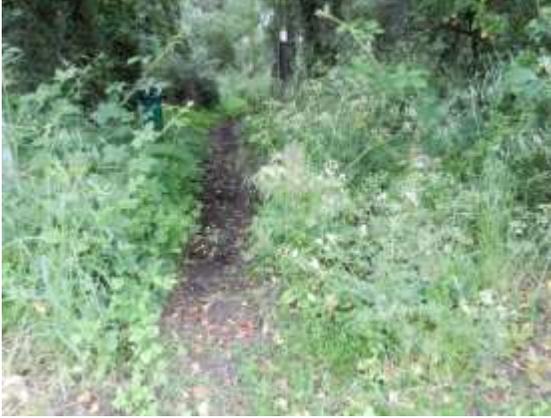
02/06 2014	G56	SU 5333 6441	Entrance to a path running long the northern side of Crookham Common from the Crookham Park. There are two round posts, one fitted with a 'no motorbike' sign which is rotten and snapped.	There is no need for the low dragon's teeth posts so remove as they a trip hazard when covered with vegetation.  Fit a new motorbike sign with channels to the post in G57 (cut down post to 1.5m and cap).	3	1	No.

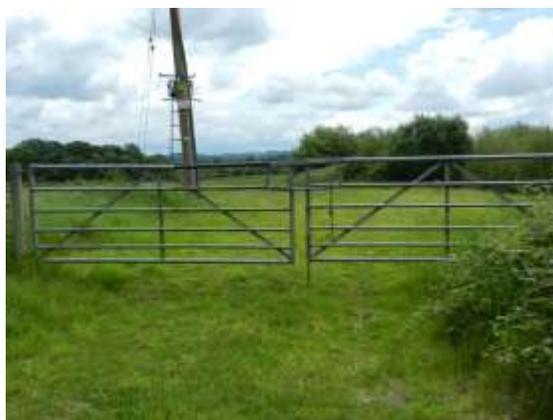
Date Visited	Report Ref.	Location	Findings	Recommendations	Priority Level	Cost Band	Any Work Completed?
02/06 2014	G59	SU 5334 6439	Royal Mail post box No. RG1961.	None.	n/a	n/a	
02/06 2014	G60	SU 5337 6437	Old cast footpath sign with stile symbol. This sign is a PRoW sign placed on a non-designated path. The path is a very useful and important path upon common land that links the public footpaths THAT/26/2 and THAT/16/1 and also the defined path along the north of Crookham Common road.	Request PRoW team to install permitted footpath signs at this location and at SU 5363 6435. Remove the current sign. Maintain the path width to a minimum of 1m width.	4	1	No.
02/06 2014	G61	SU 5316 6431	2 x 6 bar galvanised metal field gates. Locked with a padlock. This gate gives access into the network of fields beyond. Access to this gate is across the common from the gate in G62. It is unlikely to be the responsibility of the management team to maintain this structure.	Maintain the access to this gate to the full width of the gate.  Investigate and keep on file the access agreement to the private land.	3	1	No.

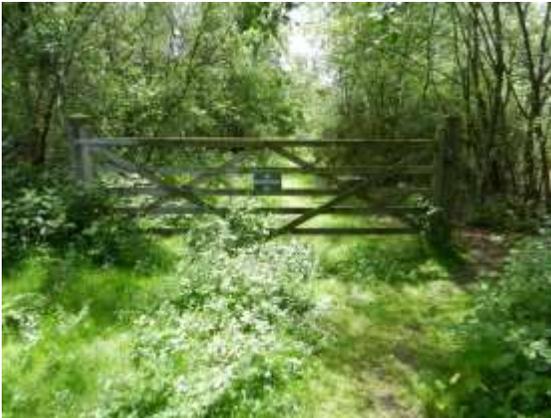
06/06 2014	G68	SU 5244 6437	5 bar wooden field gate locked with an estate padlock. Displays a 'no motor bike' sign with WBC branding. Vegetation encroaching all around the gate with just a 70cm gap to the northern side with tree branches at head height.	Clear an accessible gap of a minimum of 1.5m plus allowing a 3m walking tunnel head room. This access point should be accessible to those on horse back.	3	1	No.

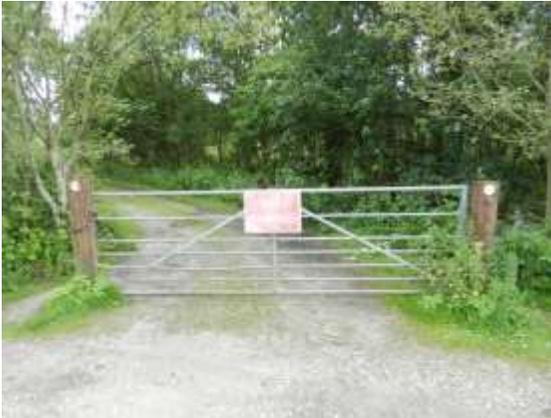
06/06 2014	G71	SU 5204 6447	7 bar galvanized metal field gate. 4m accessible gap. Gaps either side are approx 1m. There is a chain and padlock on the gate which is of unknown origin. The gate allows access along a track to a private property within the site boundary (encroachment recorded).	There should not be a private padlock only. Site management vehicles and emergency vehicles should have access through the gate so add an estate padlock to the chain.	2	1	No.

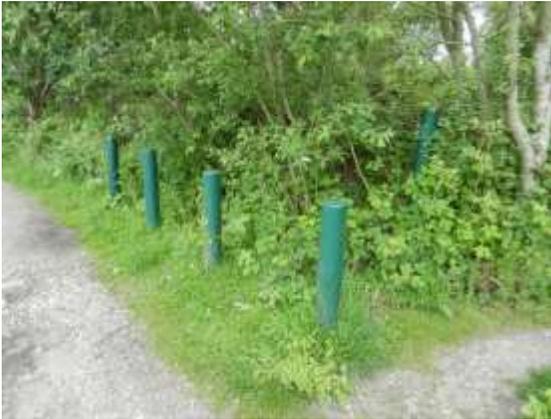
06/06 2014	G74	SU 5204 6447	More of the same bollards as described in G73. They prevent further encroachment of the informal layby.	As in G73, the multipole laybys along this road need to be reviewed. Part of the solution is to improve and formalise the path that runs alongside Old Thornford road from Crookham car park. This will encourage the use of the car park and reduce the number of cars literally queuing for space in front of the livestock fence entrance point on the corner of Old Thornford road.	4	2	No.

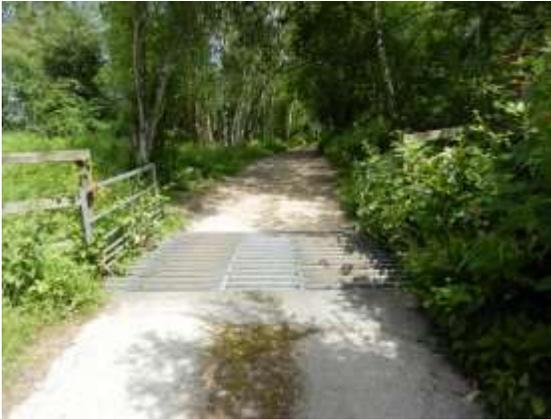
12/06 2014	G77	SU 5134 6405	Galvanised steel cattle grid, 3m accessible width. The guard fencing is not properly fixed and may fall into the road. Reflective stickers or similar required for the end of each fence so they can be seen at night (one has already been damaged). The grid fills quickly as it is on a slope with a n unsealed track above its location so water carries silt in. Encroaching vegetation hides the edge of the structure and should be cleared well back.	Secure the guard fencing and replace damaged section. Fit reflective strips. Clear vegetation back by 2m.  Routinely clear grid of dirt.	2	1	No.

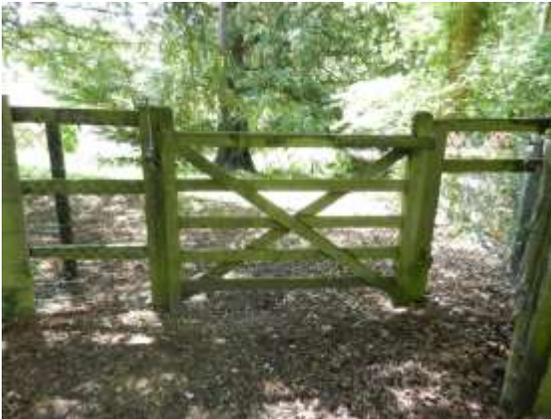
12/06 2014	G80	SU 5112 6395	Wooden bridle gate. 150cm accessible width. In report as it was recorded as an access point previously by WBC though is on private boundary with Foxhold House. Is fitted with an autolatch. Has chain around structure but not locked. Historically gives access to a 8 x 4m, 2m tall chicken coup built on common land but now looks disused.	Investigate if this is a publicly accessible gate or private access point only. Investigate the coup as part of the larger encroachment investigations.	4	n/a	No.

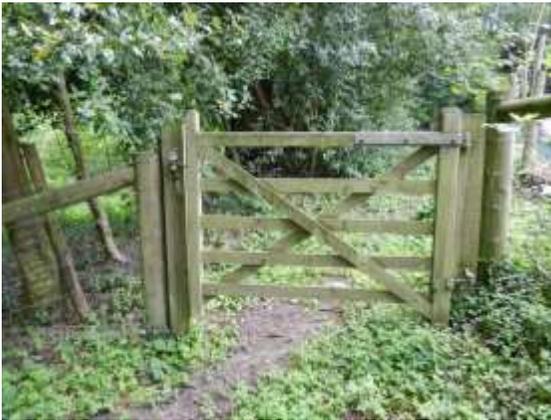
12/06 2014	G82	SU 5094 6408	Wooden bridle gate, 150cm accessible width. Slight adjustment on the hinges required to close properly. Beyond site boundary leads to a short path below Heads Hill cottage and then back into the site. No livestock grazing discs.	Fit 2 x livestock grazing discs and adjust hinges.	3	1	No.

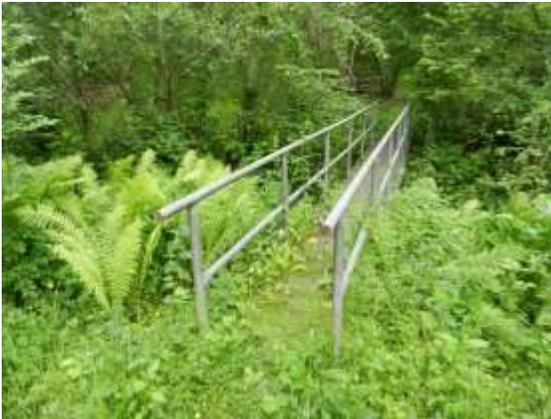
12/06 2014	G83	SU 5094 6410	Footbridge. Metal girders resting on concrete supports. Galvanised steel handrails, 44cm and 84cm high. Accessible gap is 56cm. 10m in length. Wooden slats nailed to wooden beams within the metal structure. Chicken wire over the wood planks. Showing signs of rust along girders. Vegetation heavily encroaching on structure.	Undertake a condition/safety check. Clear back vegetation. Fit welded wire mesh as this material lasts longer than chicken wire. Is within a steep gully so the narrow accessible width is not a major concern.	2 3	1 1	No. No.

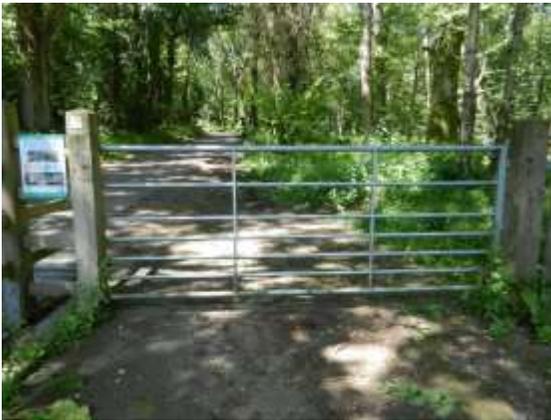
03/07 2014	G96a	SU 4899 6393	7 bar galvanised metal field gate with off-set hinges to assist self-closing. Has a striker and triangular gravity catch. Allows for the avoidance of the cattle grid by those with horses for example. Accessible width is 3m. Currently does not latch properly. Displays two livestock grazing discs (faded).	Re-position catch so it closes properly. Consider fitting an 'easylatch' extended sprung lever.  This location would be appropriate for a site name sign and relevant branding and contact numbers.  It is best practice that these gates should have the latch/catch on the furthest end of the gate from the cattle grid so preventing possible straying onto the grid and the traffic noise going over the grid spooking the horse.	2	1	Yes. Gate opens and closes freely.

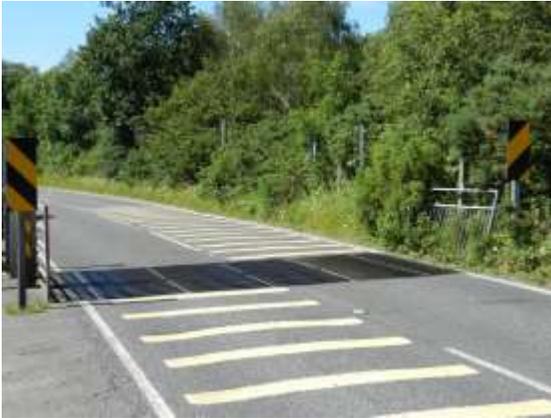
03/07 2014	G99	SU 5025 6535	2 lane cattle grid. There is damage to the northerly metal barrier fence. Vegetation is encroaching upon the structure.	West Berkshire Highways is responsible for the maintenance. Review if reflective tape/sign is clean and in good order on the end of the metal fence barriers alongside the grid.	4	n/a	Enquiry made.

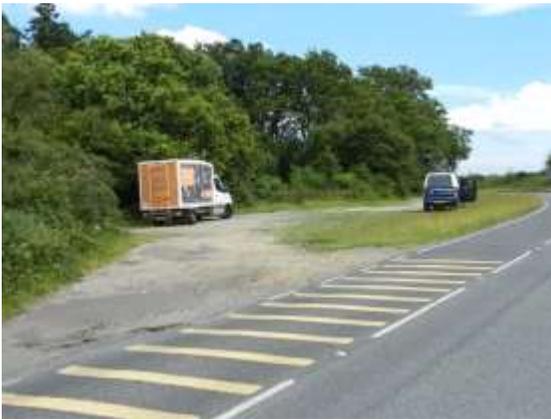
03/07 2014	G101	SU 5039 6492	Unofficial layby north of Bury's Bank road. A historical pull in area with various surface materials and parts of a concrete slab. Very large potholes at road edge. Is used regularly by those wishing to take a break. Access is possible onto the main common area south across the road.	A review is required to decide upon parking areas which will be maintained but not necessarily promoted. This layby is on a corner so access can be difficult in and out. If maintained the potholes and raised concrete pieced need immediate attention.	2	Un-known	No.

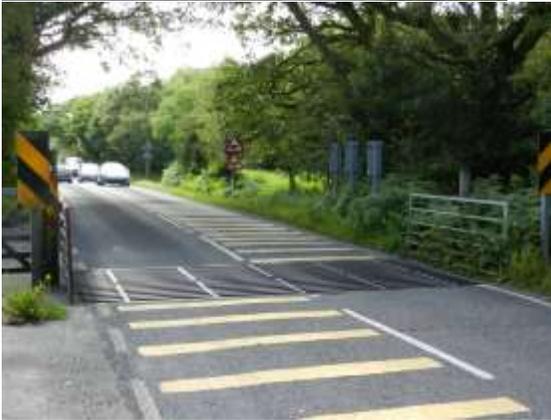
03/07 2014	G103	SU 5121 6493	2 lane cattle grid. There is good approach signage. There is no end reflective signage on the fence barriers so vehicles can gauge the maximum width at night or low light conditions. Vegetation is encroaching upon the structure.	West Berkshire Highways is responsible for the maintenance. Review if reflective tape/sign is clean and in good order on the end of the metal fence barriers alongside the grid.	4	n/a	No.

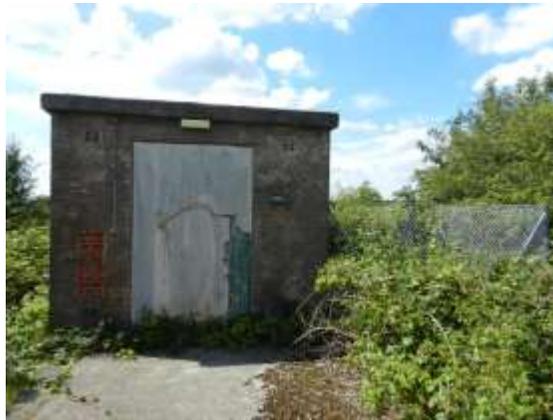
Date Visited	Report Ref.	Location	Findings	Recommendations	Priority Level	Cost Band	Any Work Completed?
03/07 2014	G107	SU 5025 6505	Disused substation used during the time of the airfield. A small compound is attached surrounded by chain-link fence and an access gate which was open. The building is known as 309. The interior has been vandalised and therefore the historical interest has been largely lost.	Continue to secure the building to prevent unauthorised access.  Consider future uses for the building such as an interpretation venue with historical pictures and information, bat hibernacula or similar.  For more information, see HEMP document.	4	n/a

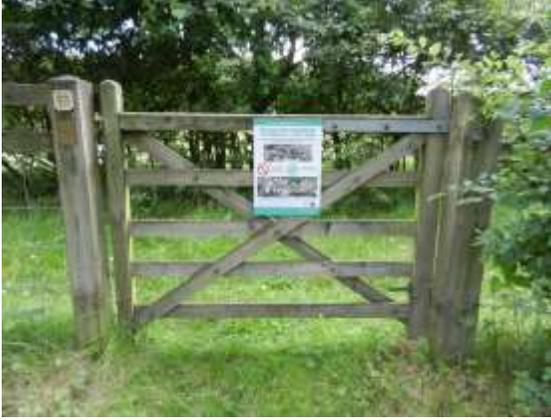
03/07 2014	G113	SU 5127 6494	Wooden bridle gate with off-set hinges to aid self-closure. Fitted with a triangular gravity catch which requires the visitor to lean over the gate to open the catch from the non-grazed side. This can be awkward or impossible for some users. Displays 1 stock grazing disc (faded) and a seasonal ground nesting bird sign.	The gate has low use because of its location. However to assist opening it would be cheap and easy to fit an auto-catch which has an extended lever.  Fit two new stock grazing discs to the latch post.  Clear the path on the Commons side as it was not clear which way to go.	3	1	No.

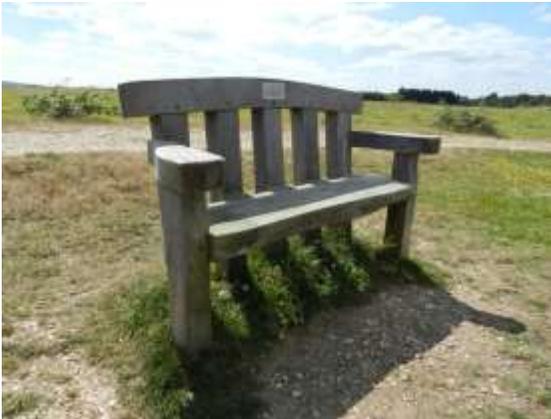
15/07 2014	G115	SU 5188 6496	Solid oak wood bench with arm and back rest. Measures: 133 x 33 x 51cm above the ground. Memorial bench presented by the 1978 Greenham Common Campaign. One of three memorial benches upon the commons. The height of the bench seat is at the max height recommended by BBOWT guidance. Attrition of the ground in front of the bench has added to the problem.	The bench height should be checked regularly and when it reaches 53cm it should be re-sited preferable within plinth so the ground height, surface type and vegetation encroachment can be managed.	4	1	No.

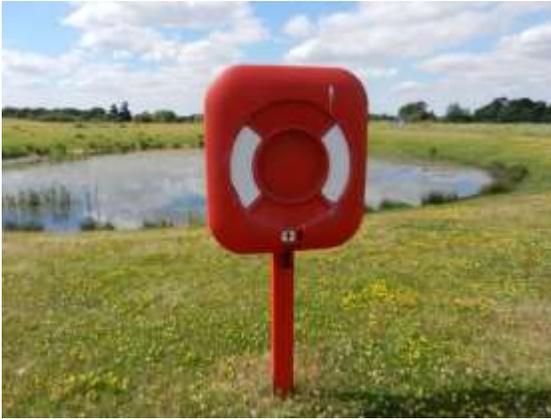
15/07 2014	G116	SU 5193 6496	24" Perry Buoy life ring with orange polypropylene rope in a Glasdon manufactured case and stand. Good condition.	Undertake regular checks.	4	n/a

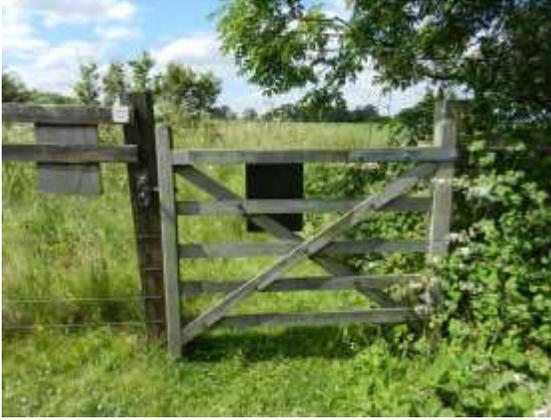
15/07 2014	G117	SU 5197 6499	Wooden bridle gate fitted with striker and triangular gravity catch. Vegetation encroaching around the gate and the road side is heavily vegetated. Displays 2 x stock grazing discs (faded) and 1 x no motorcycle disc (faded). There is no other connecting path on the road side so the gate may actually be redundant. 148cm accessible width.	It is not recommended to have gate that leads only to a busy road without there being a path. Consider removing the gate if agreed by the Commission.  If the gate is to be retained, replace stock grazing discs and no motorcycle sign.	4	1	No.

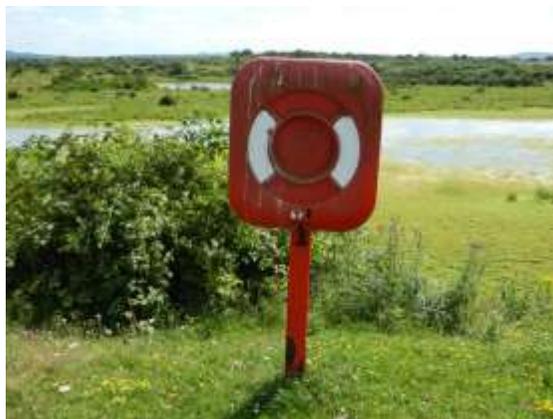
Date Visited	Report Ref.	Location	Findings	Recommendations	Priority Level	Cost Band	Any Work Completed?
15/07 2014	G118	SU 5178 6489	24" Perry Buoy life ring with rope in a Glasdon manufactured case and stand. Case is loose on the stand and the post is showing signs of rust. The case is very dirty due to birds using the vantage point.	Clean and paint the metal work. Tighten the casing to the post.	3	1	No.

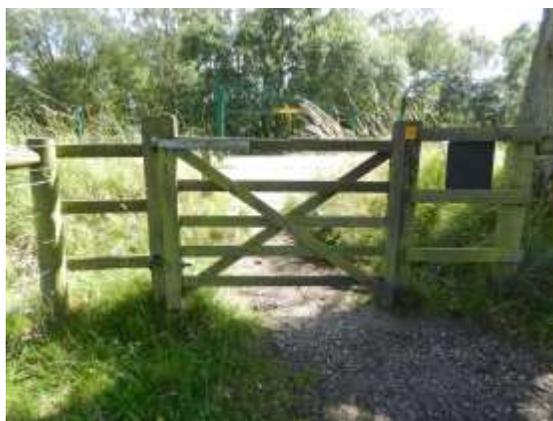
15/07 2014	G120	SU 5235 6457	Wooden bridle gate, 149cm accessible width. Fitted with standard triangular gravity catch. Displays 2 x stock grazing discs (1 faded), 1 x no motorcycle disc (faded).	The gate is directly across Old Thornford road from Crookham car park and is therefore well used. It is recommended that the gate is fitted with an 'Easylatch' system with an extended lever and sprung striker to allow easier access from both sides of the gate and at different heights. Replace faded sign discs.	3	1	No.
------------	------	--------------	--	---	---	---	-----

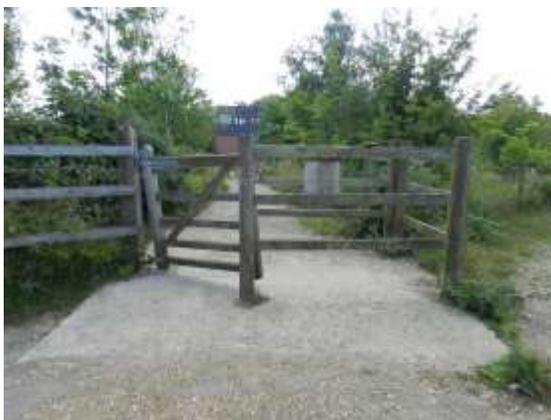
31/07 2014	G132	SU 4940 6449	Wooden kissing gate with square internal space. The gate is fitted with off-set hinges which need repairing. There is a triangular gravity catch fitted to the Commons side of the structure which is difficult to access from the common. The catch post is heavily split. The catch loop on the gate is not fixed properly as it is missing the retaining nuts. The surface through the structure is concrete and extends beyond.	The gate receives high use from pedestrians and cyclists commuting to and from the business park. The gate is just accessible with a bicycle but a bridle gate would be easier to use by cyclists and those using electric disability vehicles. The potential is for this access point to have associated car parking and an improved connecting path to the road and path network within the business park.	3 4	1 2	No.
------------	------	--------------	---	--	--------	--------	-----

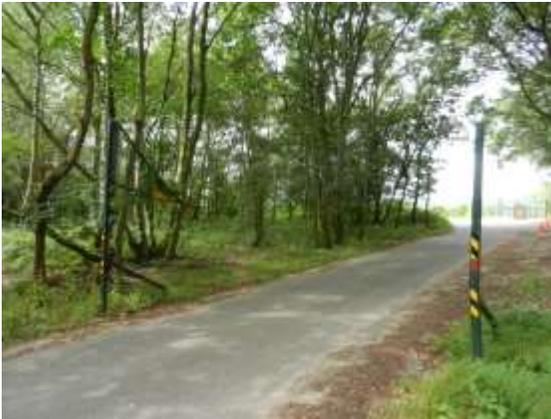
31/07 2014	G141	SU 4882 6430	Green painted metal height barrier which has a 2m max height clearance sign. And has a 5m accessible width. It is fitted with a non-state padlock which was fitted by the owners of the GAMA site. The height barrier is primarily for the use of the GAMA site owners as it has little purpose as an access management tool for the Commons.	If the structure is owned by WBC then there should be an estate padlock fitted so access can be gained beyond the gate. A solution would be to have a 'daisy chain' of two padlocks which can independently open the gate.	4	1	No.

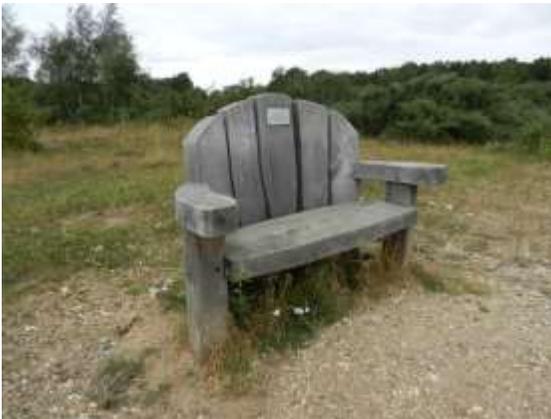
31/07 2014	G143	SU 4830 6497	Solid oak bench with arm and back rest(s). Measures: 120 x 37 x 44cm above the ground. Good condition. Current view is obscured by gorse.	Clear vegetation regularly around the bench and also the view.	3	1

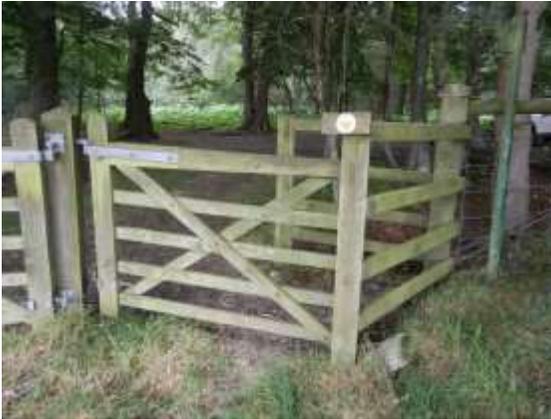
31/07 2014	G150	SU 4804 6434	Wooden kissing gate upon the public footpath GREE/10/1. It is installed on the boundary with Bunker Farm. Maximum accessible gap is 67cm. The hanging post is very rotten and the bridle gate to the west that also uses the same hanging post is holding the post upright due to it being latched.	At this location there is both a kissing gate and also a bridle gate. There is no need for both structures to be present and so it is recommended that the kissing gate is removed and a new hanging post fitted. The bridle gate should open into the Commons not into the private property. Request assistance and advice from the PRoW team at WBC.	2	1	Work has been completed to remove the kissing gate.

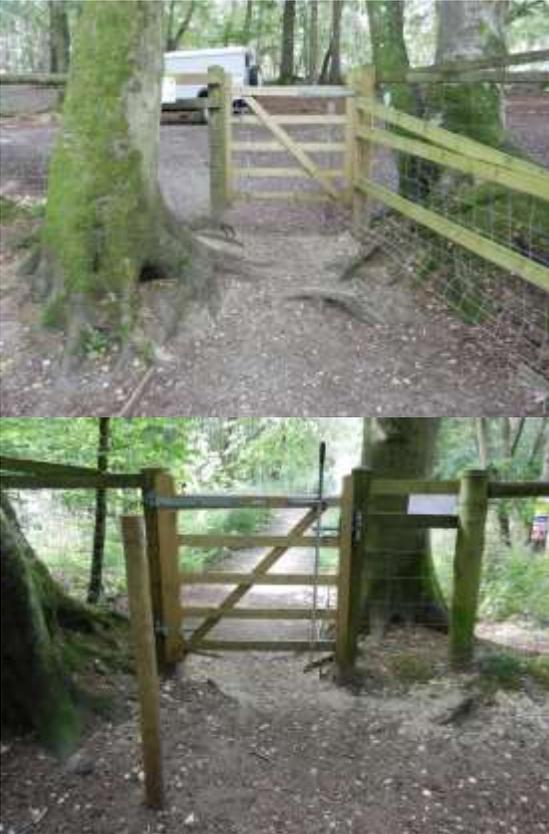
31/07 2014	G154	SU 4797 6485	Wooden pedestrian gate fitted with an extended stock proof handle (no instructions for use). This style is not needed when there is another gate at the other end of the access route. Stock proof handles are tricky to use even for the most able bodied persons. Good condition. Natural ground through structure with tree roots proud of surface and a slope is restrictive to some user groups. The terrain within the site is sloping and of a natural surface. It has been difficult to ascertain if the gate replaced a previous access structure or was new when the access route from the housing estate was installed and made formal. There is no room to move the gate to a better position and it looks like the gate was installed without any thought to the location.	The gate is only suitable for the able bodied due to its placement amongst mature trees. To prevent trips and slips the path height needs to be raised above the tree roots with a membrane installed over the roots prior to placement of surface material. Stock grazing and no motorcycle discs are required. Auditor has seen illegal moped riders using this gate. Dependent on use, this may be a good location for additional orientational information board. Stock proof handles are difficult to use and should be replaced with a straight 'easylatch' lever with grip.	3	2	The land owner of the access route should be consulted.

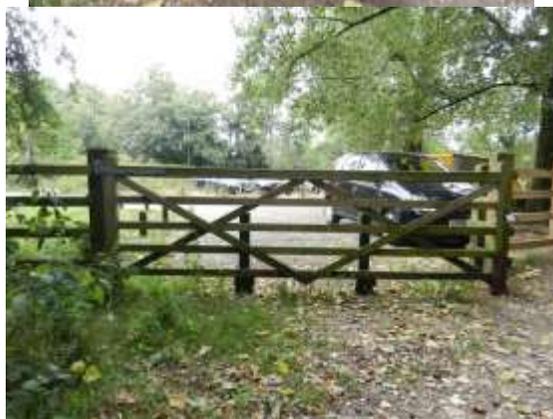
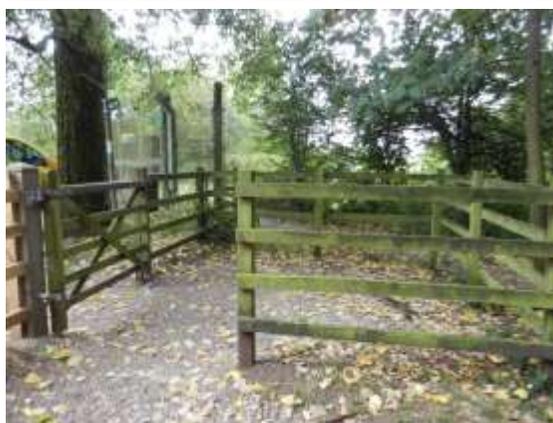
Date Visited	Report Ref.	Location	Findings	Recommendations	Priority Level	Cost Band	Any Work Completed?
01/08 2014	G161	SU 483 65266	No motor cycles sign fitted to ply board on wooden posts. Measures 53 x 35cm. Sign is all scratched and ply board is damaged. Has the WBC logo.	Consolidate signage at the nearby bridle gate and so fit a new no motor bike sign there. Remove the sign pictured.	3	1	These signs are currently being removed.
01/08 2014	G162	SU 4837 6526	Wooden 5 bar field gate with a wide 3.5m accessible gap when open. Triangular gravity catch and striker arrangement locked with an estate padlock. There is a split in the gate that has been repaired.	This access could act as a route for emergency vehicles or management vehicles. It would be recommended to have the emergency contact details for BBOWT on the gate.	4	1	No.
01/08 2014	G163	SU 4837 6526	Bridle gate fitted with a triangular gravity catch and a loop style striker. Accessible gap measure 145cm. Large (1.8 x 5.5 x 3.6 x 2) post and rail that forms a large kissing gate. Reduces the risk of cattle escaping but this arrangement is not used anywhere else on the Commons so could be more restrictive to visitors for no valid reason.	It is recommended that the gate is fitted with an 'easylatch' system with an extended sprung lever accessible more easily from both sides. Remove the post and rail and make sure the gate self-closes. This would allow easier access through the gate and also around on the Commons side to the other gate and tracks.	4	1	No.

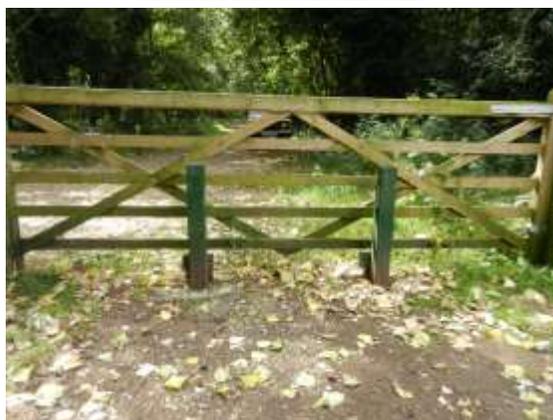
01/08 2014	G165	SU 4837 6526	Two green painted metal removable vehicle inhibitor posts. Locked with estate padlocks. Measure 78cm tall. Prevents access if the field gate was broken. Vehicles have been forced through this entrance previously and this is why the posts were fitted recently.	The presence of these posts does mean that emergency vehicles are less likely to be able to gain access(unless a keyholder was resent) at this location which also happens to be the nearest to Newbury. Enquire whether the emergency services have copies of the estate keys.	4	n/a	No.
------------	------	--------------	---	---	---	-----	-----

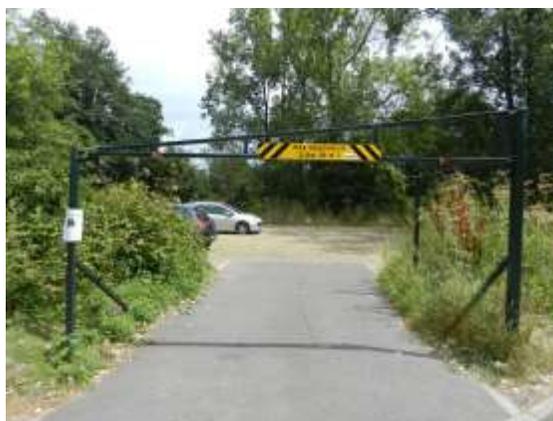
01/08 2014	G166	SU 4836 6529	Vehicle height barrier. Green painted metal measuring 4m wide and 2m max height. Warning max height sign fitted. Locked with an estate padlock. Metal retaining post present for when the gate is open. Good condition overall.	The height barrier dissuades those with camper vans or similar staying overnight as the car park beyond is open 24hours. The barrier does however restrict taller vehicles such as 4x4 and those carrying bicycles or roof boxes. Some tall adapted vehicles may also not fit beneath. Consider removal.	4	1	The gate is now being left open as part of a trial to see if this lack of restriction is abused.
------------	------	--------------	---	--	---	---	--

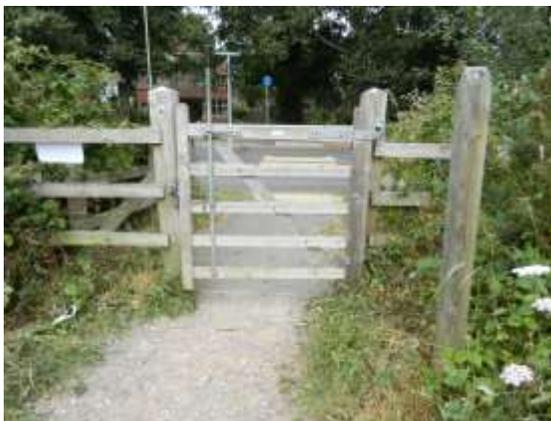
Date Visited	Report Ref.	Location	Findings	Recommendations	Priority Level	Cost Band	Any Work Completed?
01/08 2014	G169	SU 4836 6523	No littering sign (53 x 48cm) fitted to a plastic coated post. Location is questionable and is unlikely to be fulfilling any purpose as is not near the entrance and path network.	Remove the sign and post. Do not re-display.	2	1	No.
01/08 2014	G170	SU 4838 6526	Wooden WMP with a Walk 4 Life disc attached (finish). Disc is faded. Post measures 77cm tall.	Replace disc.	3	1	No.
01/08 2014	G171	SU 4858 6534	Wooden pedestrian gate with 120cm accessible gap. Fitted with an extended sprung lever with a stock proof handle which does not 'lock' because it has not been fitted correctly. There is a spring return on the gate which means a very fast gate closure speed. Road side has a sealed path and a pedestrian island upon Bury's Bank road. Common side is natural uneven surface.	Fit stock grazing and no motorcycle discs to the latch post. Fit an off-set hinge to aid closure and remove spring. Remove stock proof handle and fit a more simple 'easylatch' extended handle with grip. Suggest a dog waste bin at this location.	2 4	1 1	The spring has been removed and hinges in the off-set position.

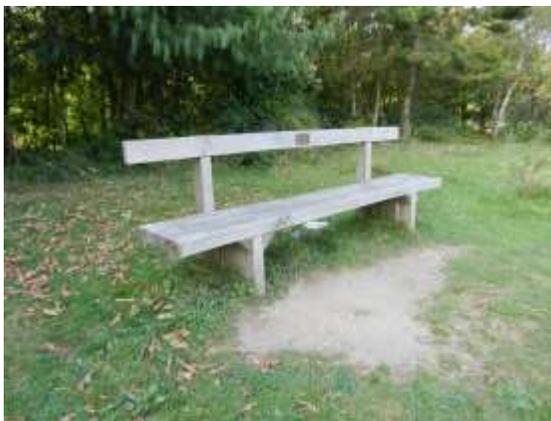
18/09 2014	G183	SU 5136 6482	Wooden bench seat with back rest. Memorial plaque.	Prevent scrub from blocking the view of Crookham pools area.	4	1	Ongoing.
------------	------	--------------	--	--	---	---	----------
