# Greenham and Crookham Commons Access Audit

*Initial baseline findings of the site's physical and intellectual access provisions.*

**Author: James Stevenson, BBOWT West Berkshire Access Audit Officer**

**Date: 27<sup>th</sup> April 2015**

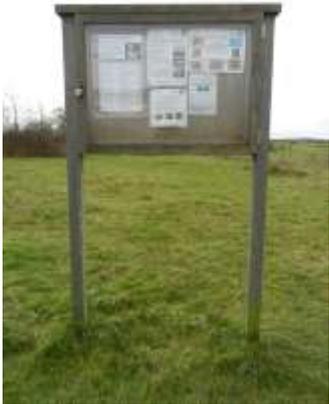
10/02 2014	G1	SU 49874 65039	Unpainted wooden display/notice board. One side has a Perspex hinge door with a padlock (code = 209). The backing for the notices is cork. Size: 112cmx75cm and 190cm tall. Condition is very good. Suggestions: The location of the board is not appropriate for those in wheel chairs or during the wet winter months and also may be a little bit high.	Ideally re-locate the display board close to main path to the common and make sure there is hard standing to and around the display. This is a good place to display events and notices.	4	1	No.

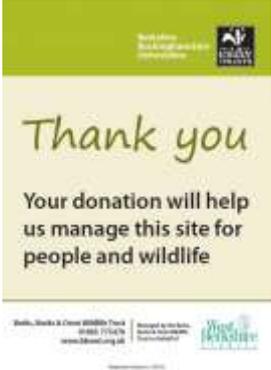
10/02 2014	G2	SU 49875 65036	New vinyl on Foamex sign fixed to a wooden post in a lectern style. Size: 21cmx30cm and approx 54cm off the ground  Located next to the donation post (G3).	There are 4 exits onto the common from the car park and a forthcoming visitor centre, therefore there may need to be thought into having more than one donation post and suitable locations for these.	4	1	No.

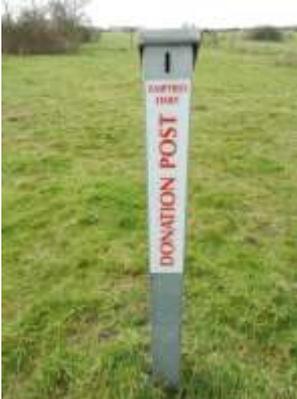
10/02 2014	G3	SU 49876 65035	Metal donation post. Sign fitted to base.	The metal post is sited amongst a grass area so it some distance from the path. So the post can be accessed more easily move next to the path. See comment for G2.	3	1	No.

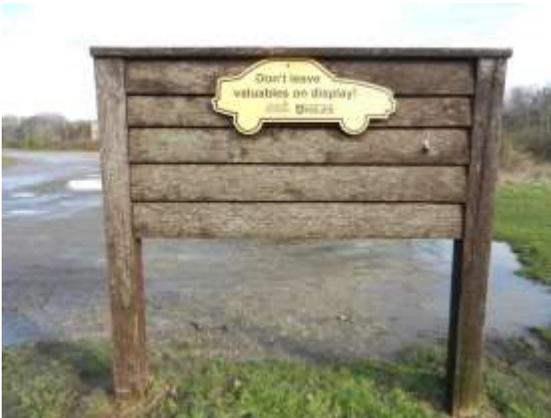
10/02 2014	G4	SU 49908 65072	<p>Commons interpretation sign within the control tower car park, one of 3 located in the three car parks. The sign is made of GRP and gives the visitor a lot of information with regards the history and wildlife present on the Commons. Some of the information is out of date and the branding no longer reflects</p> <p>On the back side of the sign is a hastily fixed 'Don't leave your valuables in the car' warning sign.</p> <p>Size: Display board; 147.5cmx73cm. Frame; 172cmx80cm and 163cm tall.</p> <p>Condition: The wooden frame is tired looking and some of the wooden trim around the board is coming away and broken. Overall appearance is dirty and in poor condition. The contact details are now incorrect.</p>	<p>Suggestions: The sign is due for replacement as the text is out of date, the waymarked routes will likely be changed and the contact details are now obsolete. The sign needs to be redesigned the same time as any waymarking occurs. The wooden frame has also badly deteriorated and needs renovation. The location is not appropriate as vehicles can park in front of the sign and make it unapproachable to those wanting to view, especially those in wheelchairs or who have walking aids. The sign itself may become redundant in this location due to the plans to renovate the control tower, depends if there will be information on the outside of the building viewable outside opening hours. The sign is included within Phase 2 of the signage replacement project. The waymarking has become defunct and needs replacing as part of a new board.</p>	4	2	No.

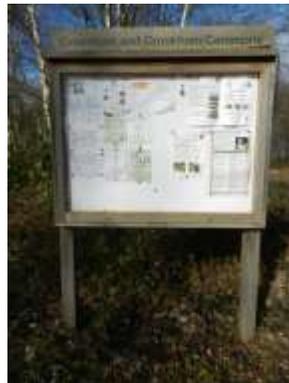
10/02 2014	G6	SU 52332 64567	<p>This Parish notice board was installed in 2011. The board is shared between BBOWT and Crookham Parish Council. The board is wooden and has a hinged Perspex cover, a triangular key is required to open the door and the back board is white and magnetic.</p> <p>Size: Display space 119cmx83cm, Frame size; 134cmx120cm and 210cm tall.</p> <p>Very good condition. The door was broken for a while from July, but has been subsequently repaired in November by the auditor.</p>	It is beneficial if signage that requires visitors to access and spend time reading the information has safe approach and an adequate surrounding area. A hard standing area accessible to those in wheelchairs and those with buggies, which is also separated from the car park, should be a priority when installing new signage in the future.	4	1	No.
------------	----	----------------	--	--	---	---	-----

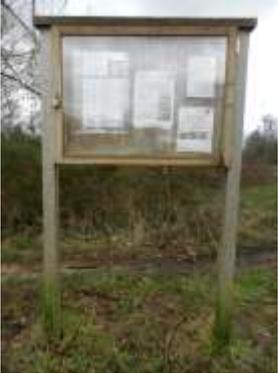
10/02 2014	G8	SU 48380 65286	This notice board is the same as in target note G1. The location again is an issue here as it is positioned in an area that is uneven and requires the visitor to stand upon grass that is wet and muddy during the winter. The area has logs laid on the ground marking out paths for visitors to follow. The logs have become very slippery and are generally ignored.	As with all information that informs and engages with the visitor, it must be accessible and within a safe area. The height is important so it can be viewed by those who use wheelchairs or are of a low stature. The notice board ideally needs moving to a better location.	3	1	Some of the logs have been removed.

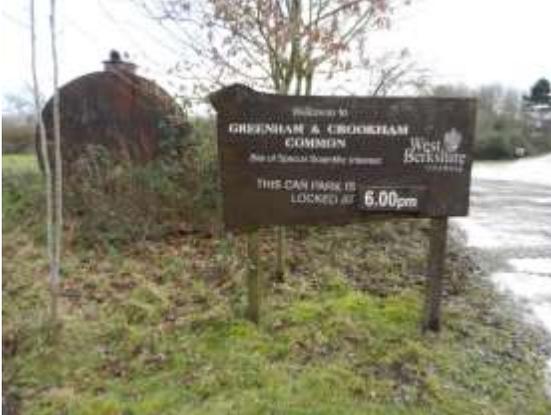
10/02 2014	G9	SU 49874 65190	This wooden routed reserve sign is situated at the entrance to the control tower car park. The sign also holds the removable closing time wooden tablets that screw to the front.  Size: 154cmx80cm and 144cm tall.  Condition: The sign looks tired and is rotting on the top.	Recommended as part of the control tower renovation new signage could be developed in partnership that will include details on the facilities available, parking layout, opening times etc. In the short term, a replacement sign is required.	4	2	A new sign has been designed and ordered and is awaiting delivery as part of Phase 1 signage replacement.

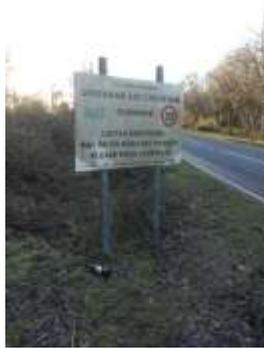
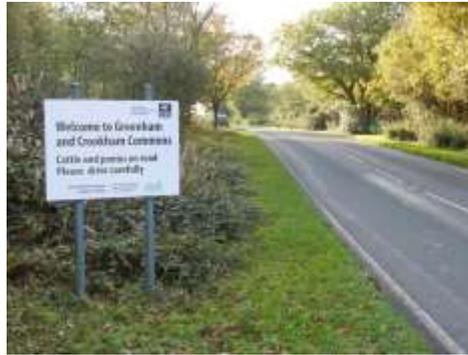
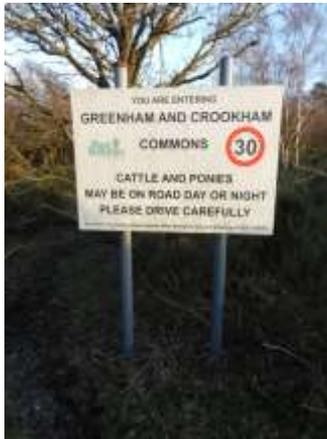
Date Visited	Report Ref.	Location	Findings	Recommendations	Priority Level	Cost Band	Any Work Completed?
11/02 2014	G10	SU 5114 6491	Sign notifying drivers that the next section of road is unfenced and to be careful of livestock roaming onto the road. The sign is broken away from the lower channel and the post tops are very rusty. The sign shows the WBC Streetcare contact number.	The 30mph roundel within the sign is not permitted by the Highways Authority. Initially clean and repair the sign. Ultimately replace the sign with correct branding and contact information. Remove the 30mph roundel from any new design.	2	1	A new sign has been installed, please see photo opposite. A 30mph roundel below the sign was not required by the Highways Authority.
			Fitted November 2014.	Review the condition of the posts and replace as necessary. Bi-annual cleaning required.			
11/02 2014	G11	SU 5027 6533	Please see comments for target note G10. The posts are rusty and the sign dirty.	Please see comments for G10.	2	1	A new sign has been installed, please see photo opposite. A 30mph roundel below the sign was not required by the Highways Authority.

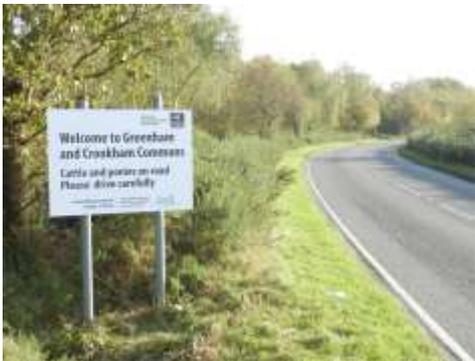
Fitted November 2014.	Review the condition of the posts and replace as necessary. Bi-annual cleaning required.

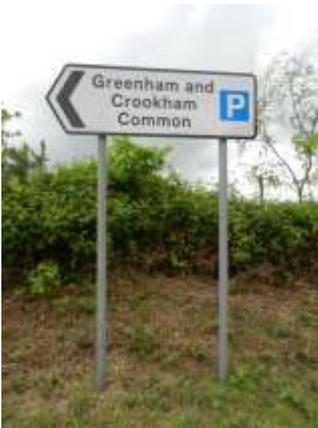
20/05 2014	G12	SU 4985 6523	Highway Sign. Measures 2m+ from the ground. The sign is viewable in advance if travelling from the easterly direction (Thatcham) along Burys Bank road. This is the only sign notifying visitors of the location of the car park.	An additional sign of the same design is required on the opposite side of the entrance road so those travelling from the westerly direction (Newbury) are notified of the car parks location. Review signage when the visitor centre is opened so any new signage can be combined thus reducing the number and of signs present at this location.	2	1	No.

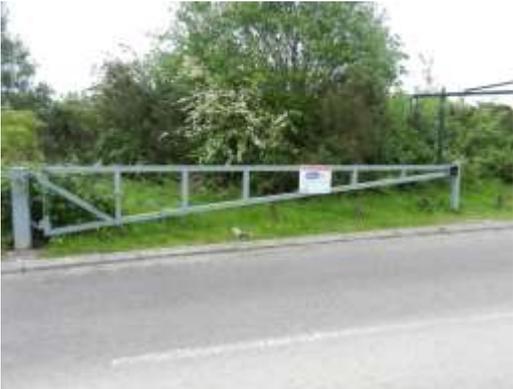
20/05 2014	G13	SU 4986 6522	Galvanised metal vehicle barrier which is locked during the night (Opened by 8am and closed 6pm/8pm). Latched open during the day. Has an integral lock barrel opened using an estate key. Displays a security notice. The initial entrance section is professionally paved with kerbs and line painted. The area is lit by street lights during the night.	Out of hours contact information required in the form of a fixed sign for visitors and emergency services.  Since initial visit the barrier has been damaged possible by a turning vehicle. Install high visibility tape/sign along the length of the barrier.	2	1	No.

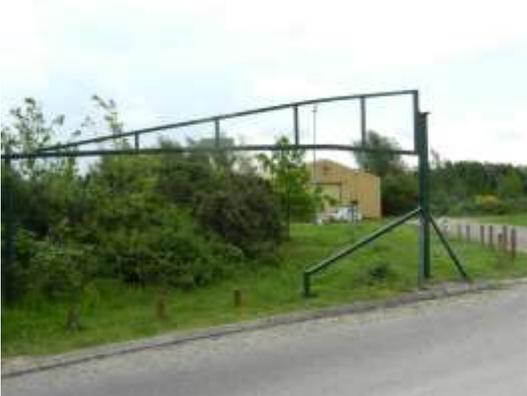
20/05 2014	G14	SU 4987 6520	Full road width green painted metal height barrier. Locked with an estate padlock. Damaged possibly by large vehicle. Max height is 2.3m.	Repair. Fit new max vehicle height sign so it is clearer to visitors. This is the main car park for the Commons and is likely to get used by visitors in a range of vehicles such as camper vans, vehicles with bicycles on the roof, tall adapted vehicles etc. Also because the control tower is being developed and PRow and BBOWT have their maintenance building within the area, a height barrier is likely to be restrictive to delivery vehicles for example. Recommend keeping the height barrier open during opening hours. Monitor the situation to make sure the car park is not being used by large lorries wanting somewhere to hold up.	2	2	Height barrier has been repaired and a new max height warning sign fitted. The barrier was left open for approx 6 months with no problems.

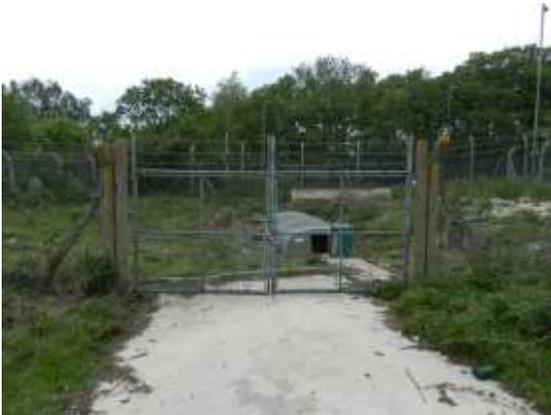
20/05 2014	G15	SU 4984 6520	Sewage digester plant. Locked with an estate padlock. Holes and gaps within the fence. Could pose a safety issue to those gaining easy access.	Secure fence and periodically check the perimeter to make sure access is not possible.	2	1	Repairs have been undertaken.

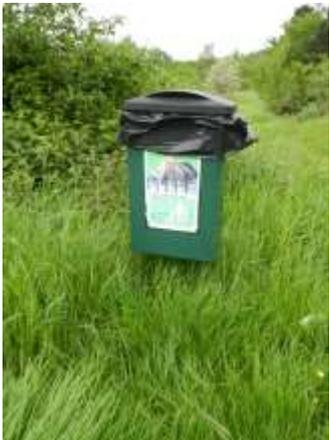
20/05 2014	G16	SU 4985 6510	<p>45 litre green painted metal dog waste bin with rubberized lid fitted to an 'Earth Anchor' stand. Advertising poster fitted to front side. Rusting slightly at the base, otherwise good condition.</p> <p>There are 10 dog waste bins in total on the Commons at key entrances and car parks. Condition is variable with the most used bins at Pyle Hill car park needing replacing.</p> <p>The bins are emptied by a contractor.</p>	<p>Consider larger 66 litre bins where the bins overflow from heavy use. Using designs such as Earth Anchors 'Easy chute' reduces the occurrence of general waste being deposited and prematurely filling up the bins.</p> <p>Bins should be easily accessible on foot and by wheelchairs. Many bins were obstructed by vegetation. The height of the bins in some cases were also too high.</p> <p>It is recommended that a BBOWT branded vinyl poster is adhered to the side of the bins giving information on the benefits of wildlife and visitors alike of picking up after your dog.</p>	<p>Poster 2</p> <p>Bin renewal 3</p>	1 1+	No.

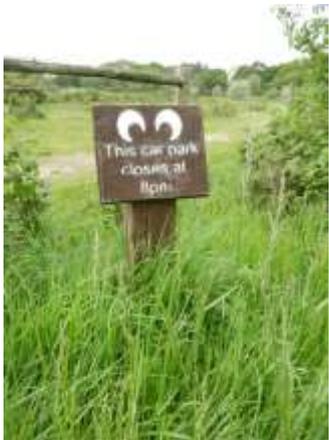
20/05 2014	G17	<p>SU 4985 6510</p> <p>Also located at:</p> <p>SU 4987 65011 / 4995 6505 and 4998 6513</p>	<p>Car park closure sign. There are a further 3 signs (one missing from its post) on exits from the car park to the Commons. the signs are important as reminders to visitors that the car parks are not open 24hours. The tablets can be replaced for the summer and winter closure times. The signs look tired and need refurbishing.</p>	<p>Either refurbish or order new BBOWT branded boards and install at the four most used exits of the car park.</p>	4	1	No.

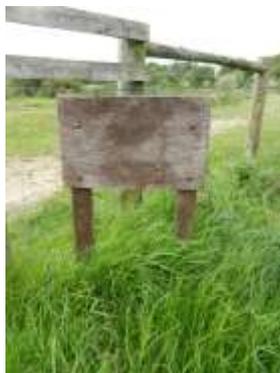
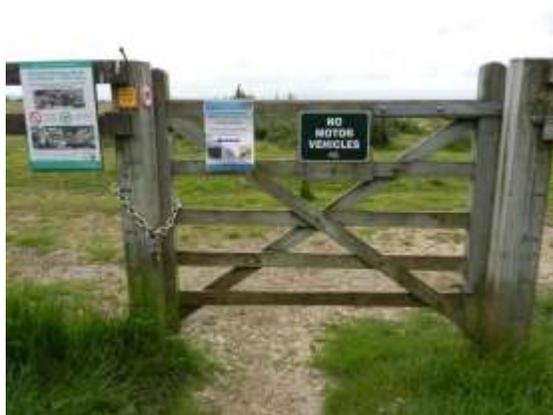
Date Visited	Report Ref.	Location	Findings	Recommendations	Priority Level	Cost Band	Any Work Completed?
20/05 2014	G18	SU 4985 6510	Ply board fitted to short wooden legs. Space to affix short term notices such as cattle round up warnings. There are a number of these boards in varying degrees of condition at entrances across the Commons. As they are low to the ground they can get obscured by vegetation and can also be missed by the visitor. The boards can be prone to unauthorised advertising.	It is more beneficial to have short term notice boards directly next to the gates and at heights that are more obvious. To reduce clutter and additional infrastructure, temporary signs could be just attached to the current fence alongside the gates. Defunct boards need removing.	4	None	No.
20/05 2014	G19	SU 4985 65103	Wooden bridle gate fitted with auto latch. 145cm accessible. Unimproved ground through the gate with vegetation encroaching. Displays: stock grazing, no motorcycles, no motor vehicles signs. Picture shows ground nesting bird signage. This gate is locked during the ground nesting bird period 1 <sup>st</sup> March – 31 <sup>st</sup> July as the area beyond the gate is a 'red' sensitive zone.	To facilitate access by those seated in (motorised) wheelchairs or of short stature or on horseback an 'easy latch' extended handle would be preferable if the gate or latches were ever to be replaced. Other gates from the car park do have easy latch mechanisms fitted.	4	1	No.

20/05 2014	G20	SU 4988 6507	Wooden bench with back rest. Seat measures: 213 wide x 40 deep x 42cm high. Condition is good. Bench is set within a plinth of compacted gravels and wood revetment which has now become proud of the ground and is becoming covered by vegetation. The bench is a memorial to Lew Lewis 1919-2009. No records of the memorial donation have been seen to ascertain maintenance agreement.	Re-set the wooden plinth flush with the ground and reinstate the gravels. Remove the encroaching vegetation. The bench has no connecting path and so the grass should be kept short to allow access.	3	1	No.

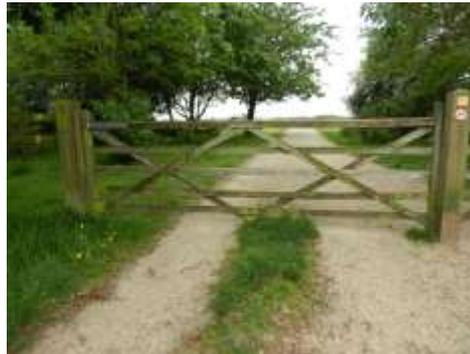
20/05 2014	G22	SU 4988 6500	Wooden 5 bar field gate providing vehicle access onto the Commons. Triangular latch and estate padlock. 350cm accessible. Gate has sustained some damage but is functioning.	The combined vehicle and pedestrian track means that more regular maintenance is required so a smooth surface is retained.  This access could be used by emergency vehicles and therefore a sign with BBOWT contact details is required.	3	1	No.

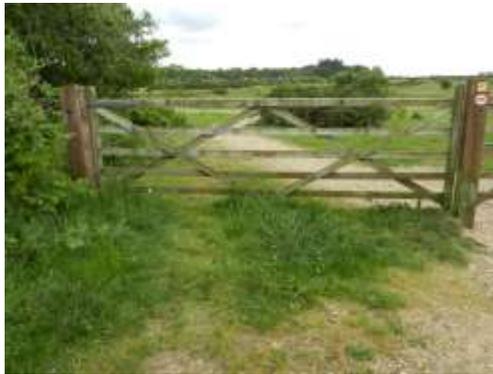
Date Visited	Report Ref.	Location	Findings	Recommendations	Priority Level	Cost Band	Any Work Completed?
20/05 2014	G24	SU 4995 6506	Wooden 5 bar field gate as fitted in G22.	Same recommendations as in G22.	3	1	No.

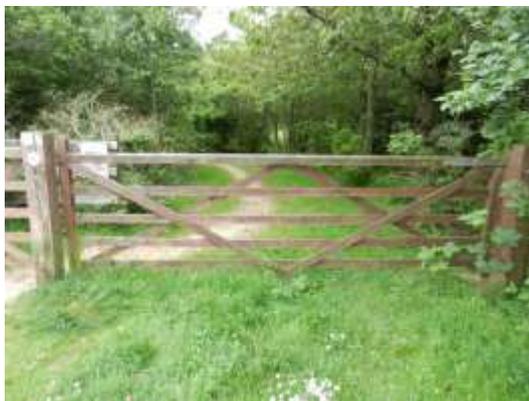
20/05 2014	G26	SU 4998 6513	Wooden 5 bar field gate. Needs adjusting as it sits on the ground. The catch has been badly bent and can be pushed opened past the padlock. Displays: stock grazing and no motor cycle discs.	Replace catch and adjust gate so it closes freely.	2	1	The catch has been replaced.
------------	-----	--------------	---	--	---	---	------------------------------

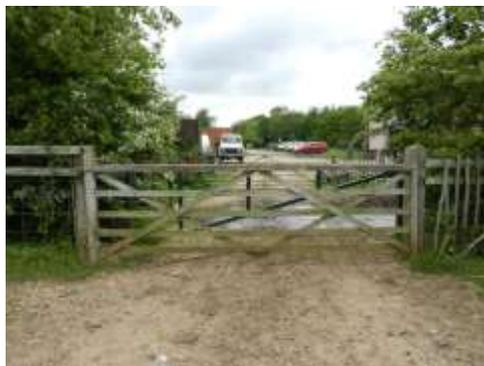
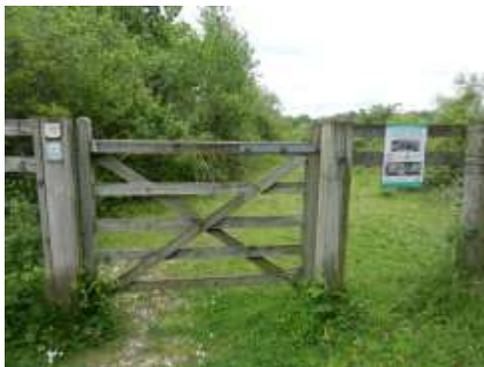
Date Visited	Report Ref.	Location	Findings	Recommendations	Priority Level	Cost Band	Any Work Completed?
20/05 2014	G27	SU 5004 6519	1x 5 bar wooden field gate and 1 x green painted metal vehicle access gate, swing type, locked with an estate padlock. Wooden gate needs adjusting. Both in good condition. Access to the maintenance building (Estovers) and the livestock pens.	Adjust wooden gate.	3	1	No.
20/05 2014	G28	SU 5004 6528	Wooden bridle gate fitted with gravity catch. This type of latch requires the user to lean over to open the gate and so is not useable by those seated, on horse back or who are of short stature or physically disabled. Displays: stock grazing, old and incorrect nesting bird season discs. Ground nesting bird zoning sign to the right of the gate. Gate has split.	Remove the old nesting bird disc. Recommend removal of gravity catch and fit an extended handle easy latch system.  Clear vegetation through the full accessible width of the gate.  Repair wooden structure.	3 4	1 1	Old disc has been removed.

20/05 2014	G29	SU 4995 6522	Green painted metal vehicle access gate, locked with an estate padlock. Prevents unauthorised access to the PRoW maintenance and BBOWT reserves building. Damage to the lock shroud at last break in. A secondary wooden field gate is also at this location but is not used. It requires adjusting so it can be used as it currently sits on the ground.	Repair required to the shroud which will also remove sharp metal.	3	1	No.

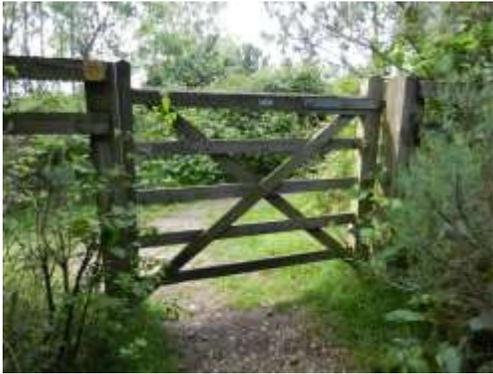
20/05 2014	G30	SU 5015 6539	<p>Wooden bridle gate. Accessible width 148cm. Triangular gravity catch fitted. Displays 2 x stock grazing discs (faded). Vegetation is encroaching and preventing access. The gate allows access along a small path to the north meeting Bury's Bank road on the inside edge of a corner. It is a dangerous crossing and an alternative route is in place with signage.</p> <p>There is no sign to show the safer PRoW permitted route.</p>	<p>It is unlikely that those on horseback or using wheelchair or similar would even try and use this route so upgrading the latch is not necessary.</p> <p>Ultimately the route is dangerous and visitors should not be encouraged to use this access point, therefore removal of the gate and positioning of a closed sign at the road side may be an option. The permitted route should be displayed on the grazed side of the fence.</p>	2	1	No.

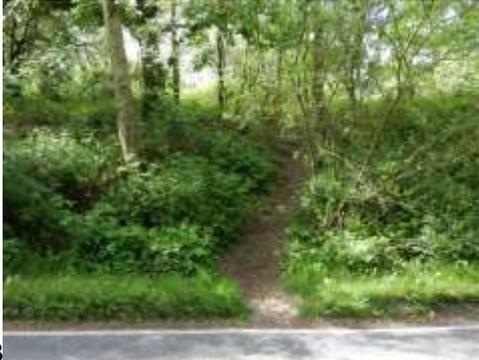
Left photo shows steep path leading to Bury's Bank Road from the access point at G30. Visibility at the bottom of the slope is very short because of the curvature of the road and vegetation density and height.	2	1	No.

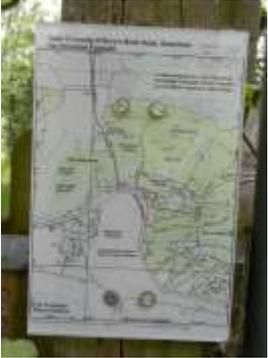
Right picture shows the signs position at 3 locations along the alternative route. One of these signs was found smashed and has been removed. A new sign is now required and also an additional sign at G30 would be prudent. The signs were produced by the PRoW team.

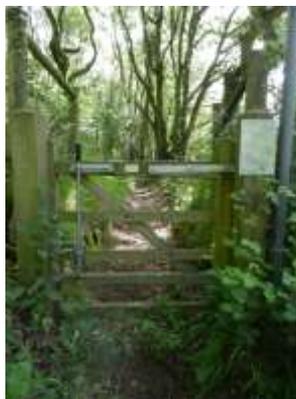
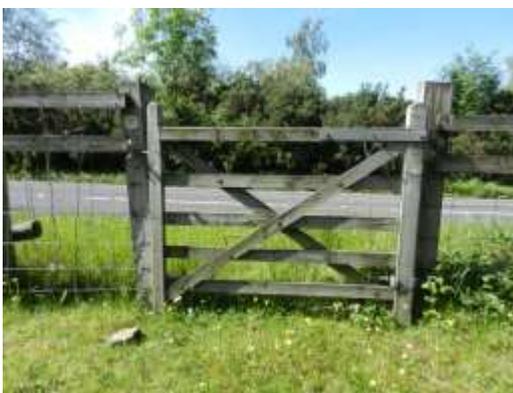
Date Visited	Report Ref.	Location	Findings	Recommendations	Priority Level	Cost Band	Any Work Completed?
20/05 2014	G32	SU 5014 6542	Wooden pedestrian gate on the boundary of the Commons. Fitted with an extended easy latch sprung handle and triangular gravity catch. Off-set hinges allow for self closing. Good condition.	Fit 2 x stock grazing discs and no motor cycle discs.	3	1	No.
20/05 2014	G33	SU 5020 6541	Wooden way marker post (WMP). Displays 2 x permitted footpath discs. Good condition.	None.	n/a	n/a	
20/05 2014	G34	SU 5021 6540	Wooden bridle gate fitted striker and catch. Due to a dislodged fence strut the latching post has been pulled over so the gate no longer latches shut. Displays 2 x stock grazing and 1 old ground nesting bird sign. The gate is redundant in its current position and should not be used by the public as it allows access directly onto a dangerous section of Bury's Bank road. The only purpose would be to allow horse riders inadvertently finding themselves approaching the cattle an option off the road.	Repair fence and make sure gate latches correctly. Consider removing as it is offering access to visitors onto a dangerous road section.	2	1	Work has been undertaken to repair the fence and gate.

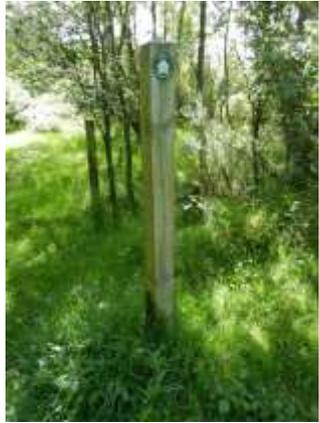
Date Visited	Report Ref.	Location	Findings	Recommendations	Priority Level	Cost Band	Any Work Completed?
20/05 2014	G35	SU 5023 6542	Wooden WMP. Displays 2 x permitted footpath discs. Good condition.	Clean	3	1	No.

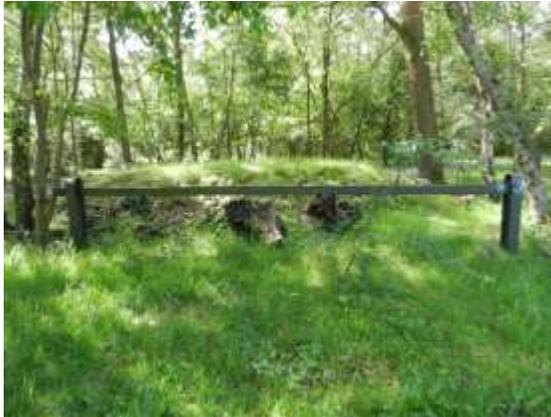
20/05 2014	G36	SU 5035 6525	Green painted sliding metal vehicle barrier. 4m accessible gap. There was once an accessible road past the barrier. A large mound of earth has been deposited behind the barrier so essentially the barrier has become redundant.	If no longer required and for purely aesthetics, remove the barrier.	4	1	No.
------------	-----	--------------	---	--	---	---	-----

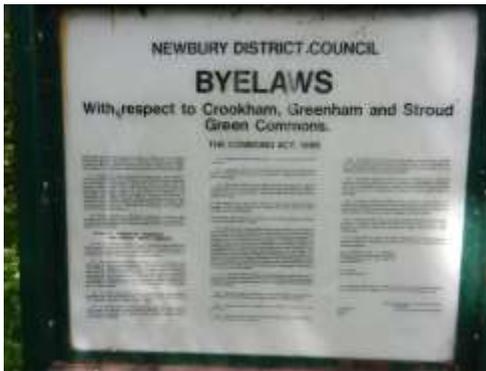
20/05 2014	G37	SU 5032 6523	Byelaw sign, other side shows map of the area the byelaws apply to. The sign is now redundant due to the enactment of the Greenham and Crookham Act 2002 as the byelaws no longer apply at this location.	Remove the sign.	2	1	No.
------------	-----	--------------	---	------------------	---	---	-----

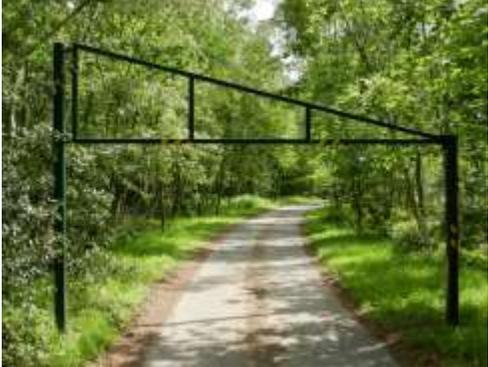
20/05 2014	G39	SU 5045 6527	Green painted metal vehicle height restriction barrier. Swing type locked with an estate padlock. 205cm accessible height, 4m access width. No max height information sign fitted. There is no height barrier retaining post when open.	Fit height information sign to the south side of the barrier.  Install a retaining post so the barrier is not capable of swinging back on to a vehicle when open.	2	1	A max height sign has been installed.

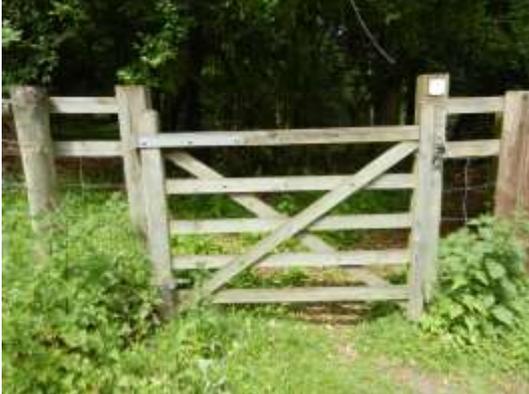
20/05 2014	G42	SU 5056 6507	Wooden bridle gate within the stock fence line. Fitted with a striker and triangular gravity latch which is loose. Displays 2 x faded stock grazing discs.	Make repairs to latch and fit new stock grazing discs.	3	1	No.

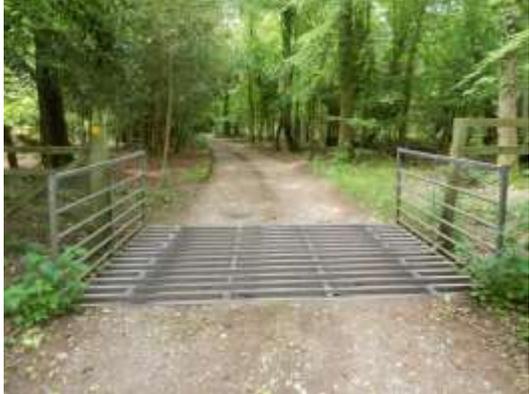
20/05 2014	G43	SU 5055 6504	Metal cattle grid providing access to private properties to the north.	Do not allow to become filled with debris. Reflective strips on the end of each of the side barriers would be advantageous when approaching the cattle grid at night.	4	1	No.

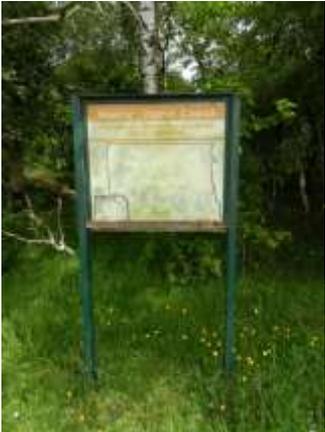
20/05 2014	G45	SU 5039 6439	Byelaw sign, other side shows map of the area the byelaws apply to. The sign is now redundant due to the enactment of the Greenham and Crookham Act 2002 as the byelaws no longer apply at this location.	Remove the sign.	2	1	No.

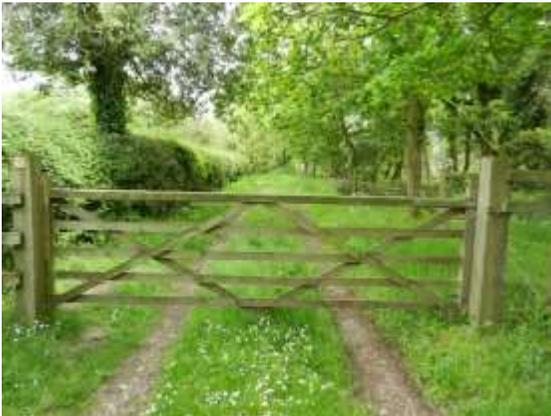
20/05 2014	G46	SU 5065 6491	5 bar wooden field gate. Provides vehicle width access to un-grazed area around private properties further east. Displays 2 x grazing discs which need cleaning. 3m Accessible width. Gate is difficult to operate, needs adjusting. Has a striker and triangular gravity catch.	Adjust gate.	3	1	No.

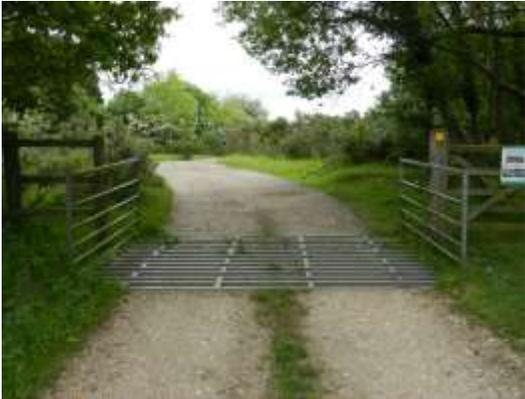
20/05 2014	G47	SU 5074 6493	Cattle grid. Prevents livestock from approaching private properties to the north. Land north of the grid is still owned by WBC.	Clear grid on a regular basis to prevent livestock encroaching. Attach reflective tape or similar to end of metal side guards to warn motorists of their presence during the night.	2	1	No.

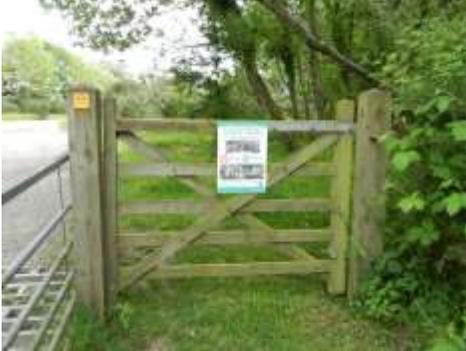
20/05 2014	G48	SU 5072 6491	Wooden bridle gate fitted with a striker and triangular catch. Displays 2 x stock grazing discs and a ground nesting bird zoning sign (temporary).	The current latch and catch restricts some users such as horse riders wanting to use the gate. An extended easy latch system would improve accessibility.	4	1	No.

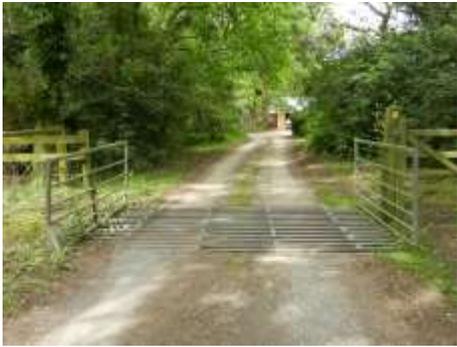
20/05 2014	G51	SU 5114 6500	Cattle grid. Damage to the western side metal guard fence. Is becoming full of detritus.	Repair/replace guard fence and attach reflective material to the ends so vehicles can see the edge of the entrance at night and avoid collision.	3	1	No.

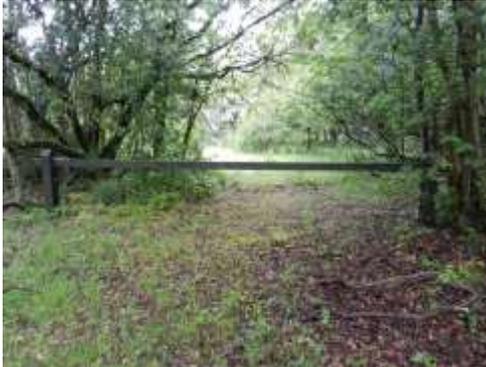
20/05 2014	G52	SU 5099 6491	Green painted metal vehicle barrier installed on the entrance to an old access road. Sliding type that has been welded so can not be opened. Prevents unauthorised access but will become redundant in time as vegetation develops.	None.	n/a	n/a

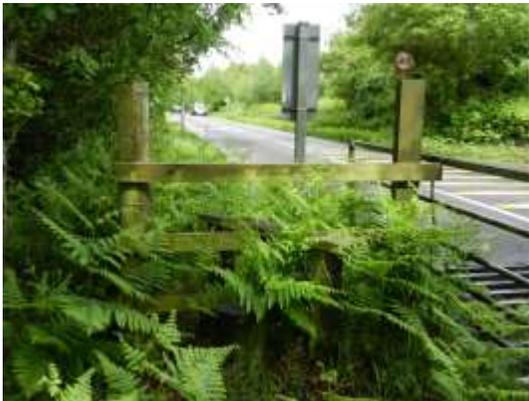
20/05 2014	G54	SU 5125 6496	Wooden stile. Measures: top step; 102 x 15 x 62cm off ground, bottom step; 103 x 15 x 38 off the ground. Top rail is 30cm above top step. Facilitates access along the northern road edge of Bury's Bank road. Encroaching vegetation has obscured the access structure and roadside is becoming difficult to navigate. Little used.	Vegetation clearance required. Is likely to get very little use so not a priority for replacement with a gate.	3	1	No.

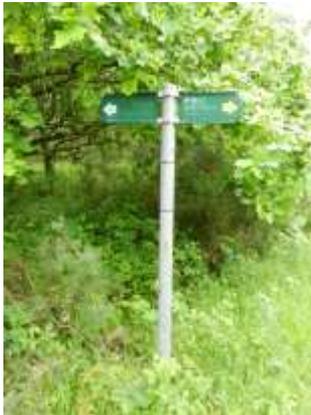
02/06 2014	G55	SU 5284 6448	PRoW finger post in grey. Displays: Public bridleway 'Thatcham Station 1 ¼ miles', Public footpath 'River Enbourne ¾ mile'. The post is very rusty and loose in the ground, both finger signs are faded.	Request a new post from PRoW team and clear vegetation that is encroaching (tree).	2	1	No.

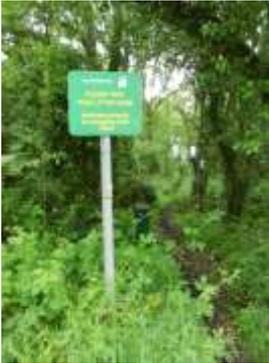
02/06 2014	G57	SU 5333 6441	'No littering' sign. Placed 2m high which is not in keeping with location.	The sign is no longer suitable at this location and should be removed. As in G56, cut post down to 1.5m, cap, and fit a no motorbike sign to the post.  Install a BBOWT reserve sign in this location.	3	1	No.

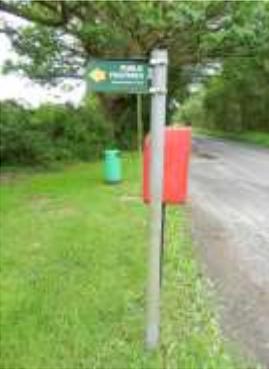
02/06 2014	G58	SU 5334 6439	PRoW finger post in grey. Displays: Public footpath 'Thatcham Station 1 1/2 miles'. Top of post is rusty.	Cut top of post and install new cap.	4	1	No.

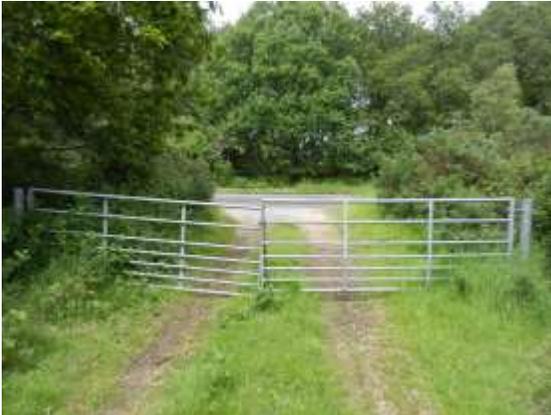
02/06 2014	G62	SU 5320 6437	2 x 7 bar galvanised field gates locked with a chain and a combination padlock and an Estate padlock. There is a 15m pull in off Crookham Common road could be susceptible to fly-tipping. Visitors squeeze past the hanging post on the eastern side. The gates currently do not hang parallel. The gate allows access to a track that leads to the gate in G61.	Make adjustments to the gates so they hang correctly. Maintain and clear vegetation to the full width of the gates so they can be opened without interference. During 2014 the gate in G63 was found to be off its hinges, possibly to provide access, no contact from landowner was made.  See G61.	3	1	No.

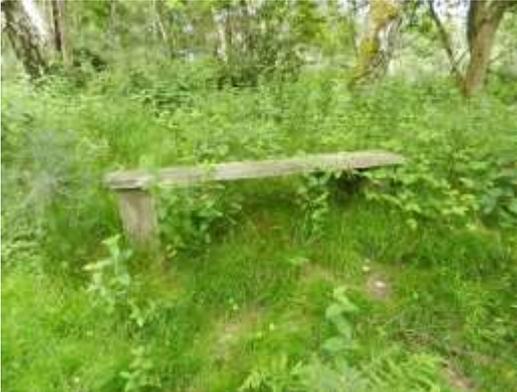
02/06 2014	G63	SU 5312 6437	Wooden bench. Measures 145cm long. The bench is somewhat hidden and can not be seen from the path. It is also very low to the ground and encroached by vegetation.	From the informal path maintain a path to the bench and the pond over which it looks. Maintain a vegetation clear area around the bench. Re-site the bench so it is useable and safe.	3	1	No.

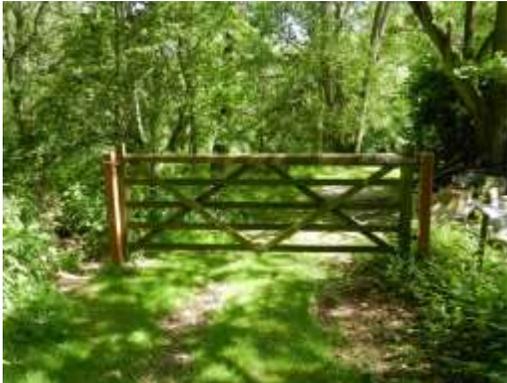
06/06 2014	G69	SU 5233 6416	5 bar field gate mounted on metal posts. The gate has no latch and is instead tied shut with a rope. There is a sign 'no motorbikes beyond this barrier' without branding. The access gate is not within the management responsibility of BBOWT and allows access to the neighbouring property to exercise their commoners rights if exercised.	There is no agreement to allow management vehicles or persons or the general public along the private drive to Thornford road.	n/a	n/a

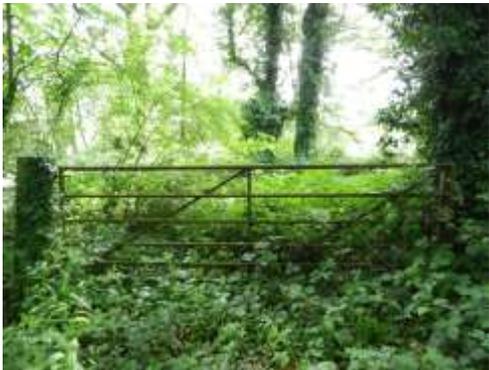
06/06 2014	G70	SU 5200 6409	6 bar metal field gate with metal hanging post. Locked with an unknown padlock. Surrounded by light scrub.	Remove padlock and replace with an estate padlock. Clear vegetation around the gate and maintain the access. There is no requirement for visitors to use this entrance.	3	1	No.

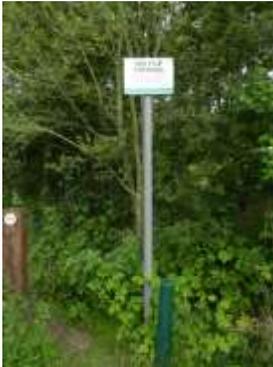
06/06 2014	G72	SU 5204 6447	Highways metal sign (40cmx30cm) 'no fly tipping' with WBC logo. Warns that CCTV is in operation. Sign placed on a 2.m grey post.	The sign is placed at such a height it is not instantly noticeable. There is only one of this type of sign and would recommend if warning signs are being placed in this area then it would be beneficial to install a greater number in areas that are being fly-tipped.	4	Un-known	No.

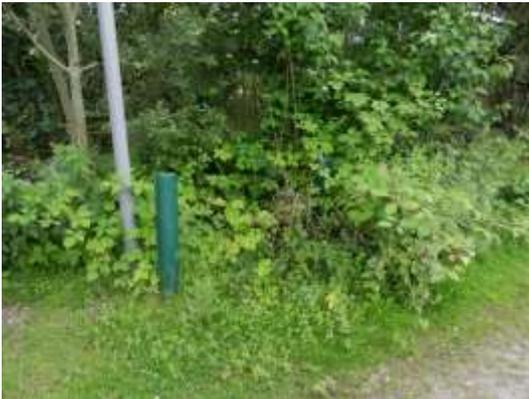
06/06 2014	G73	SU 5204 6447	2 x 12cm wide, 73cm tall green painted metal bollards. As vegetation develops the purpose of the bollards is getting less necessary. The many laybys along this road need to reviewed and consolidated. More bollards will be necessary.	This area along Old Thornford road is heavily poached by informal laybys and therefore prevention of new laybys being formed is necessary. It is preferential for visitors to be persuaded to use Crookham car park where management can be focused and safety is improved.	4	1	No.

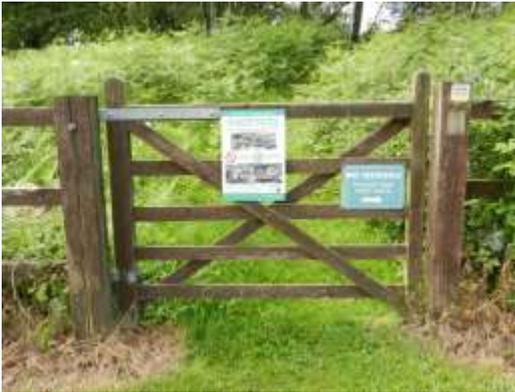
06/06 2014	G75	SU 5195 6413	Wooden bridle gate fitted with an 'autolatch' and striker to assist opening from both sides. There is a sign requesting horse riders use the gate further north on the fence line. This may be to reduce damage to the ground through this gate. There is a stock grazing disc fitted. Gate gets stuck on the ground when opened. GNB sign displayed.	The request for horse riders to use certain gates is necessary in certain locations. A suitable gate which can be opened from horseback must be close by. Adjustments to the ground is required so gate opens correctly. An 'easylatch' system is preferable for all as it is easier to open from both sides.	3	1	No.

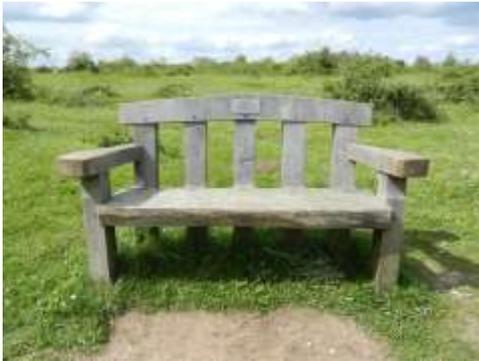
06/06 2014	G76	SU 5166 6431	Solid oak bench with arm and back rests. Measures 138 x 40 x 50cm off the ground. It is fitted without a plinth to prevent wear and vegetation growth. Memorial to '1978 Greenham Common Campaign'. Good condition and sound in the ground. It is positioned some 6m from the track which means there is likely to be wear to and from the bench.	It is preferable to site furniture close to tracks and paths so visitors can access the item easily. If the bench is positioned because of a view, then management of the surface and vegetation is required to and from the main track/path.	3	1	No.

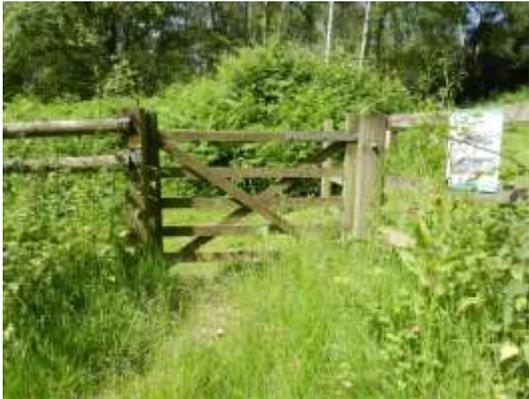
12/06 2014	G78	SU 5133 6405	Wooden bridle gate with a 146cm accessible gap. Fitted with an autolatch to aids opening from both sides. Gate needs adjusting at the hinges and striker needs a nut fitting. Vegetation is heavily encroaching. This gate should be accessible by horse riders who are wanting to avoid the cattle grid. It is likely that this entrance will have low use by horse riders so any improvements should be reasoned.	Clear vegetation well back from the gate. Fit an 'easylatch' extended handle sprung latch to the gate so it can be opened more easily. The area around the gate should be large enough to accommodate horses wanting to manoeuvre.	3 4	1 1	No. No.

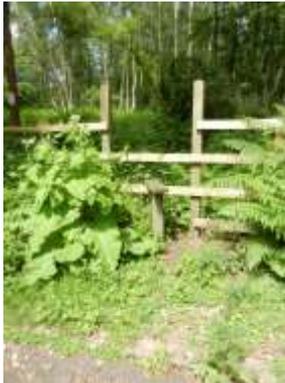
12/06 2014	G79	SU 5134 6392	Wooden stile. Measurements: Top step: 108 x 15 x 69cm high. Lower step: 107 x 15 x 30cm high. Top rail 30cm above op step. 98cm gap with stability posts 170cm tall. Stile looks little used but recently installed so is in good condition. Vegetation encroaching and hiding the steps.	A stile is always the least welcome form of access structure. Because of its position and obvious little use it is not a priority to be changed for a more accessible structure such as a gate. As part of managing paths and routes on site access structures and their need and purpose should be reviewed.	4	1	No.

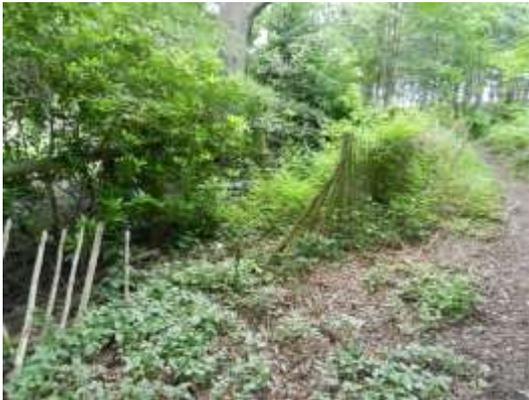
12/06 2014	G81	SU 5114 6410	Defunct hazel paling extended from boundary of private properties. Historically installed by reserve team to give extra protection from livestock. Since private boundary fences have been upgraded and the temporary fencing is no longer required.	It is the responsibility of landowners with shared boundaries with the grazed common to protect their land from livestock. In some cases assistance has been given in the past. So no ambiguity can arise with boundary placement the hazel paling needs removing as soon as possible.	2	1	No.

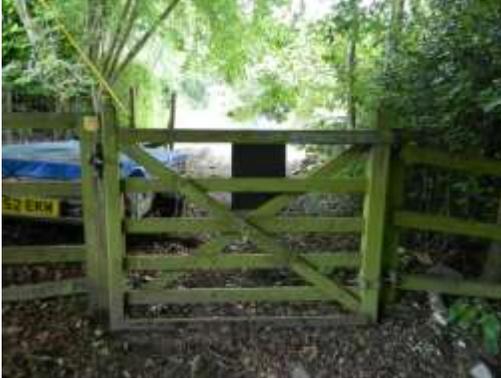
12/06 2014	G84	SU 5093 6411	Wooden bridle gate, 150cm accessible. Fitted with an autolatch and displays 2 x stock grazing discs (one damaged). A ground nesting bird sign can be seen in the picture.	Fit new stock grazing discs. Consider upgrading lever to an easylatch sprung and extended lever that is easier to use.  The storage of a trailer in front of the gate could cause an obstruction to visitors.	3	1	No.

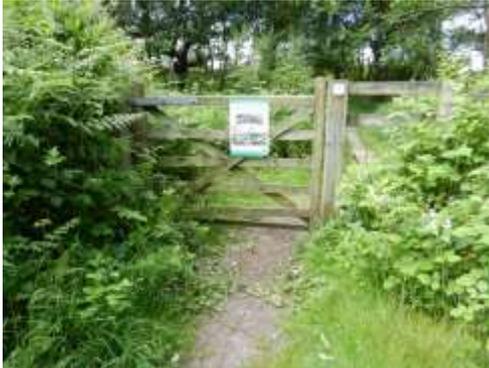
12/06 2014	G85	SU 5080 6420	Wooden bridle gate fitted with an autolatch that has a longer lever so it can be more easily reached from both sides of the gate. Displays two stock grazing discs which are faded. Vegetation is encroaching well into the accessible area.	Make sure that vegetation is cleared the entire width of the access gate (150cm) and kept short beyond with no overhanging branches below 3m introducing into the walking tunnel. Replace stock grazing discs. Consider fitting an easylatch extended sprung lever that is more easily used by pedestrians and horse riders alike.	3	1	No.

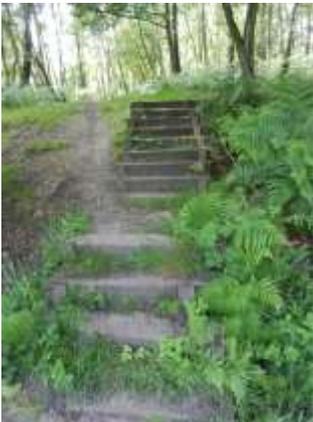
12/06 2014	G86	SU 5093 6422	Flight of 11 steps, 128cm wide and 26cm deep and 16cm drop. No hand rail fitted. A desire line has meant that there is a new walked line and has subsequently become the route for water to erode. Many of the steps have become overgrown. Bicycles use this trail and add to the wear. In places stobs are proud of the step.	Using temporary fencing the desire line route could be prevented. Planting could assist keeping visitors to the original route. Alternatively the steps need to be moved and follow the most straight forward and direct route. Persuading visitors to use the steps would dissuade cyclists.	3 4	1 1	No.

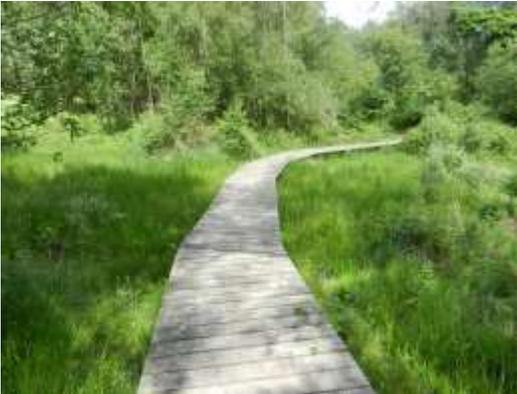
12/06 2014	G87	SU 5094 6423	25m x 1.2m wide wooden boardwalk. Good condition. There is a step of 22cm at the eastern end. There are no edge/kick boards or non-slip covering. The height in some places is 61cm above the ground which therefore requires there to be handrails present. Vegetation is encroaching in places.	Fit non-slip welded wire mesh to the surface. At points that are above 30cm in height, fit handrails. Fit edge boarding along the entire length. It would be more beneficial to provide a slope rather and step on the eastern end of the structure.	2	1	No.

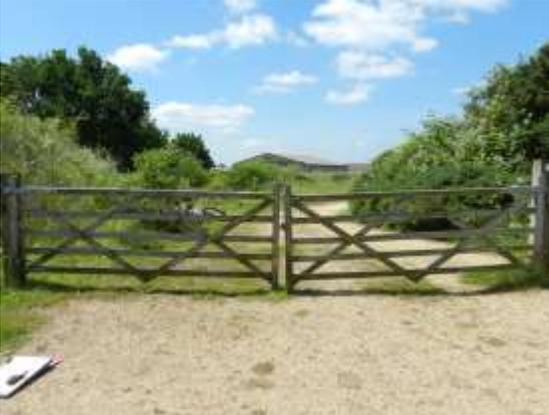
17/06 2014	G88	SU 5068 6438	Double 5 bar wooden field gate with a double gate fastener. There is a chain and three padlocks non of which is the Estate padlock so access is not possible for management purposes. Gates in good condition but need adjusting at the hinges.	It would be beneficial to have access to the land beyond as the actual site boundary ends beyond the gate.	4	1	No.

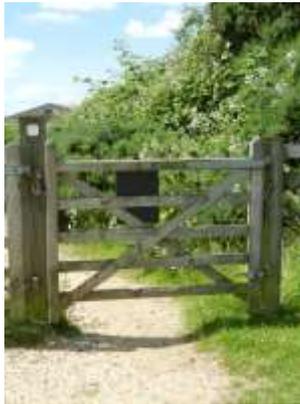
Date Visited	Report Ref.	Location	Findings	Recommendations	Priority Level	Cost Band	Any Work Completed?
17/06 2014	G89	SU 5068 6439	Wooden bridle gate with 150cm accessible gap. No off-set hinges so a return spring has been fitted which means a very fast close speed. Simple striker and gravity latch fitted. Gives access to an informal and non-advertised route into the business park. The route is to change during 2015 and will instead follow the site boundary fence line incorporating a flight of steps (G91). Currently the route is used by horse riders wanting to access trails on the commons.	The gate requires the removal of the spring and instead an off-set hinge needs to be fitted. An 'easylatch' sprung extended lever would be beneficial so visitors can more easily open the gate from both sides. Fit new stock grazing discs. The ability to access the commons from the business park is important and changes to this access are of concern. This is discussed later in the report.	3 4	1 n/a	No.

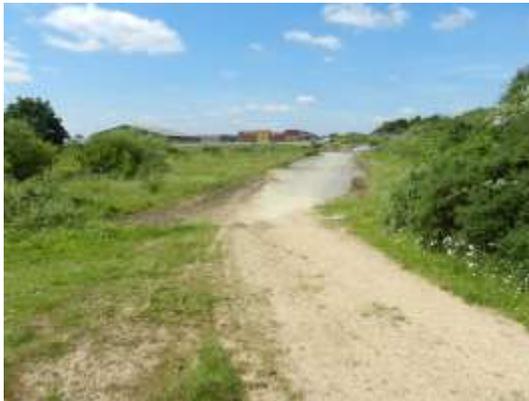
17/06 2014	G90	SU 5067 6437	As mentioned in G89, an undesignated track that crosses the undefined boundary of the business park approx. where the tarmac finishes in the picture. The path turns south at a fence and then passes through a gate that is locked during the night across an old airbase pad. A gate on the other side of the pad gives access onto the business park road network.	As mentioned in G89, access from the business park is an important route for those wishing to access the commons from the south. Those living within the Martindale area to the south of the commons use this access when they wish to walk or ride their horses.	4	n/a	
------------	-----	--------------	---	---	---	-----	--

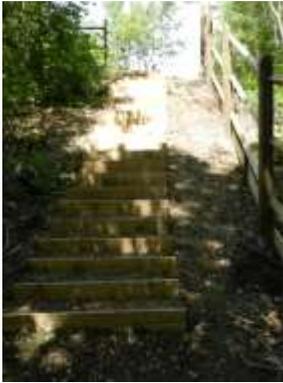
17/06 2014	G91	SU 5060 6423	Flight of 24 steps newly installed (2014). Installed on the business park land as part of a new eastern route onto the common, replacing that current informal route as already mentioned in G89/90. No handrail fitted or rest spots as it is a long flight of steps. None of the route is currently signed or advertised.	There will almost certainly be opposition to this route being used instead of the relatively flat route currently. Horse riders will not have access nor will visitors with accompaniments such as pushchairs. It would be good for BBOWT to start talks with the business park to determine this is the new route and how it will be managed and signed.	4	n/a

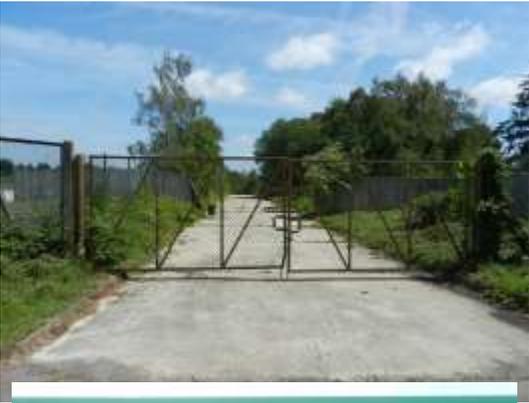
17/06 2014	G92	SU 5040 6419	A large 6m double metal gate upon the business park. From initial information this is likely to be the new entrance to the route leading to the entrance gate as shown in G89.	BBOWT would be advised to speak to the business park owners so they can ascertain what levels of access provision there will be on this new route.	4	n/a

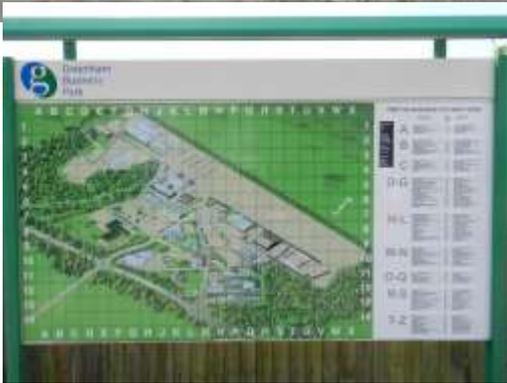
17/06 2014	G93	SU 5027 6394	This is the Greenham Business Park orientation and business location map next to a layby after passing the information/security office. Currently there is no information on this sign which tells visitors how they can access the commons and where they are able to park. There is also no information on the paper map available from the security/information building.	Visitors are quite likely to arrive at the business park looking for the old air base and the commons. Therefore it would be advantageous if the signs are to be changed, that additional access information is added. BBOWT should make Greenham Business Park aware of this idea.	4	n/a

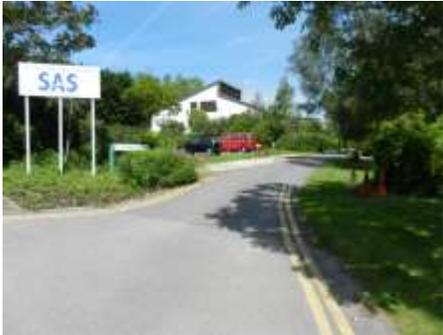
17/06 2014	G94	SU 5033 6388	This is a track that leads into the Hogscombe/Martindale area of the commons. There is a sign to the left which reads 'private no access' which is incorrect and misleading. There is a layby with space for 4 cars that is for those visiting the peace garden to the east of the track.	Review the wording on the sign. This area is not managed by BBOWT.	4	n/a

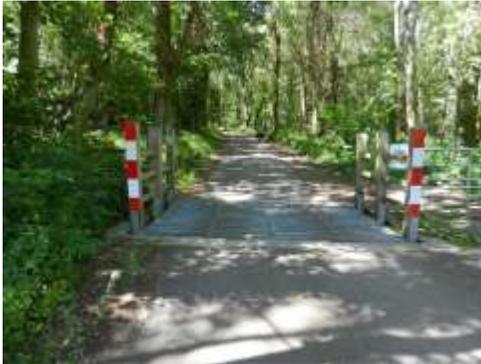
03/07 2014	G95	SU 4899 6392	Substantial highways spec cattle grid which includes an animal escape slope. Wooden integrated barriers either side with red/white signage, both are damaged. The accessible width is 370cm.	Not known who is responsible for the maintenance of the cattle grid.	4	n/a

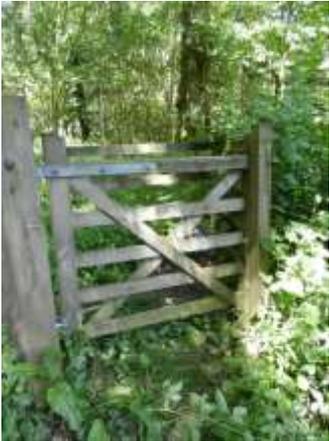
03/07 2014	G96b	SU 4900 6393	Wooden kissing gate without latch. Vegetation encroaching upon structure. Displays an old ground nesting bird sign (removed during visit). Accessible width 1m. A bus stop is situated very near on the A339 so it is feasible that this would be a suitable entrance for those travelling by public transport and this should be kept in mind.	Routinely clear vegetation. Fit reserve name sign including appropriate contact numbers. Fit stock grazing discs to warn that grazing animals are present.	3	1	No.

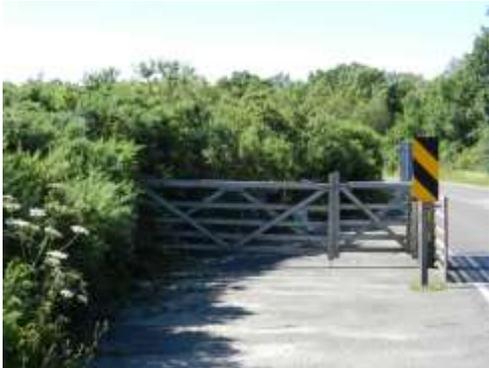
03/07 2014	G98	SU 5025 6534	5 bar wooden field gate and 1.2m accessible pedestrian gate held closed with a lift over latch. A drop bolt has been fitted to the field gate. 2 x stock grazing discs (faded). Old ground nesting bird sign (removed). Gates are very stiff to use. Vegetation is heavily encroaching. Pedestrians should be dissuaded from using the gate as there is no verge.	The gate is not up to British Standard for horse and rider. Liaise with horse and carriage riders to see if the current arrangement is suitable or what improvements can be made.  Clear gorse back from the road and the structure.	3	1	No.
