# Greenham and Crookham Commons Access Audit

*Initial baseline findings of the site's physical and intellectual access provisions.*

**Author: James Stevenson, BBOWT West Berkshire Access Audit Officer**

**Date: 27<sup>th</sup> April 2015**

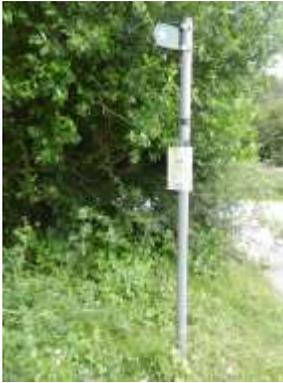
03/07 2014	G100	SU 5028 6523	PRoW finger post fitted with a short permitted footpath sign. Also fitted to the post are instructions on how to link up with the public footpath GREE/6/3 as detailed in target note G30/31.	None.	n/a	n/a

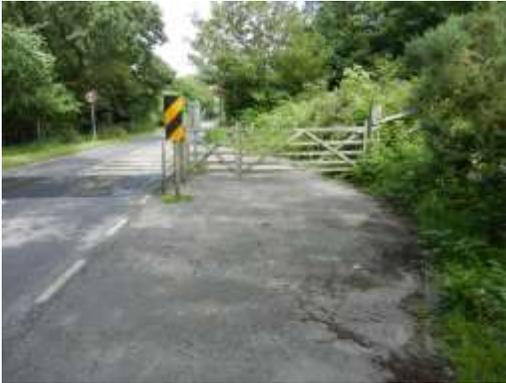
03/07 2014	G102	SU 5121 6493	5 bar wooden field gate and 1.2m accessible pedestrian gate held closed with a lift over latch. A drop bolt has been fitted to the field gate. 2 x stock grazing discs (faded). Old ground nesting bird sign (removed). Sight lines are short looking east.	Best practice as detailed by the BHS says that the field gate hinge is best situated next to the cattle grid so that the latch is far from the noise and danger of the passing traffic. Consider reviewing this option. Cut back vegetation and improve sight line.	3 4	1 1	No. No.

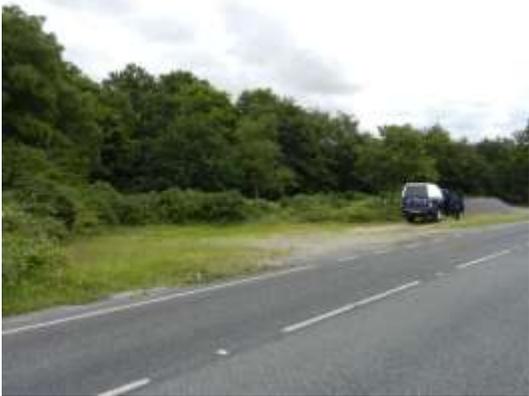
03/07 2014 More photos on next page.	G104	SU 5097 6484	Informal pull-in off the north of Bury's Bank Road. Surface is mostly naturally occurring gravel with some large pieces of concrete. Both access points at either end have very large potholes as well as dips and rises within. There is limited visibility when turning west from the eastern exit/entrance. Several tonnes of highways gravel was present at the time of visit, this has since been removed. The responsibility of maintenance falls to BBOWT.	The parking area is useful and well frequented by those wanting to walk in the immediate area or cross the road to the Common. It is not recommended that the parking is advertised as this will require formalisation and increased maintenance of the car park but maintenance of surface should be to a quality where vehicles can gain smooth access without damage.	2	2	No.

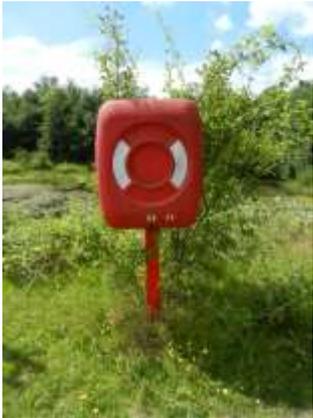
03/07 2014	G105	SU 5004 6512	24" Perry Buoy life ring in a Glasdon manufactured case and stand. Good condition but a little dirty. There is a dog rose growing in close proximity that needs removing as it is encroaching on access to the safety device.	Vegetation should be removed within 2m of the structure and maintain a wide clear access to the front of the case from the neighbouring water feature.	3	1	Work is occurring to replace all the life rings and clear vegetation.

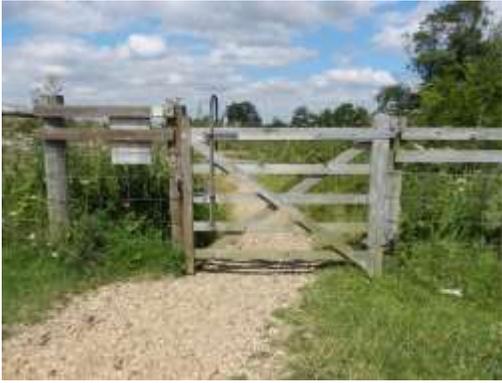
03/07 2014	G113	SU 5127 6494	Wooden bridle gate with off-set hinges to aid self-closure. Fitted with a triangular gravity catch which requires the visitor to lean over the gate to open the catch from the non-grazed side. This can be awkward or impossible for some users. Displays 1 stock grazing disc (faded) and a seasonal ground nesting bird sign.	The gate has low use because of its location. However to assist opening it would be cheap and easy to fit an auto-catch which has an extended lever.  Fit two new stock grazing discs to the latch post.  Clear the path on the Commons side as it was not clear which way to go.	3	1	No.

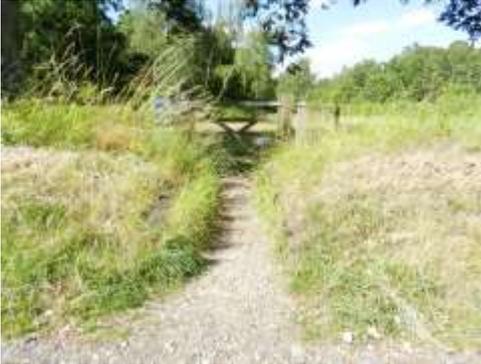
15/07 2014	G121	SU 5235 6457	Narrow 80cm wide gravel path with railway sleepers preventing material falling from the banks alongside. One of the sleepers is falling over. The narrowness of the gap and the hidden sleepers reduce the accessibility of the path.	The path should be widened to 150cm with a manoeuvring area by the gate for horse riders. This would make the access more visible from the car park.	2	1	No.

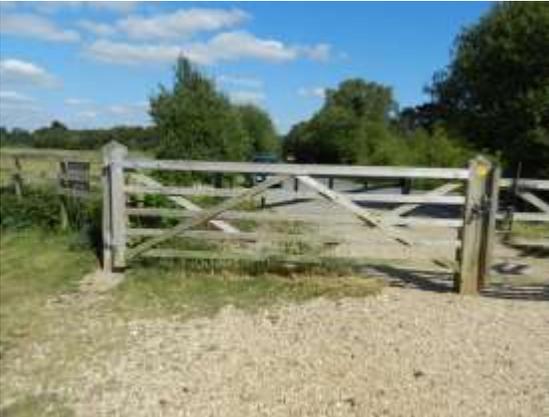
15/07 2014	G122	SU 5208 6461	5 bar wooden field gate with a wide accessible width of 3.5m. Locked with an estate padlock. Good condition.	Maintain and prevent encroachment by vegetation.	3	1	n/a

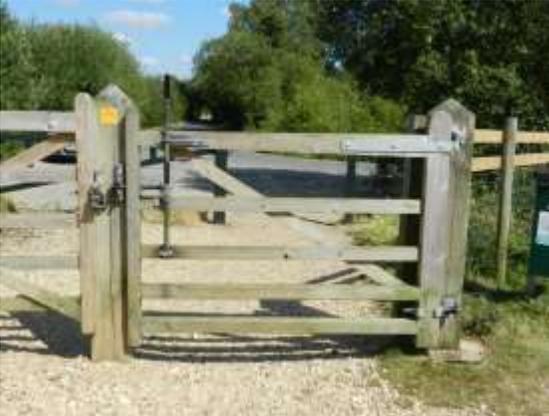
15/07 2014	G123	SU 5208 6461	Wooden bridle gate with an accessible width of 150cm. Fitted with an 'easylatch' extended lever system that facilitates access from both sides of the gate and by horse riders. Good condition. Displays 2 x stock grazing discs.	Add a no motorcycle disc on the non-grazed side of the latch post. This is a high use gate so regular maintenance checks and services (greasing of hinges and latch/catches) is required.	3	1	The gate was serviced at the time of visiting. A routine gate inspection schedule is required.

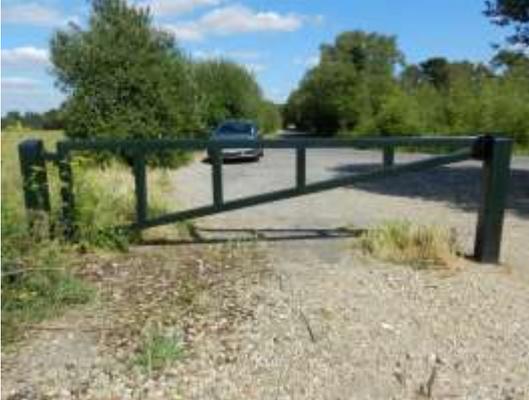
15/07 2014	G124	SU 5209 6461	Green painted metal hinged/swing type vehicle barrier with integral lock that is opened with an estate key. Accessible width is 3.7m. Good condition.	Visitors routinely park in front of the barrier as there is space off the road. Previous signage to request no parking was vandalised. It would be better if the gate was closer to the road so preventing vehicles from parking. As mentioned elsewhere, there needs to be a review of the parking along old Thornford Road.	4	n/a

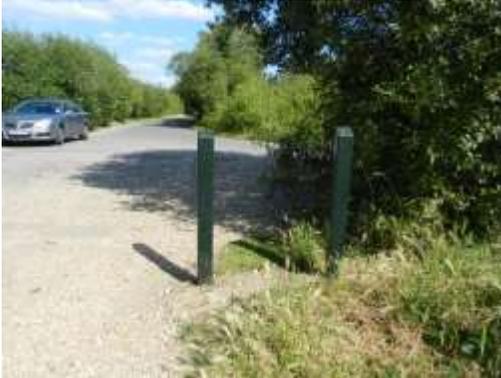
15/07 2014	G125	SU 5209 6460	3 x metal concrete filled posts. 10 x 10cm and 1m tall. Prevents unauthorised access around the vehicle barrier. 1 is at an angle but the tree in the picture also acts as a barrier. The maximum accessible width is 146cm which is for all user groups.	Reflectors may help to prevent collisions by turning vehicles at night.	4	1	No.

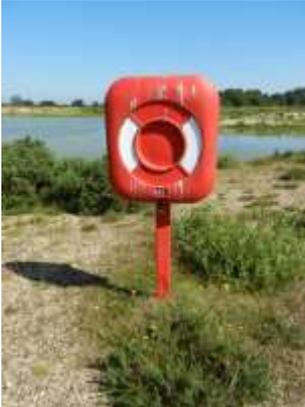
22/07 2014	G126	SU 5199 6466	24" Perry Buoy life ring in a Glasdon manufactured case and stand. Cover does not close with bungee. There is no rope.	Fit rope to life ring ASAP. Repair case and clean. Assess life ring for expiry date/condition.	1	1	No. Work has been started to repair and replace broken or missing equipment.

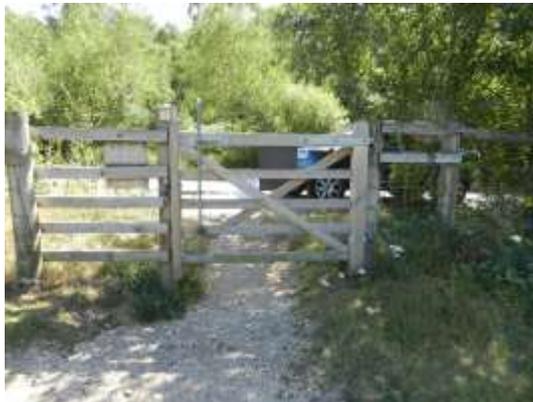
22/07 2014	G128	SU 5171 6466	Wooden bridle gate fitted with a sprung extended trombone handle lever. Displays 2 x stock grazing discs, 1 x no motor cycle disc. 140cm accessible width. Trombone handles are designed to make it even easy to open the gate from both sides. In reality they become worn and wobbly and do not function smoothly. They can also snag the reins of a horse rider. Overhanging vegetation needs to be cut back for those approaching on horseback. Ditches present by road.	This gate is signed as a horse rider entrance from the gate to the south described in G75. Recommend replacing the trombone handle with an 'easylatch' straight extended lever (it is possible to cut the installed handle and fit a grip as an easier fix). Reinstate material through the gate as there is substantial wear to the surface and thus the gate and levers have become higher for visitors to operate.	3	1	No.

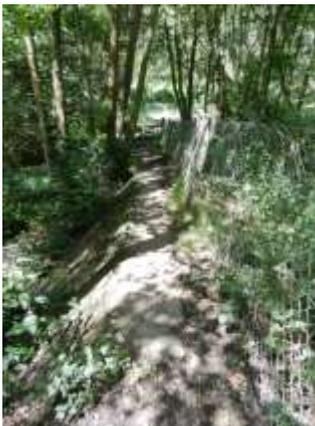
22/07 2014	G129	SU 5170 6419	9m section of path goes across the top of a concrete bund, steep drop of 3m to the south and chain-link fence to the north. Path width is just 70cm and the concrete can become slippery. There is a serious risk of slips and falls.	The balance pond to the north is almost dry and so the chain-link fence is becoming redundant. Therefore it could be removed allowing for a wider path. A hand rail should be fitted to the south of the path to prevent falls. Encroaching trees will need to be cleared to allow free access.	2	1	No.
------------	------	--------------	---	---	---	---	-----

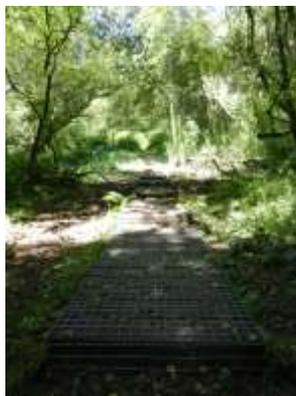
Date Visited	Report Ref.	Location	Findings	Recommendations	Priority Level	Cost Band	Any Work Completed?
22/07 2014	G130	SU 5167 6420	30m section of stepped boardwalk with a width averaging 92cm. Max height off the ground is 36cm and risers are 15cm. Covered in welded wire mesh. Good condition.	The height of the boardwalk should mean the addition of a handrail and edge/kick boards should also be fitted. The terrain is challenging but visitors may appreciate the extra stabilisation afforded by handrails especially in wet conditions.	4	2	No.

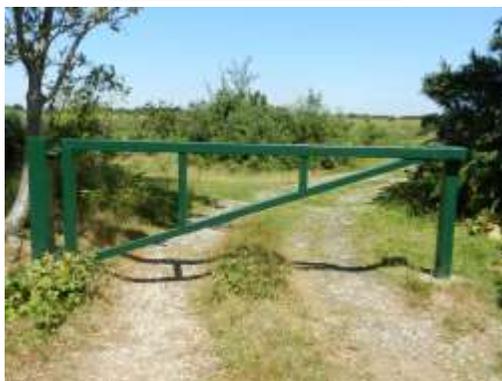
22/07 2014	G131	SU 5110 6423	Green painted metal vehicle access gate, hinged/swing type, fitted with an integral estate lock. Good condition. Access to the east of the gate measures 108cm which would restrict horse riders and some mobility scooters. Raised concrete through the gap and an uneven surface means access is again restrictive.	Removing the wooden post present would mean a gap of 150cm. encroaching vegetation was bad and severely narrowed the gap. This needs to be cleared regularly during the growing season.	3	1	Vegetation was cut whilst at the location. Post remains.
------------	------	--------------	---	---	---	---	--

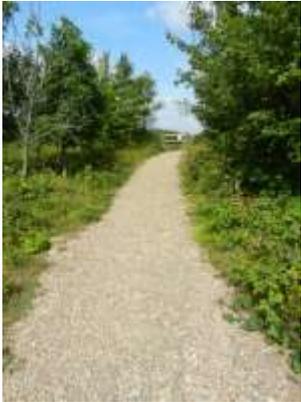
31/07 2014	G133	SU 4942 6448	<p>The path from the gate described in G132 has an improved sealed surface with small diameter loose gravel to improve grip. The surface ends abruptly and to continue means navigating large quarry stone soak away and dodging the wheelie bins and left rubbish. Alternatively veering over the natural grass surface and dropping down the kerb into the car parking area.</p> <p>The natural surface becomes slippery and muddy in the winter.</p>	<p>It seems very strange that the path was not completed and this should be made a priority. Recommend for there to be parking available for visitors at this location so those travelling from south of the Commons would not have to travel all the way around to the northern main car park at the control tower.</p> <p>Consult with Greenham Business Park as to the possibilities of these recommendations and adding this facility to the maps and information the park provides on site and electronically.</p>	4	2

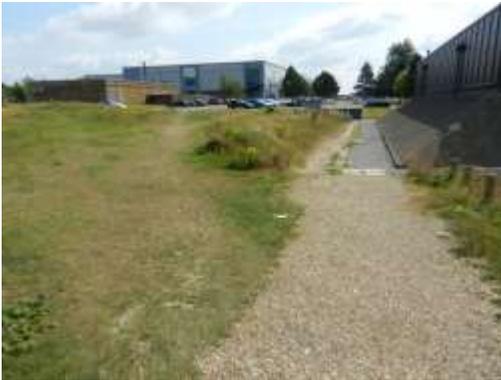
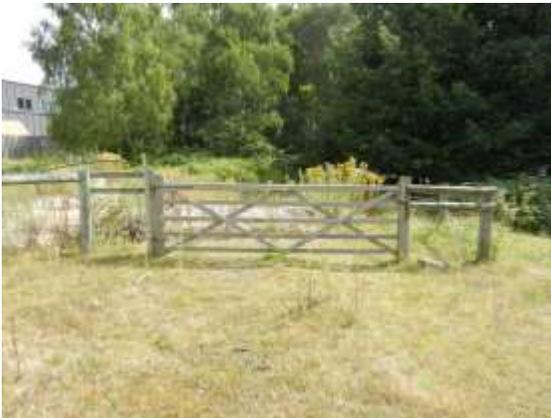
31/07 2014	G134	SU 4943 6440	<p>5 bar wooden field gate with 3.6m accessible width. It is locked with a chain an estate padlock as the lath is broken. Because of previous theft from the business park and the commons being used as an escape/entry point, a 2 foot ditch has been dug behind the gate which makes the gate redundant. Beyond the ditch the access track is now blocked by huge mounds of green waste.</p>	<p>This access point for management and emergency vehicles is the only access along the southern boundary that a large vehicle such as a fire engine or large machinery could have used. Consider re-opening access if improved security such as metal vehicle barriers is installed.</p>	4	2	No.

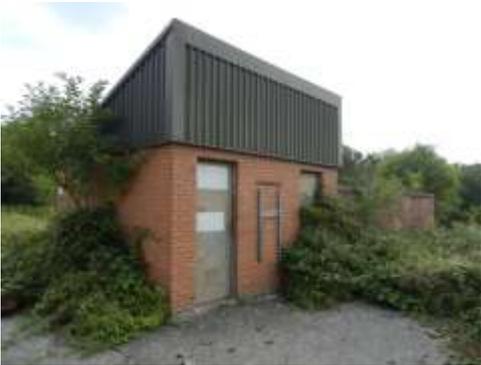
31/07 2014	G135	SU 4939 6437	Ex-airbase building which is secure but has had historical vandalism to the roof and aperture. There are loose metal objects within the partially fenced compound but access was denied because of vegetation.	Keep structure maintained and prevent access into building. Investigate metal objects within the compound and remove/make safe to prevent theft or harm. Consider alternative uses and add interpretation. This helps to preserve the building.	4	1	No.

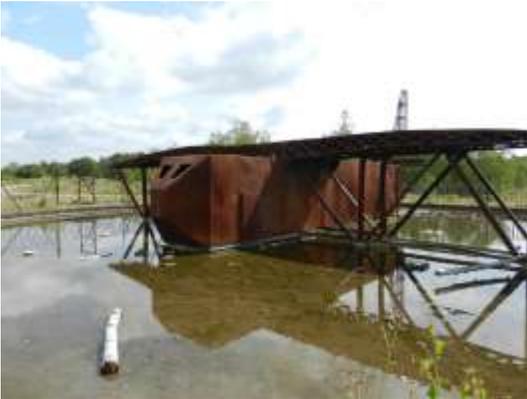
31/07 2014	G136	SU 4925 6428	Ex-airbase metal fire plane. Once used as a training structure. Hazel paling fence has been installed since to prevent access. The structure is of keen interest to visitors but does pose a safety issue due to the small openings and it is easy to climb. The shallow water is also a drowning risk if someone was to fall from the structure and become unconscious.	The fire plane is a focal point due to its size and unusualness. An investigation is required to see if it should be preserved or left to slowly decompose. The safety issues need to be addressed. Adding interpretation would engage and inform visitors to the site. Make sure that any fencing installed does not obscure the view to children or those seated on mobility scooters for example.	2	Un-known	Preliminary enquiries have been made by the auditor to investigate how to preserve the structure. Original design plans are available.

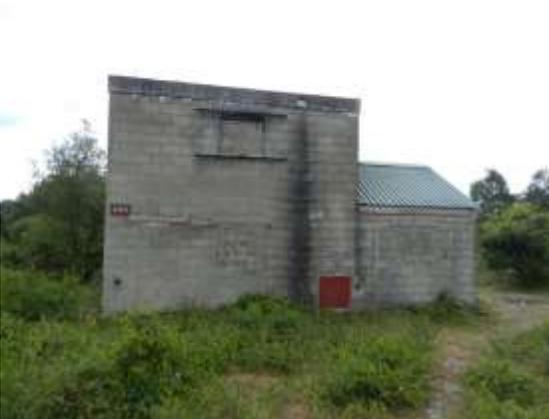
31/07 2014	G137	SU 4928 6423	Ex-airbase building No. 280. This building has been converted into a bat roost/hibernacula. Secure at time of visit but has had break-ins historically.	Maintain the building to prevent access by the public. Install interpretation as to its history and current function.	4	1	No.

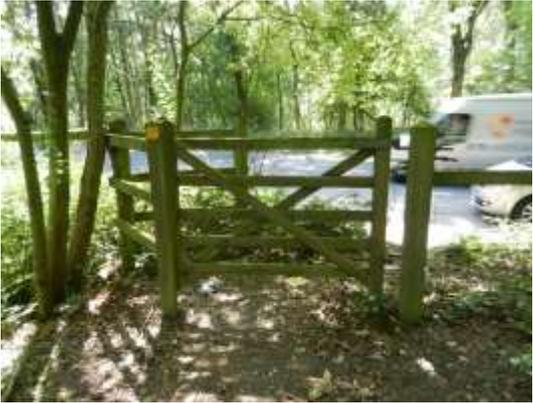
31/07 2014	G138	SU 4943 6392	Wooden kissing gate with a maximum manoeuvring space of 66cm. Displays 2 x stock grazing and 1 old incorrect nesting bird season discs. The gate allows access from the 30m layby on the A339 and from the footpath. There is reasonable slope up to the gate. Natural surface through the gate. Old carpet has been laid on the ground within the Commons over a muddy section. Waste collects in this location likely from parked vehicles.	The restrictive kissing gate does also prevent motorcycles accessing the Commons at this location which is somewhat hidden. Also the gate cannot be left open which may lead to cattle walking onto the very busy A339. Unlikely to advertise parking and entering the Commons at this location due to the minimal parking area. Vehicle security is also of concern. Routinely litter pick and remove carpet, instead improve the path using natural materials.	3	1	No.

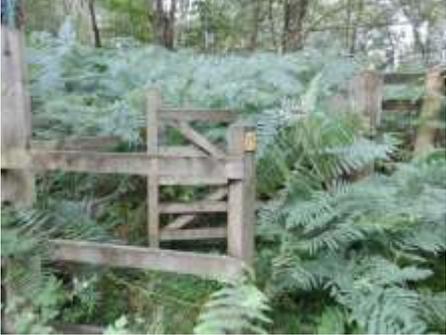
31/07 2014	G139	SU 4963 6393	Wooden kissing gate with a maximum accessible gap of 70cm. The gate has been built on a slope so it is somewhat tricky to navigate. Encroaching bracken totally obscured the gate. The location of the gate means it is unlikely to be ever used. There are no paths on either side of the structure.	Leave in situ. No need to improve accessibility. Keep clear of vegetation.	3	1	No.

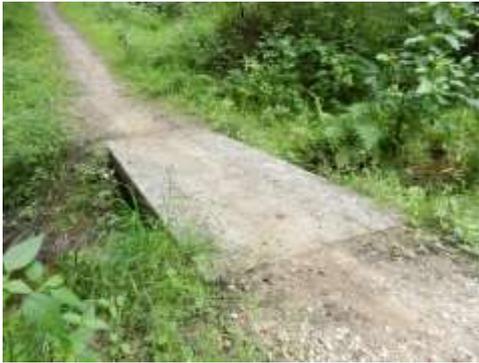
31/07 2014	G140	SU 4899 6442	Wooden bridge made using 4 thick wooden beams covered with welded wire mesh stapled to the surface. Measure 260cm x 107cm wide. Evidence shows it is well used by cyclists and therefore the installation of handrails would not be suitable. Good condition and fit for purpose.	Given the short length of the bridge and the range of users handrails are not advised. Maintain structure and keep vegetation from encroaching over the edge of the structure to prevent falls. Keep structure flush with the ground at either end.	3	1	No.

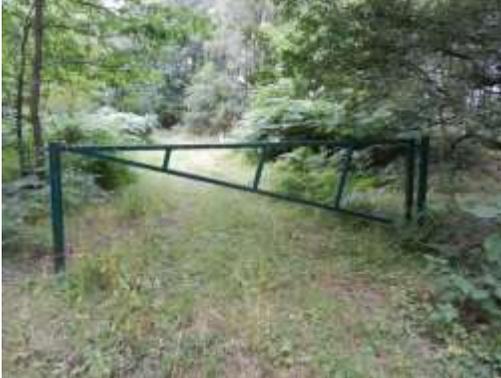
31/07 2014	G142	SU 4883 6429	Green painted metal vehicle barrier, hinged swing type, locked with an estate padlock. Paint is flaking and rust is showing. The access is useful for management vehicles and machinery.	Maintain and re-paint. Keep vegetation tunnel open to prevent encroaching and loss of accessible route.	3	1

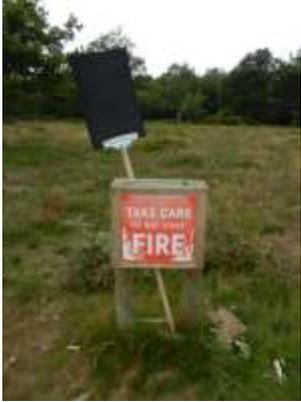
31/07 2014	G144	SU 4823 6491	Wooden fire beater stand with a single beater installed (new). Fire warning sign is faded/worn away.	It is recommended that 3 beaters are installed at each stand. The sign needs replacing with a new sign. Keep vegetation well back from the stand so it can be seen.	3	1	No.

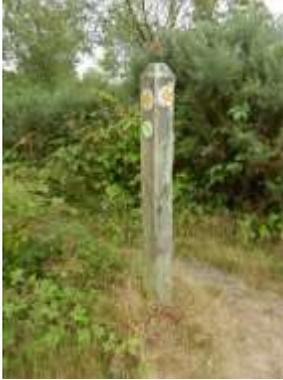
31/07 2014	G145	SU 4823 6491	Wooden WMP. Displays: 2 x public footpath, 1 x Walk 4 Life disc(s). No WBC branding on the ROW discs. Post looks tired and is loose in the ground.	Fit new PRoW discs. Reinstate post so it is firm in the ground.	3	1	No.

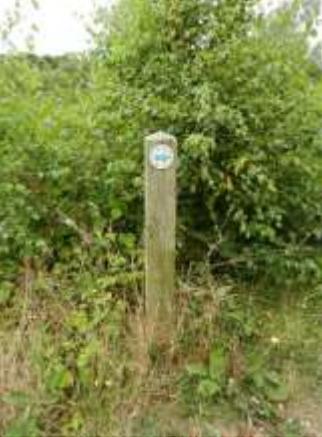
31/07 2014	G146	SU 4826 6496	Short (80cm) wooden WMP. Displays Walk 4 Life disc (faded).	Request new discs for the Walk 4 Life route to replace the faded discs on-site. Keep clear of vegetation. A taller post would be better suited to location.	2	1	No.

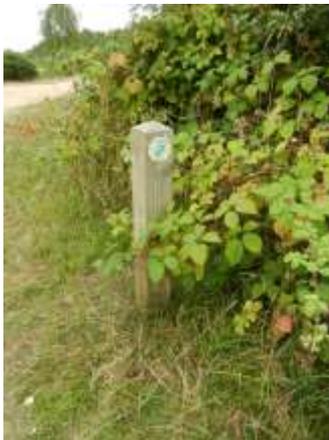
Date Visited	Report Ref.	Location	Findings	Recommendations	Priority Level	Cost Band	Any Work Completed?
31/07 2014	G147	SU 4828 6495	Short (80cm) wooden WMP. Displays Walk 4 Life disc (faded).	Request new discs for the Walk 4 Life route to replace the faded discs on-site. Keep clear of vegetation. A taller post would be better suited to location.	2	1	No.

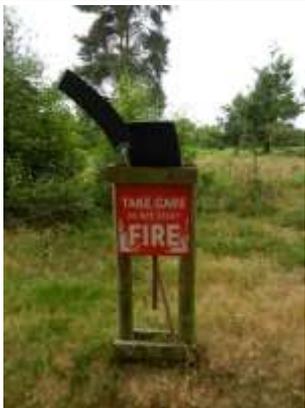
31/07 2014	G148	SU 4817 6460	Wooden fire beater stand with two beaters installed, both new but one has a short handle?. Fire warning sign is also fitted and legible.	It is recommended that 3 beaters are installed at each stand. Replace the short handle beater. Keep vegetation well back from the stand so it can be seen.	3	1	The short beater was removed at the time of the visit. New beaters still required.
------------	------	--------------	--	--	---	---	--

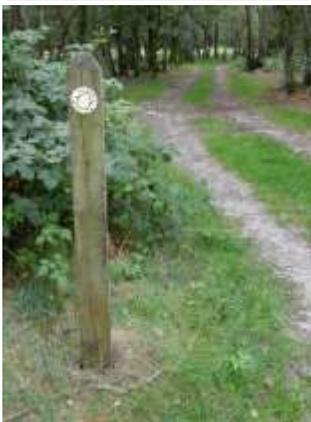
31/07 2014	G149	SU 4814 6448	Wooden PRow WMP with two old type public footpath discs. Post is rotten at the base.	Fit a new post and public footpath discs.	2	1	No.
------------	------	--------------	--	---	---	---	-----

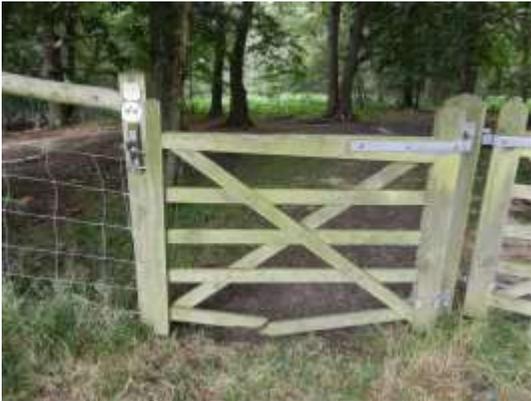
31/07 2014	G151	SU 4804 6434	Wooden bridle gate with a 150cm accessible width. Opens out of the Commons. Hanging post is rotten. Displays: 2 x stock grazing discs and 1 no motorcycle disc. Bottom rung of the gate is broken. Fitted with a simple striker and triangular gravity catch.	Replace post as soon as possible. Repair the gate and re hang so it opens into the common. Fit an 'autolatch' which extends the triangular gravity latch with an extended lever so it is easier to operate from both sides. There is no requirement for the motor bike sign as there is a stile at the A339 end of the public footpath to the south.	2	1	Work has been completed to install a new bridle gate and signage.

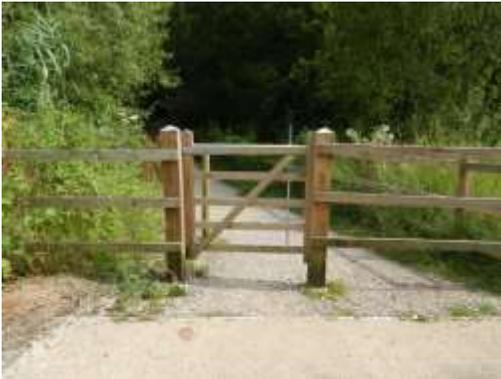
31/07 2014	G152	SU 4792 6487 Not within site boundary	Wooden pedestrian gate off Capability Way. 116cm accessible gap. Fitted with an extended lever and sprung latch with triangular gravity catch. Not installed correctly as the striker does not reach the catch and so opens freely. Surface is a type 1 with fines.	This access point onto the Commons is a very useful link for the recent housing development in this area. The managers of the public open space should be responsible for repairing the gate.	4	1	Unknown.

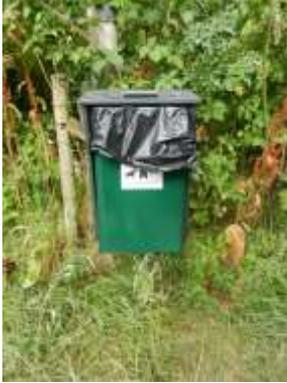
31/07 2014	G153	SU 4792 6488  Not within site boundary	Dog waste bin with earth anchor. Style prevents the depositing of large amounts of general waste. Unknown who empties bin. The bin is located very close to the gate described in G152. This makes it easier to empty but location would have been better placed near the Commons boundary.	Review the levels of dog waste left on the ground along this route and within a short distance of the boundary gate. Visitors may not realise who is responsible for emptying the bin and cleaning the access route and blame may be directed at BBOWT. Appropriate signage on who manages the access route could be advantageous.	4	n/a	No.

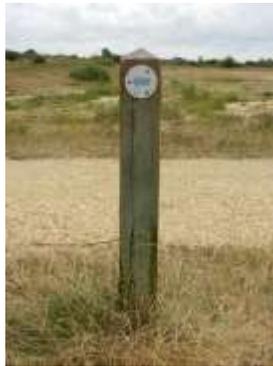
Date Visited	Report Ref.	Location	Findings	Recommendations	Priority Level	Cost Band	Any Work Completed?
01/08 2014	G155	SU 4797 6485	Wooden WMP. 76cm tall. Displays 1 x Walk 4 Life disc which has faded.	Replace disc.	3	1	No.

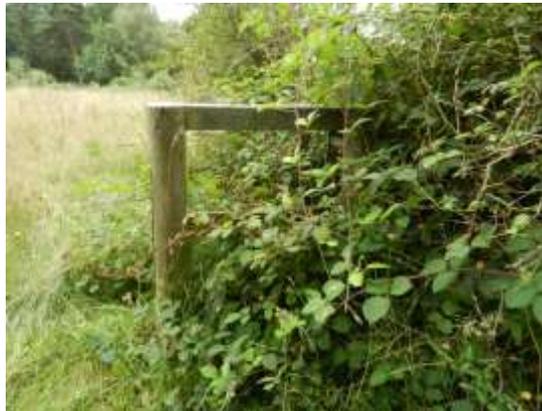
01/08 2014	G156	SU 4864 6417	Wooden fire beater stand. No fire warning sign or beaters installed. Covered in vegetation so is difficult to spot.	Assess the relevance of its location. If deemed to be suitable, clear vegetation at least 2m around the structure and fit warning sign and 3 beaters.	2	1	No.
------------	------	--------------	---	---	---	---	-----

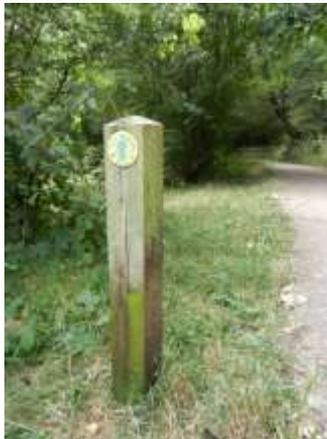
01/08 2014	G157	SU 4817 6507	Wooden WMP. 75cm tall. Displays 1 x Walk 4 Life disc which is dirty.	Clean disc.	3	1	No.
------------	------	--------------	--	-------------	---	---	-----

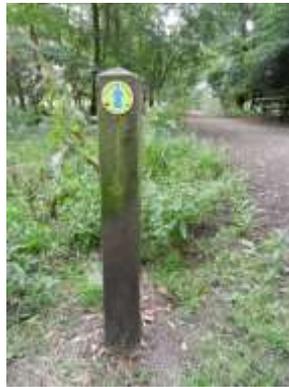
Date Visited	Report Ref.	Location	Findings	Recommendations	Priority Level	Cost Band	Any Work Completed?
01/08 2014	G158	SU 4831 6514	Wooden WMP. Displays 1 x Walk 4 Life disc. Post measures 83cm tall.	Clean disc and post.	3	1	No.

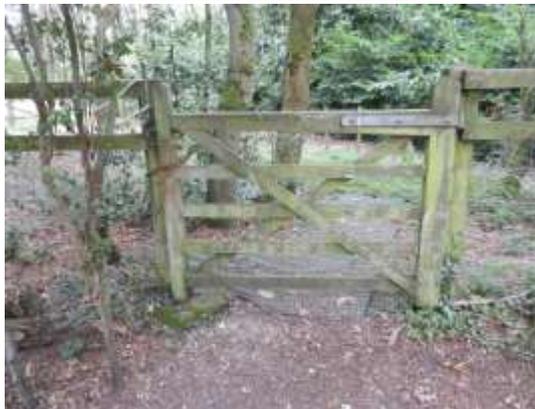
01/08 2014	G159	SU 4831 6515	Wooden bridle gate fitted with an 'autolatch'. This is a private access for the disabled landowner of the adjacent land. The latch post is rotten so the gate does not open effectively. The gate is locked.	Though it is the neighbouring private landowners responsibility to fence livestock out of their land, it may be prudent if ever the fence line was to be maintained to liaise with the landowner and offer assistance with repairs.	4	n/a	No.
------------	------	--------------	--	---	---	-----	-----

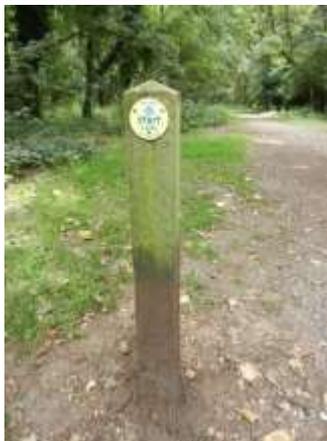
01/08 2014	G160	SU 4836 6526	Wooden WMP. Displays 1 x Walk 4 Life disc which is faded. Post measures 80cm.	Replace disc and clean post.	3	1	No.
------------	------	--------------	---	------------------------------	---	---	-----

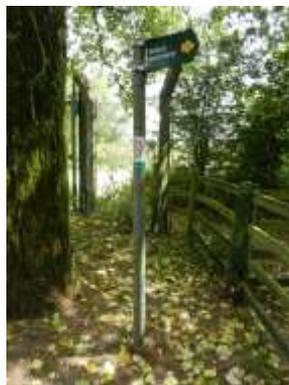
Date Visited	Report Ref.	Location	Findings	Recommendations	Priority Level	Cost Band	Any Work Completed?
01/08 2014	G164	SU 4837 6526	PRoW finger post displaying 1 public footpath pointer sign. Post is rusting badly. Post has a dog fouling fine sticker attached.	Clean and inspect post.	3	1	No.

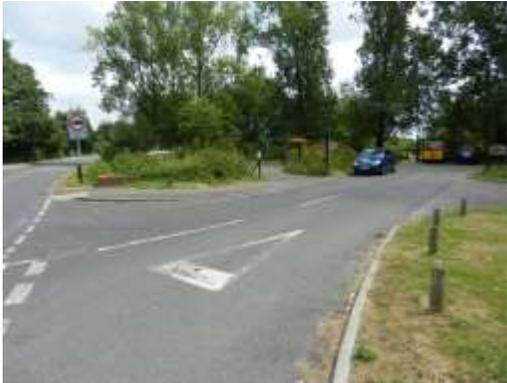
01/08 2014	G167	SU 4837 6529	Pyle Hill car park suitable for 12 cars below the height of 2m beyond the height barrier. The surface is a concrete cell arrangement that is in good condition but the design makes for a very uneven surface which would not be easy to navigate with a pushchair or a wheelchair. There are no blue badge holder priority disabled bays. The surrounds are shabby with dragons teeth missing or damaged and unkempt vegetation. The large hybrid black poplar trees are rather imposing and reduce the light levels and welcoming feel. There is no signage relating to the parking facility. Many visitors park on the access road as seen on the right of the picture and thus block access to gates and information boards. This makes for a dangerous place with cars manoeuvring around. The historical airbase gate is looking tired and in need of renovation and interpretation.	This is one of the busiest entrances to the Commons and therefore parking is at a premium with visitors jostling for space or parking on pavements. The car park cannot be extended due lack of space. To make the car park a more functional welcoming entrance: install a welcome sign on the road side, a sign informing visitors of the presence of main car park, prevent parking in front of the gates and orientation boards, remove height barrier, restore the airbase perimeter gate and install interpretation, move notice board to the cordoned off area, remove the hybrid black poplar trees, cut vegetation and install native plant species within the green areas.	4	3	No.

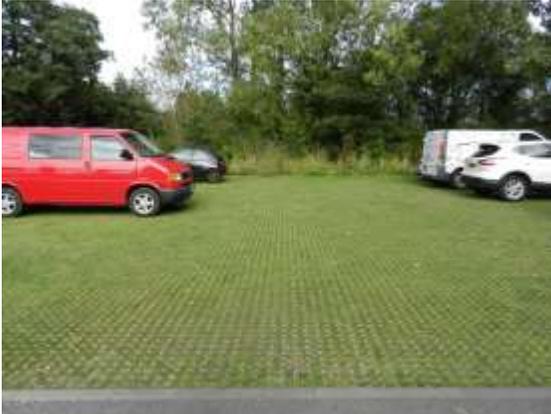
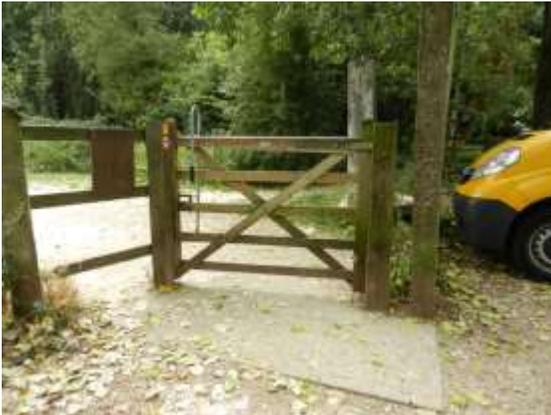
01/08 2014	G168	SU 4838 6527	Wooden bridle gate with a concrete pad beneath the structure. Gate as a stirrup long lever handle to aid access for both sides. Hs run out of adjustment at the hinges (off-sett). 145cm accessible gap and displays 1 x stock grazing and 1 x no motorcycle discs.	This is a very high use gate and so gets a lot of wear. Regular maintenance checks and servicing required. Replace stirrup handle that prematurely wears the gate structure and becomes wobbly. Fit another stock grazing disc.	3 4	1 n/a	No.

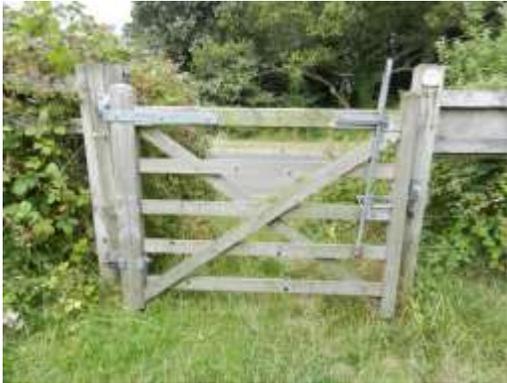
01/08 2014	G172	SU 4865 6532	Wooden bridle gate with a 150cm accessible gap. Ground beneath structure is uneven with a hidden step to the north. A section of armoured cable is protruding right beneath the gate. The gate is fitted with a sprung stirrup handle which is very wobbly. Displays two stock grazing discs and 1 x no motor cycle disc, all faded.	Smooth the surface through the gate way and remove the cable. Replace the stirrup handle with a long lever and end grip. And make good worn pieces. The gate is not well used and the suitability of a gate in this location could be reviewed.	2	1	Some work has occurred to make good the gate fittings.

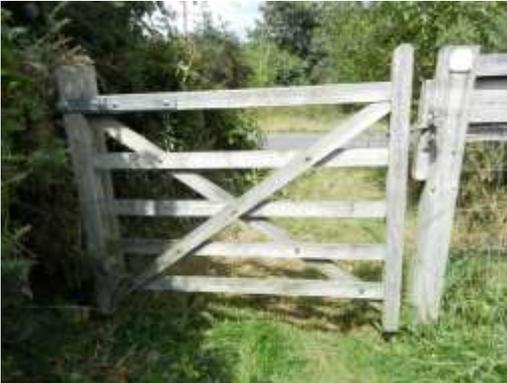
01/08 2014	G173	SU 4882 6528	Wooden bridle gate with a 150cm accessible gap. Off-set hinges and a striker and triangular gravity catch. Does not latch very well. Public footpath GREE/6/3 ends on the opposite side of the road. Sight lines on the edge of Bury's Bank road are very poor and a windblown willow is leaning towards the structure. Displays 2 x stock grazing and 1 x no motor cycle discs all faded.	Replace discs. Improve sight line and remove leaning tree. Remove more of the vegetation so the gate is easily accessible and visitors cannot get snagged clothing.	3	1	No.

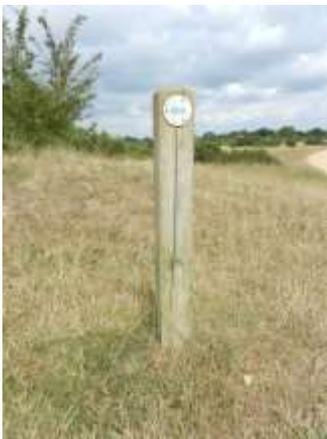
01/08 2014	G174	SU 4868 6507	Wooden WMP, displays 1 x Walk 4 Life disc which has faded. The post measures 87cm tall. Post is slightly wobbly in the ground.	Firm up post and replace disc.	3	1	No.

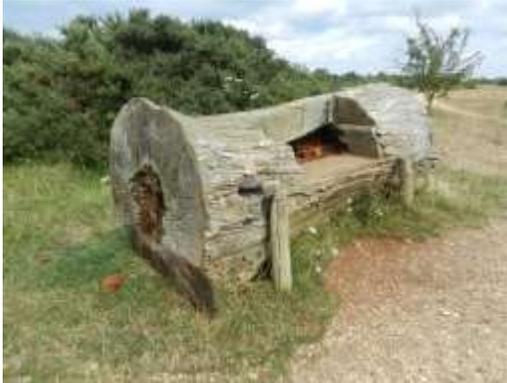
01/08 2014	G175	SU 4868 6507	Large wooden tree trunk with a seat cut out. The seat fits in with the natural landscape but caution is needed as it does not fit with guidelines for accessible seating. As long as accessible seating is also provided then a mix of styles can be used. The log is becoming very rotten which adds to the interest but not unfortunately to the function. Benches can become the focus of littering and this structure with its gaps and holes is likely to become filled with litter.	Review the provision of accessible seating. This location with its view of the bunkers and Commons is attractive and may be the furthest point to which those with some disabilities or those with minimum mobility can make. Therefore an accessible bench would be recommended at this location. A blue badge parking space at Pyle Hill car park should be provided to assist.	4	1	No.

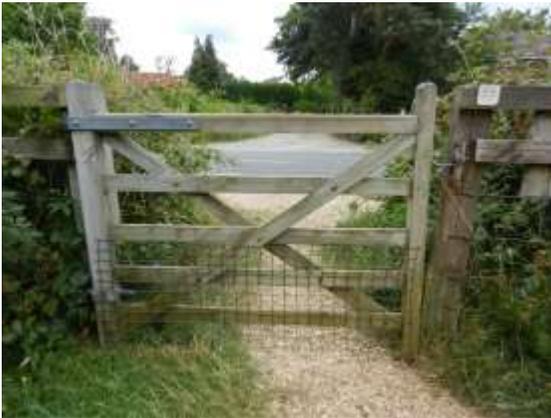
01/08 2014	G177	SU 4917 6511	Wooden bridle gate with a 150cm accessible gap. Fitted with a striker and triangular gravity catch. The gate is at an angle because of tension from the fence line and therefore the gate does not shut properly. There is wire mesh fitted to the base of the gate to prevent dogs running out into the road, this however hinders the gate returning to the closed position as it gets tuck on the ground.	Repair the gate so it closes efficiently and securely. Both the stock grazing and no motor cycle discs need replacing. Widen the surface through the gate and level. Keep vegetation much further back.	2	1	Work has occurred to sort the latching problem.

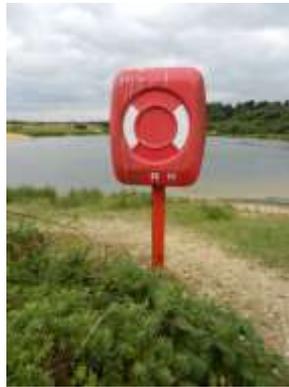
Date Visited	Report Ref.	Location	Findings	Recommendations	Priority Level	Cost Band	Any Work Completed?
01/08 2014	G181	SU 4964 6506	24" Perry life ring within a Glasdon life ring holder and stand. NO rope is attached. The case does not shut properly. Vegetation in front of the structure.	Fit rope immediately and make repairs to the case. Clear back vegetation 3m from the structure to maintain visibility when required. Clean case.	1	1	All life rings are about to be refurbished and new parts fitted where needed.

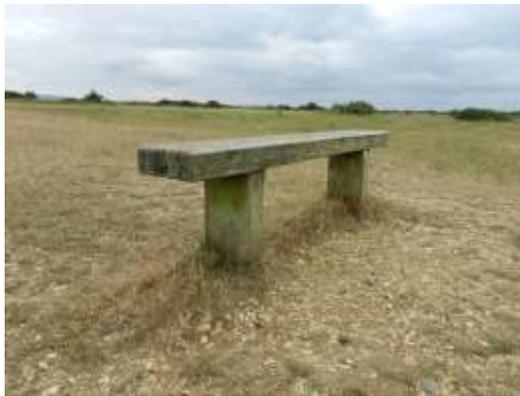
01/08 2014	G182	SU 4959 6502	Wooden bench with no back or arm rests. Measures: 183 x 26 x 60cm above the ground. The height is above the BBOWT guidance of 52cm maximum. The bench is sound and is showing signs of natural weathering. The location is good and well used.	Reinstate at a lower level and at the same time plane the top so it restores a smooth surface. Treat if necessary.	3	1	No.
------------	------	--------------	--	--	---	---	-----

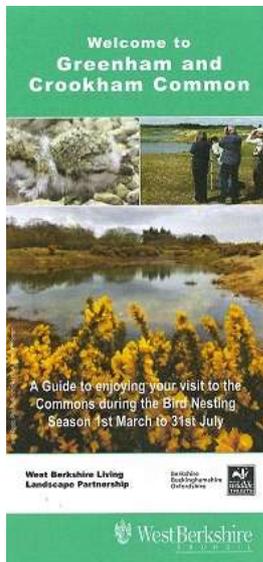
This leaflet was produced in partnership with WBC and BBOWT to inform visitors to the site about the red and green zoning that applies during the ground nesting bird season. It was a useful tool for the site wardens that were present during the nesting bird season. Due to BBOWT now managing the site on behalf of WBC some of the contact information is now incorrect. The leaflet also mentions the general regulations for access as detailed upon the Commission website. As mentioned in the background information, the CRoW Act does not apply to the whole of the Commons so it is not strictly accurate to put these regulations upon a leaflet that is for the whole of the Commons. The leaflet is not in print and there are no more copies being distributed. Recommend removing leaflets from public circulation if discovered.

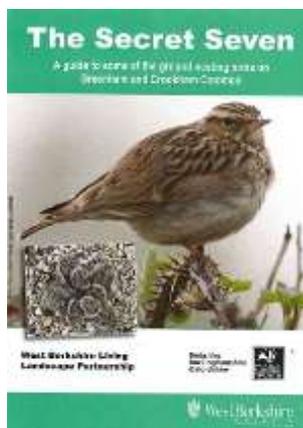
This leaflet was to aid the identification of ground nesting birds commonly seen on the Commons and to promote the Commons as a special area for wildlife. Again due to BBOWT now managing the Commons the contact details are incorrect.

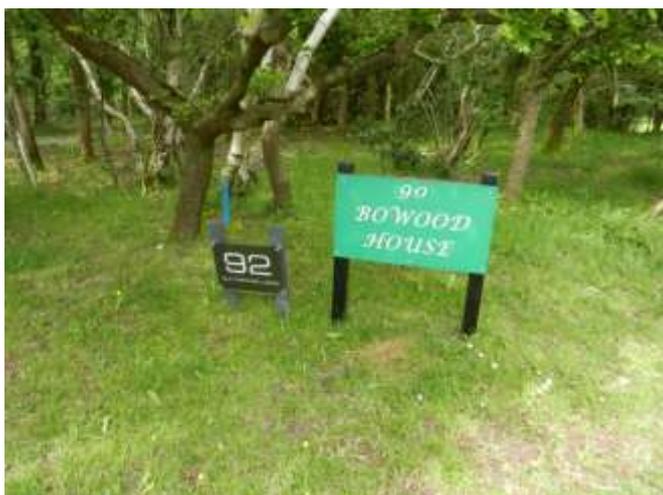
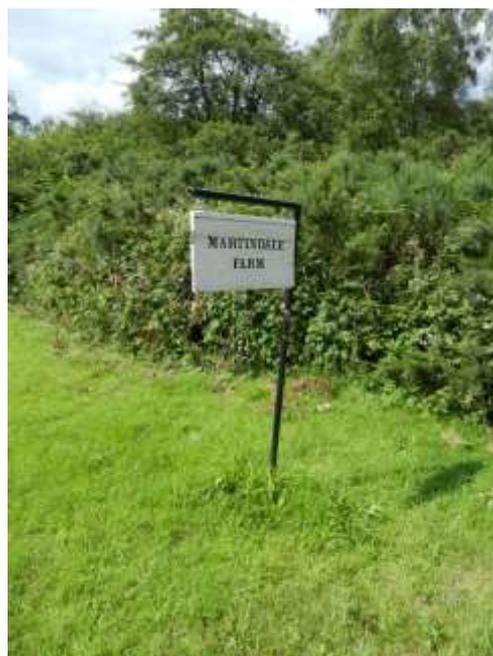
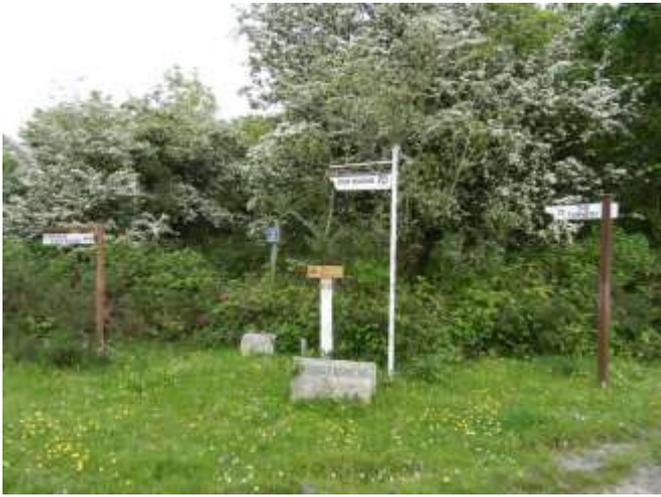
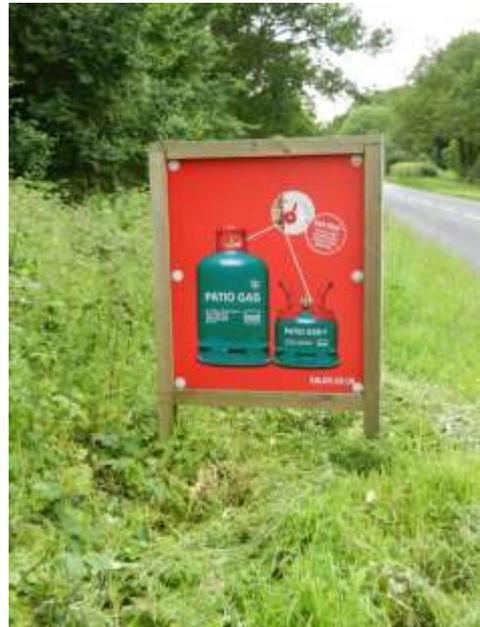
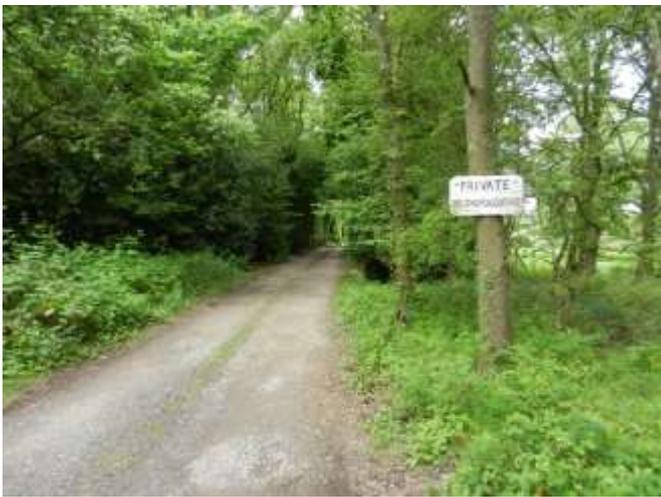
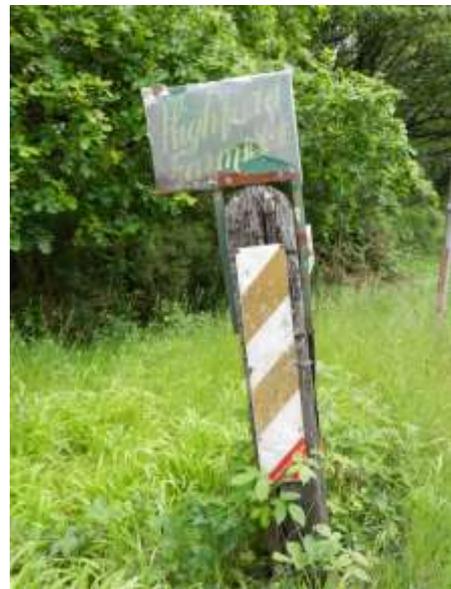
Private property signage is prevalent around the site in a wide range of designs and associated age and quality conditions. There are also signs for commercial enterprises such as that pictured above (Crookham). It is understandable that private properties would like direction/location signs so their visitors can find them. In relation to access, signage has the ability to:

- block access
- pose safety issues because of condition or location (blocking sight lines for example)
- confuse visitors trying to orientate themselves
- provide incorrect information as to the public access rights
- unaesthetically pleasing
- become waste (mainly temporary signage)

The recommendation would be to have a set of guidelines and designs as to what signage is permitted and where it can be located. The placement of commercial signage could also be within the design guidelines. This would have to be approved by the Commission.

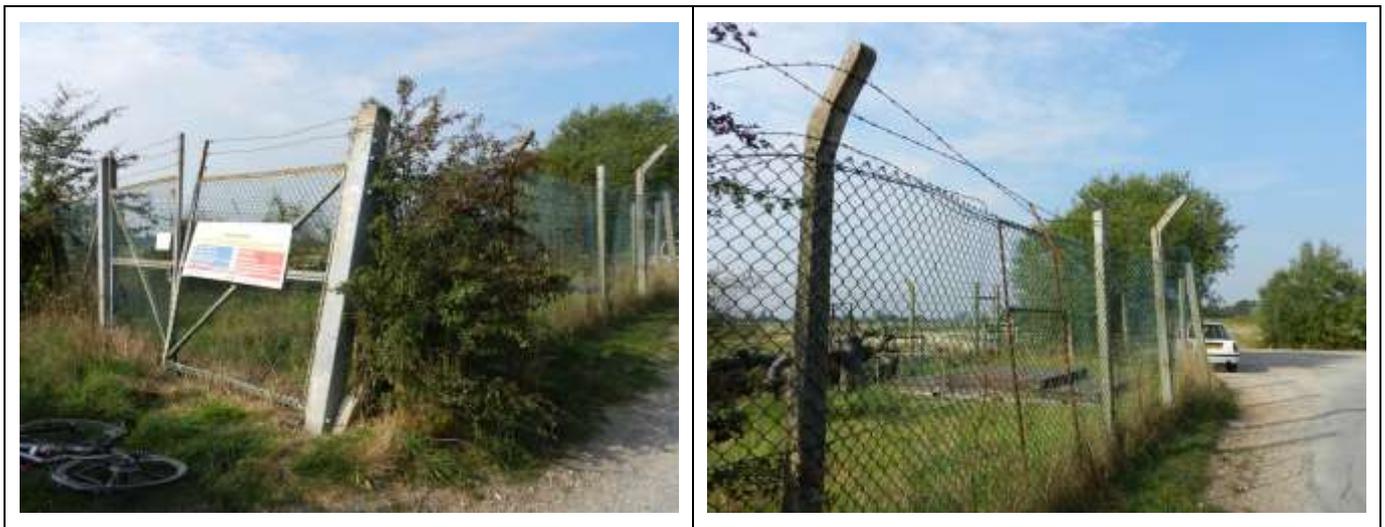
#### 3.7.3.1 Pipe line termination compound

The compound is owned by the Ministry Of Defence and so responsibility for maintenance and safety does not lie with BBOWT. All fences and structures have since been removed (March 2015). It is recommended to install dragons teeth and plant naturally occurring vegetation (keep low to retain view) to prevent parking upon this area.

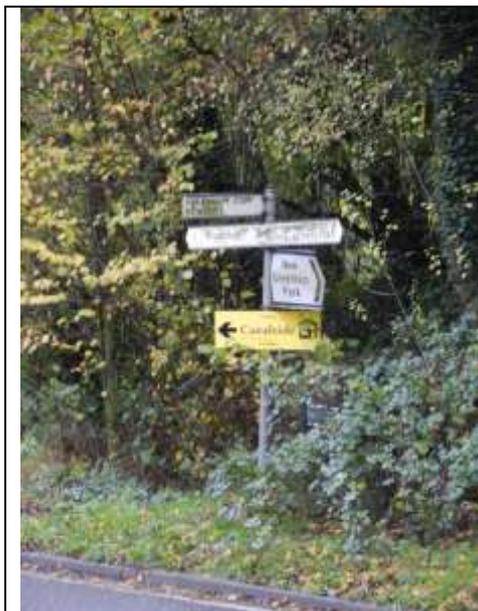
Greenham Common sign located on Crookham Hill at the junction with Bury's Bank Road. Photo looking north. The word Common has been abbreviated and the sign is very small and covered in green algae. SU52376539

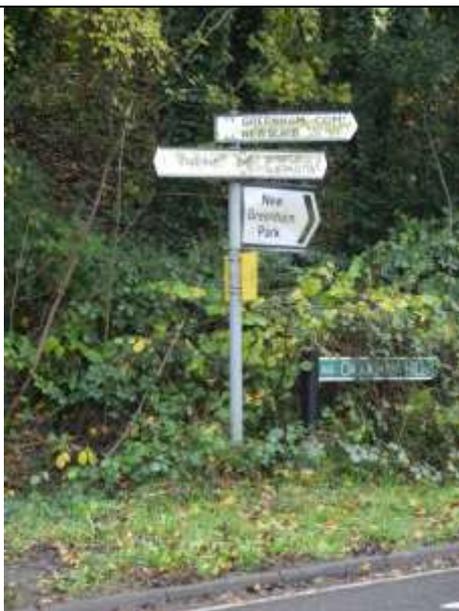
Greenham Common sign located on Crookham Hill at the junction with Bury's Bank Road. Photo looking south. The word Common has been abbreviated and the sign is very small and covered in green algae. SU52376539

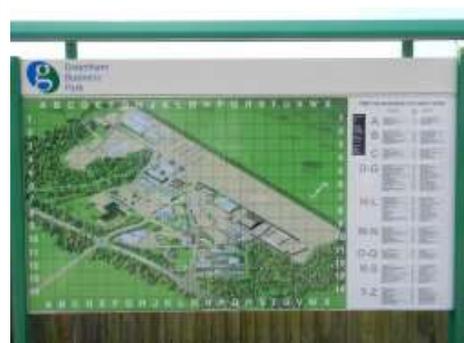
The Greenham Business Park site map. Access onto the Commons is not highlighted.

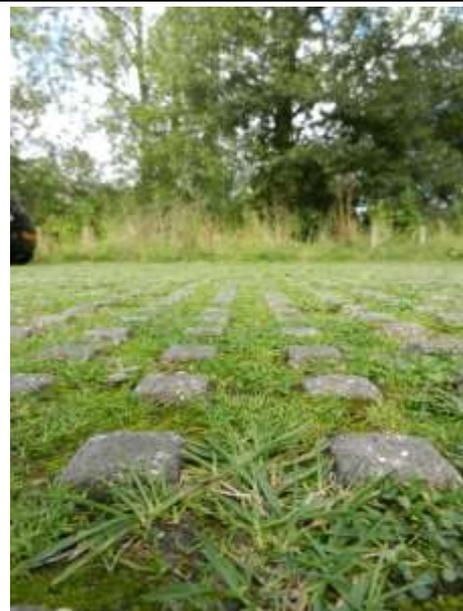
The car park surface uses a permeable concrete cell surface suitable for heavy vehicles. The type used means there are raised 'buttons' that are very awkward to walk upon and are not suitable for wheel chairs or pushchairs or those who use walking aids.

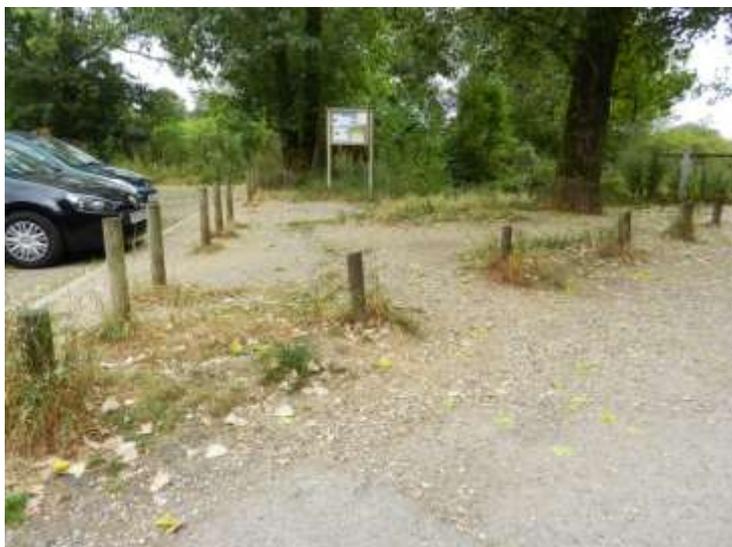
Access from the car park to the gates is either out of the paved entrance/exit or between dragons teeth wooden posts as pictured. Previously simple paths were formalised using logs but these were removed at the request of the auditor as they became very slippery when wet. Now the area is heavily worn and uneven. The notice board is inaccessible to those seated and difficult to reach if the visitor has an accompaniment.

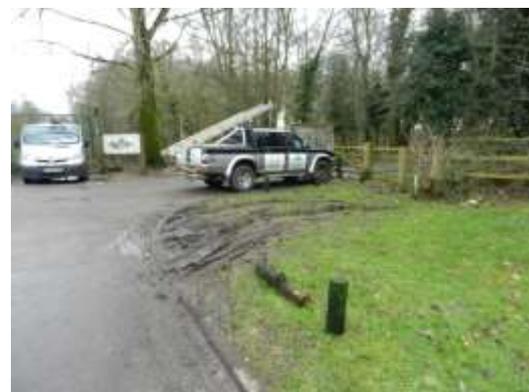
Cars park in the informal paved area as there are no restrictions. The gates can become blocked by vehicles and pedestrian safety is a concern. Once the 'dragons teeth' along the edge of the grass areas are knocked down vehicles pull on to them. The two vehicles in the picture would not have been able to fit under the height barrier and hence have parked where they are.

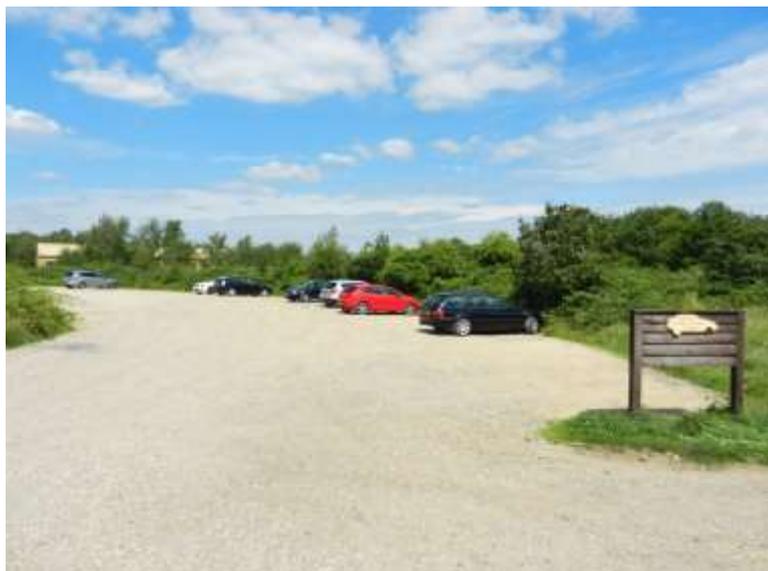
Photo looks north from the control tower building at the largest of the parking areas. The orientation and information board is on the right of the photo. The surface is unsealed and patched using Type 1 gravels. The vegetation between the car parking bays is becoming tall and dense so car and personal security is a worry. There are no individual parking bays.

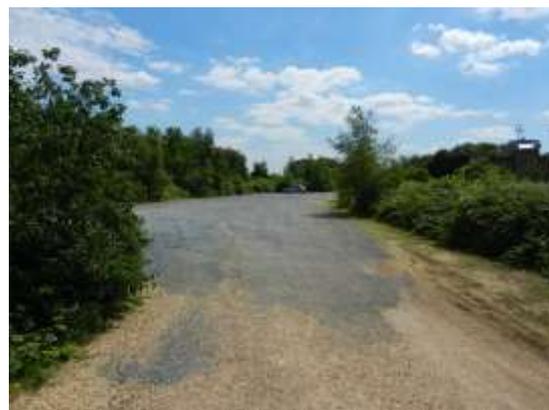
The second of the two parking areas to the east. Highways gravels were stored here and so there is a substantial amount of small gravels on the ground. This makes manoeuvring a push chair or wheel chairs difficult. This area is well used as it is quite enclosed.
