# Greenham and Crookham Commons Access Audit

*Initial baseline findings of the site's physical and intellectual access provisions.*

**Author: James Stevenson, BBOWT West Berkshire Access Audit Officer**

**Date: 27<sup>th</sup> April 2015**

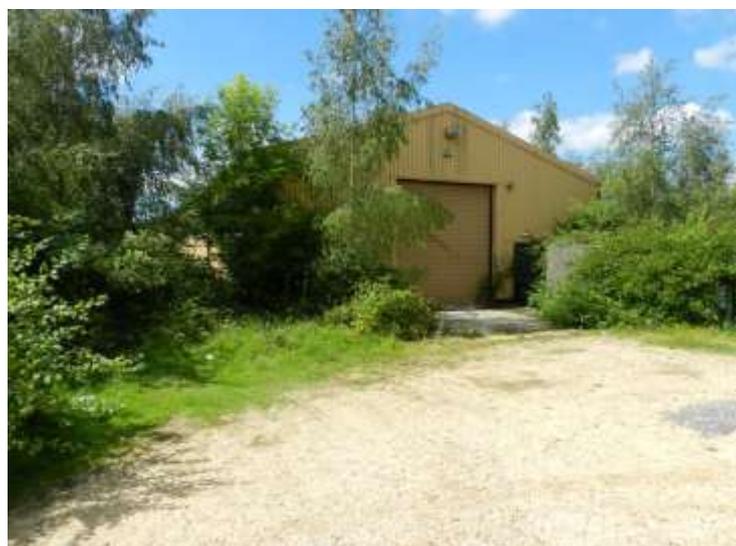
This picture shows building 150 which is within the car park area. A small enclosed area behind the building could feature unwanted activity and litter is found here on a regular basis. These areas that have no function as part of the car park should be closed to vehicles.

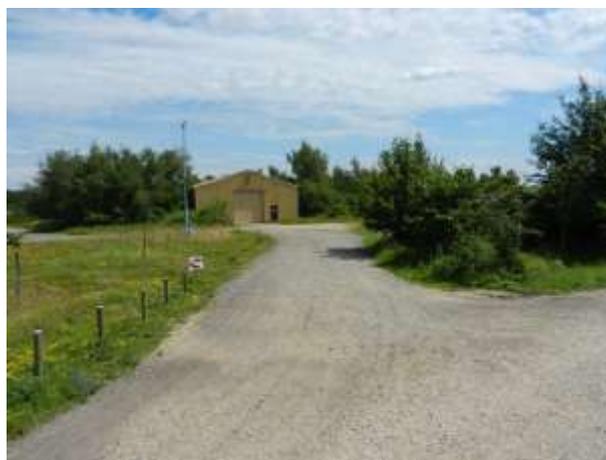
Signage within the car park has been vandalised and removed so there is no way visitors know which direction they should go. The junction pictured shows the track leading to building 150 and building 616 (now called Estovers). There is a small no entry sign which has little function. For security reasons and so visitors know where to park it would be advisable to have clear and easily readable signage. Deliveries to Estovers would also benefit of a directional sign at this point.

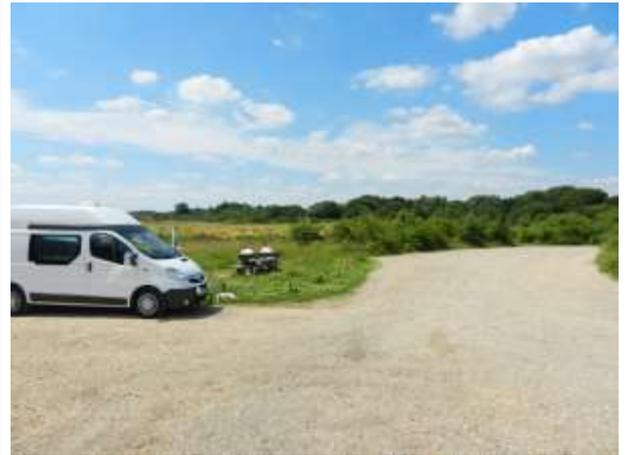
Ad-hoc parking needs to be managed so that access, views and function of the parking area is not adversely affected.

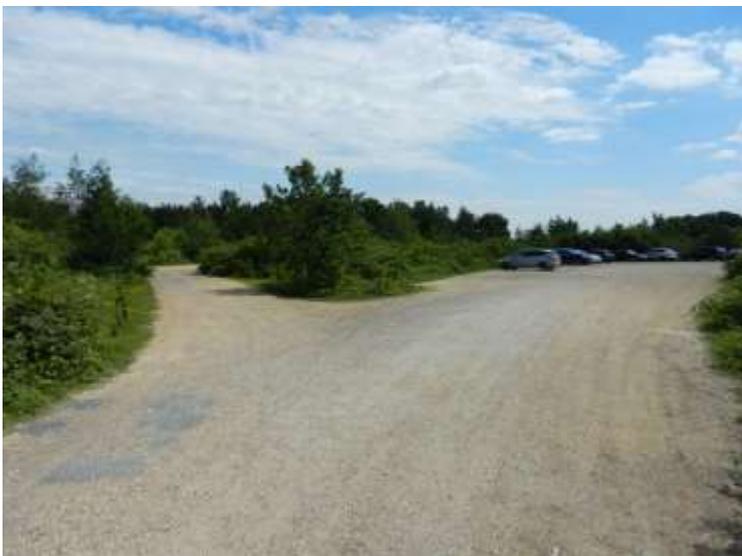
Where roads split, the right fork to the largest bay and left to the 'other bay' and access to gates onto the Commons, there could be vehicle barriers installed to manage the wear and tear on the permeable surfaces. For example, having a vehicle gate on the left fork would mean parking only in the main bay. This would mean a reduction in maintenance and during the off-season vehicles would park in a consolidated area and thus security of vehicles and peoples safety is likely to increase as there would be less lone cars.

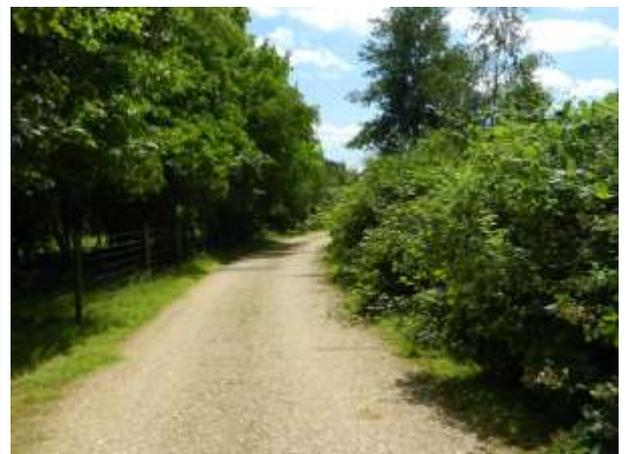
A single lane track on the east of the car park complex that performs little function and has no parking bays. Extraneous tracks increase management costs. Hidden areas also increase the risk of fly-tipping and unwanted activity.

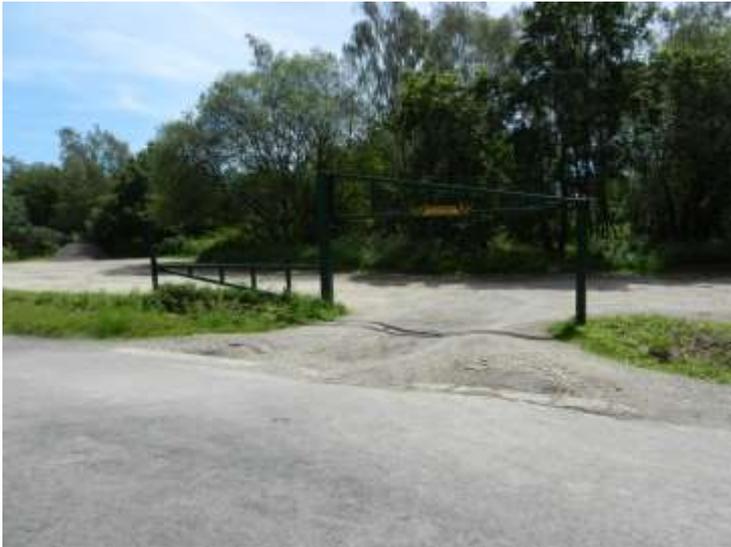
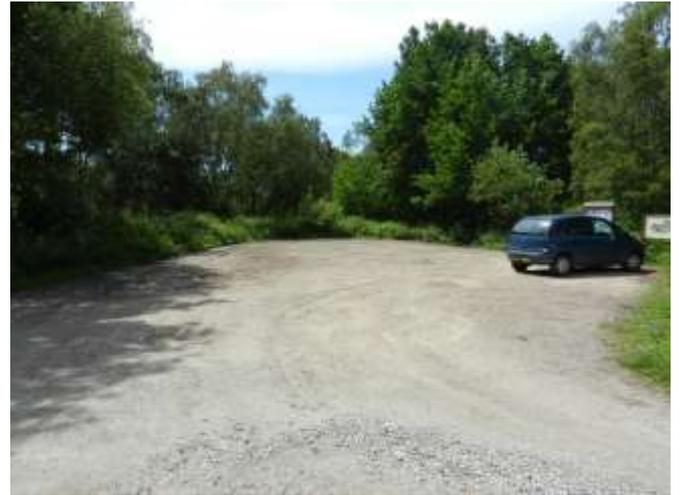
Crookham car park entrance is situated off Old Thornford road, and within eyesight of Crookham Common road. A height barrier and vehicle swing barrier is fitted to dissuade those with large vehicles or trailers wanting to camp or fly-tip. A height barrier will restrict legitimate users who are arriving in larger vehicles such as camper vans or who are towing horse boxes. In this instance because of the remoteness of the location the height barrier is required and the car park should be locked after dusk. It is recommended that should a need arise from those arriving with horse trailers or campervans, then an alternative pull-in could be built, but this is not a high priority given the existence of the main car park.

The surface of the car park is of naturally occurring gravels and added quarry stones such as Type 1. The informal area seems to be sufficient given the low numbers but should be reviewed if the car park becomes busier. Simple marked bays could be installed. The informal nature does mean that path entrances can become blocked which hinders access beyond. This could be rectified by using posts and simple signage to demarcate the entrances. As pictured, vehicles can park in front of the information signage. It would be recommended to have a boxed off section to allow visitors to approach the signage without hindrance and in safety. Just to the left of the vehicle pictured is a path that runs parallel to Old Thornford road to the Crookham pools entrance gate on the sharp corner. It is recommended that this path is opened up and signed accordingly so visitors know they can use the car park to access the main common instead of the laybys along Old Thornford road.

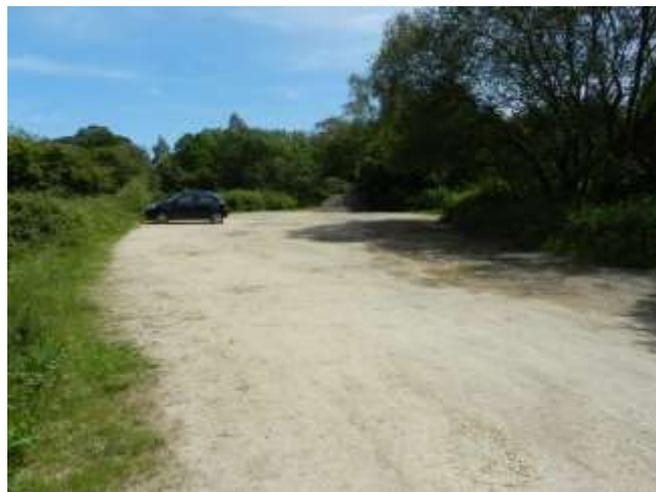
Crookham car park looking east. There are two small exits for visitors within this area, one into the un-grazed area which has had heathland renovation work in the last few years, and the other which runs parallel to Crookham Common road and gives access to the path networks to the East. The surface was in good condition.

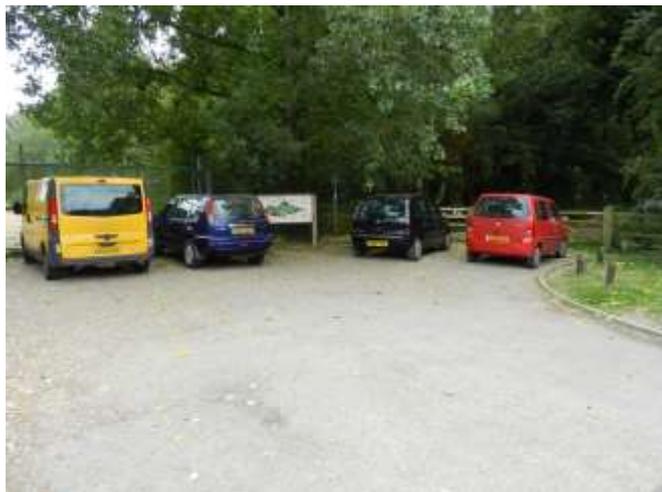
Pyle Hill. Parking restrictions are not in place so visitors legitimately park in front of the access gates.

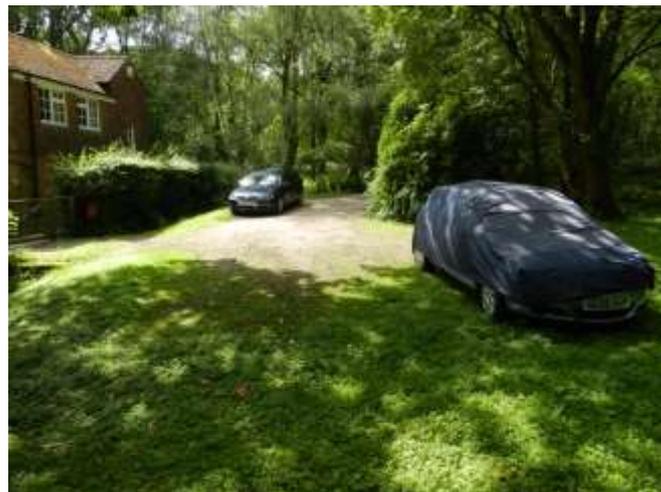
Parking around private properties is widespread with cars (taxed and untaxed), caravans and construction vehicles parked upon common land.

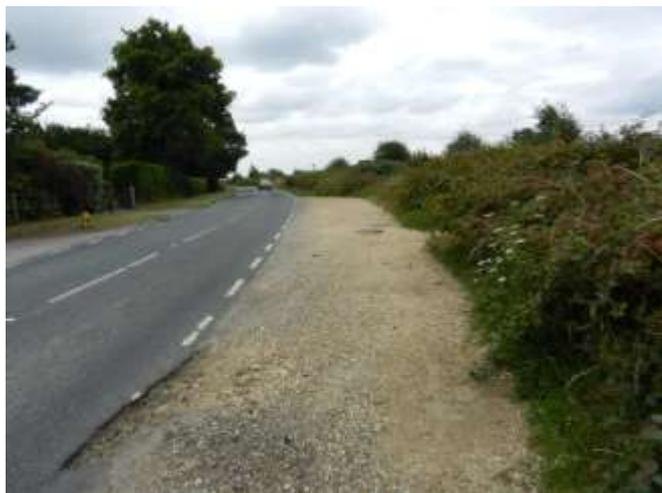
Bury's Bank Road. There are several laybys on this road that on occasion have gates through the livestock fence if present as in the photo.

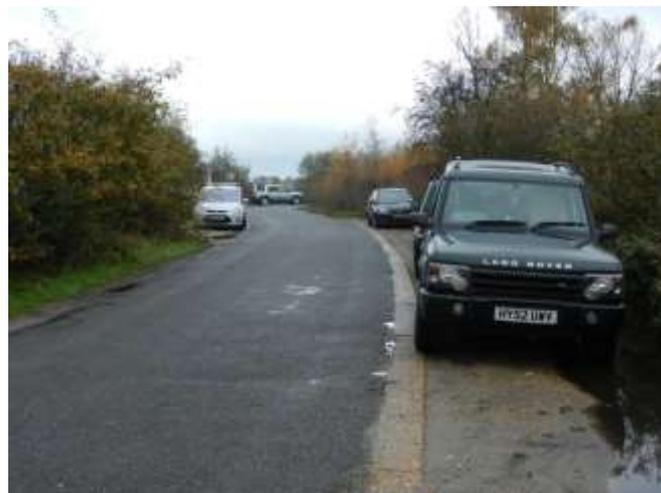
Old Thornford Road. The road is littered with pull-ins that are probably very old in their use. An interesting idea would be to close the road retaining the car park at Crookham as the access point to the Commons.

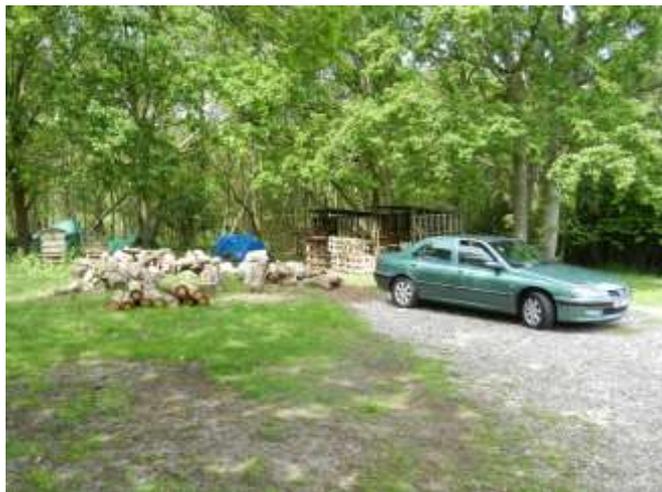
Frequently the auditor found structures built on common land to house outdoor machinery, cut wood, building materials etc. Vehicles were a common occurrence with at least 4 untaxed vehicles stored. This 'extension' of private residence not only looks unsightly and could be an environmental hazard; it also reduces the area that visitors can comfortably enjoy.

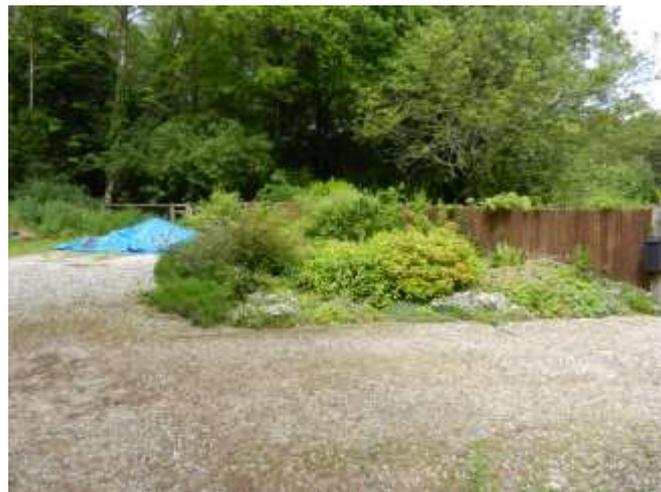
The auditor found extensive gardenisation especially to grassed areas and the cuttings were nearly always dumped nearby. In some cases garden plants were planted on the approach to private residences.

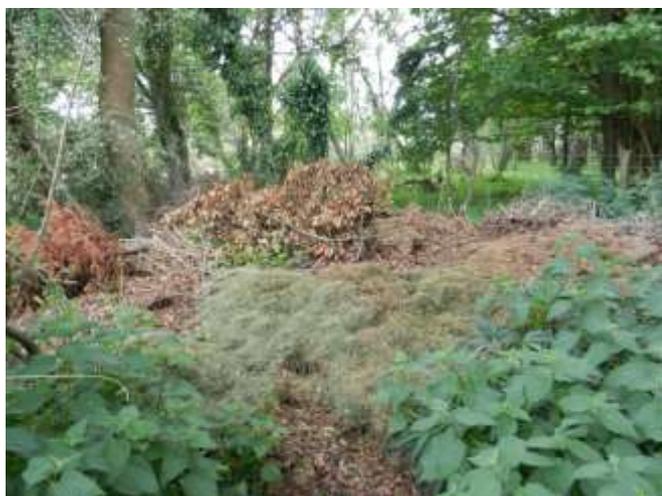
The most common occurrence is the dumping of green waste onto Common land. This occurs from private residents gardens and from the cutting of 'lawns' upon the common. There are several negative impacts from this encroachment namely; enrichment of habitats that require impoverished soils, damage to habitat due to smothering it, introduction of invasive species and garden varieties, obstruction of access and unsightly.

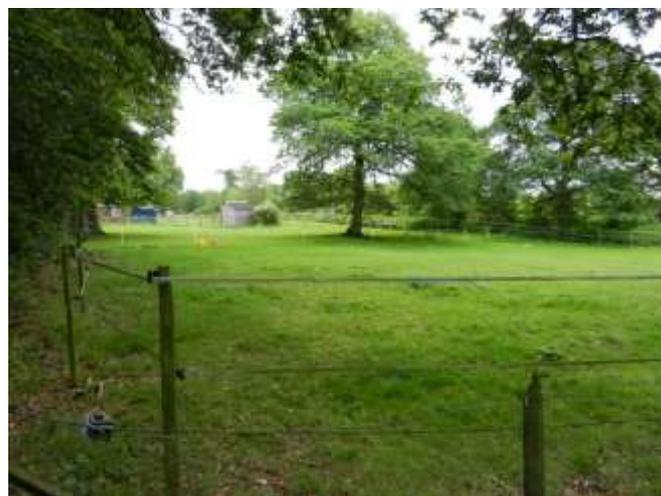
An example of a suspected encroachment where a paddock has been developed where in actual fact the common boundary is likely to be along the line of the tree seen in the distance. All boundary issues need to be checked against the definitive map. This encroachment reduces the available land that the public can enjoy.

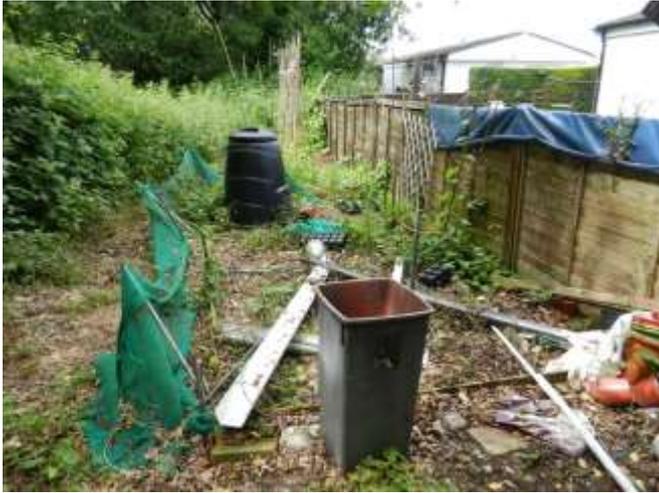
One of many examples of encroachment discovered along the edge of private land holdings. Even though some areas may appear to be of little wildlife importance, in actual fact dense scrub and woodland edges are very important. There was considerable evidence of waste, placement of sheds and movement of fences on common land in this area of Crookham.

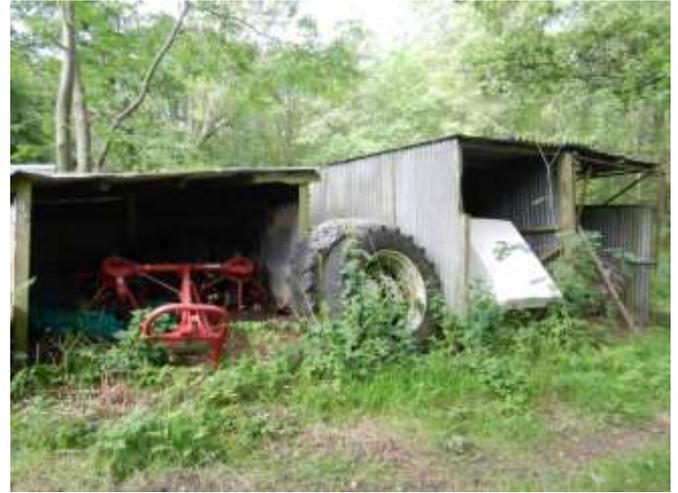
Using available definitive maps available to the auditor this possible encroachment was discovered where multiple buildings and stored machinery upon a very large area of the Commons. Other locations where machinery connected with business and private use stored upon common land were recorded. Hard standings are often installed using building rubble and the addition of access tracks to access the machinery.

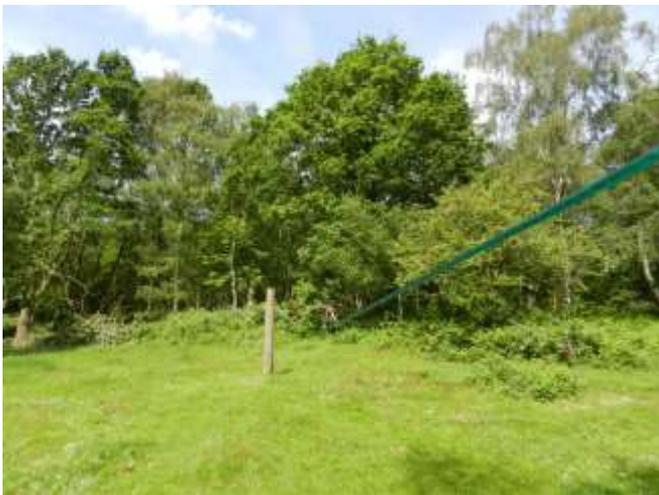
Around private residences there were found many occurrences where there was an extension of the land owners garden. Mown areas, clearance of trees and even installation of washing lines was recorded.

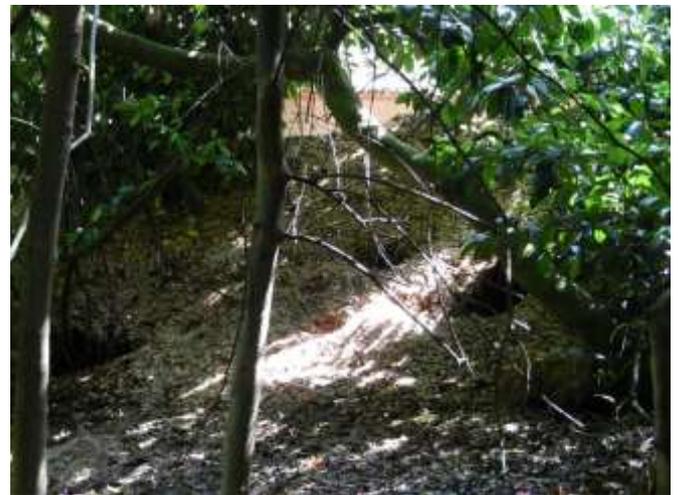
In this picture there is a mound of horse manure and bedding which was over 2m tall and covered a very large area which means a long standing arrangement of disposing of stable refuse onto the common. A gate in the fence next to the stables facilitated this activity.
